HOPE CEMETERY COMMISSION MEETING

Monday February 12, 2024 – 4:00 P.M.

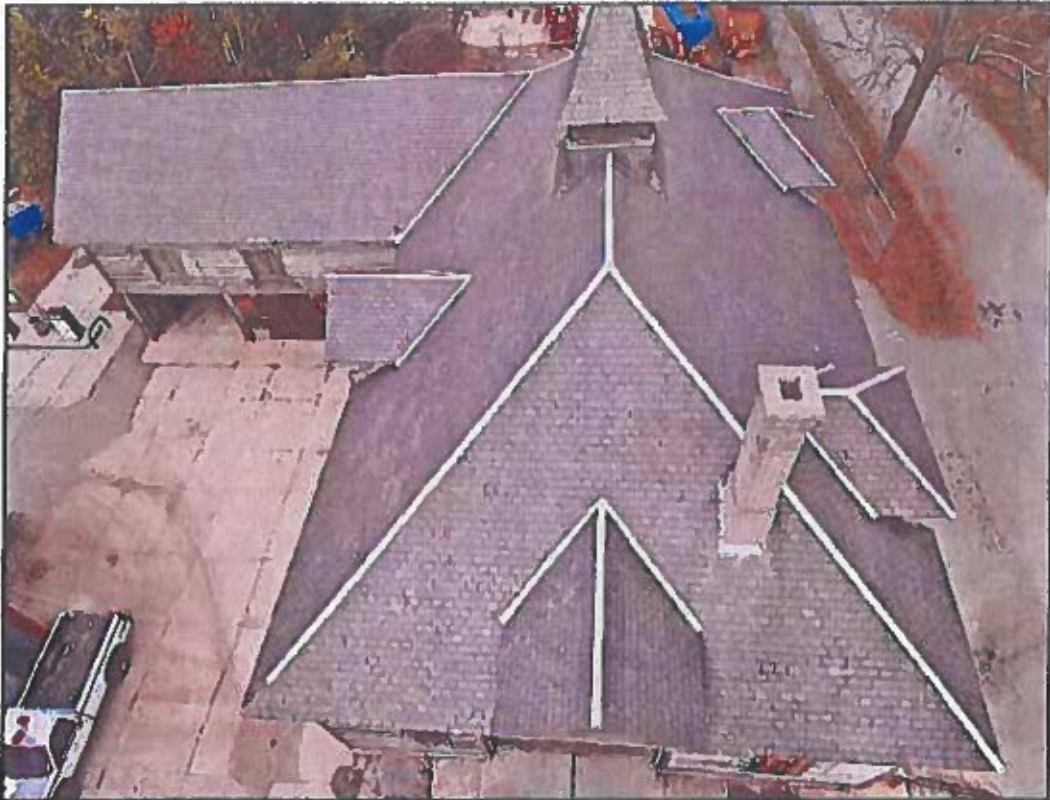
Photo 1: Overview of roof from south end.

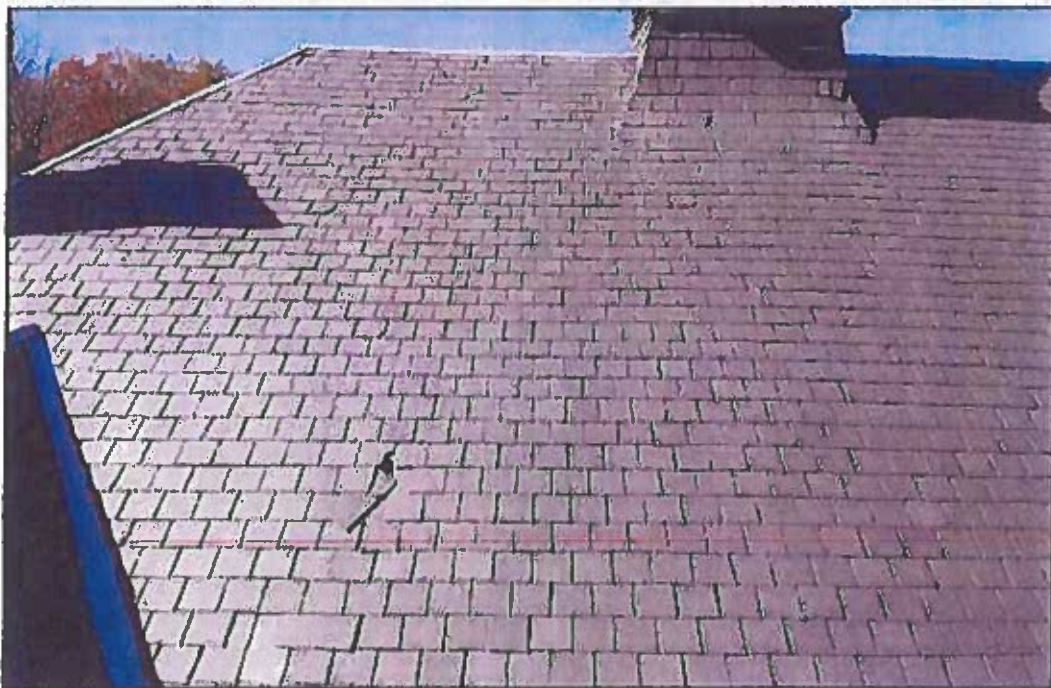
Photo 2: Southern end of east roof pitch. Only a few shingles show defects.

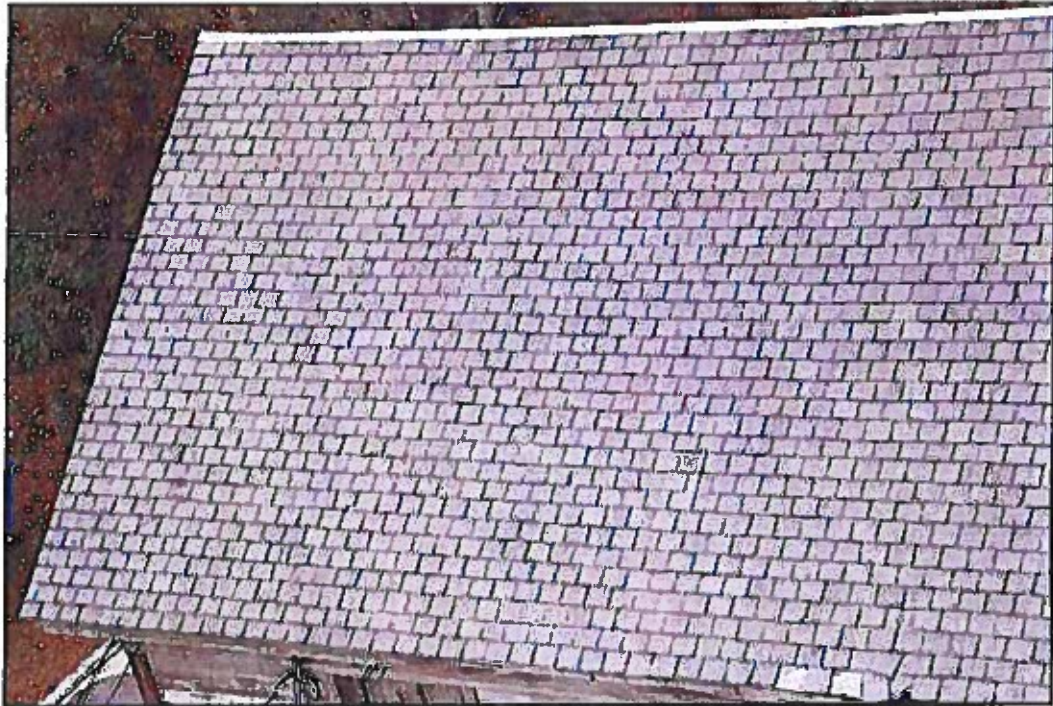
Photo 3: South pitch of ell barn roof. Note missing slates at lower right have caused considerable rot in the cornice directly below.

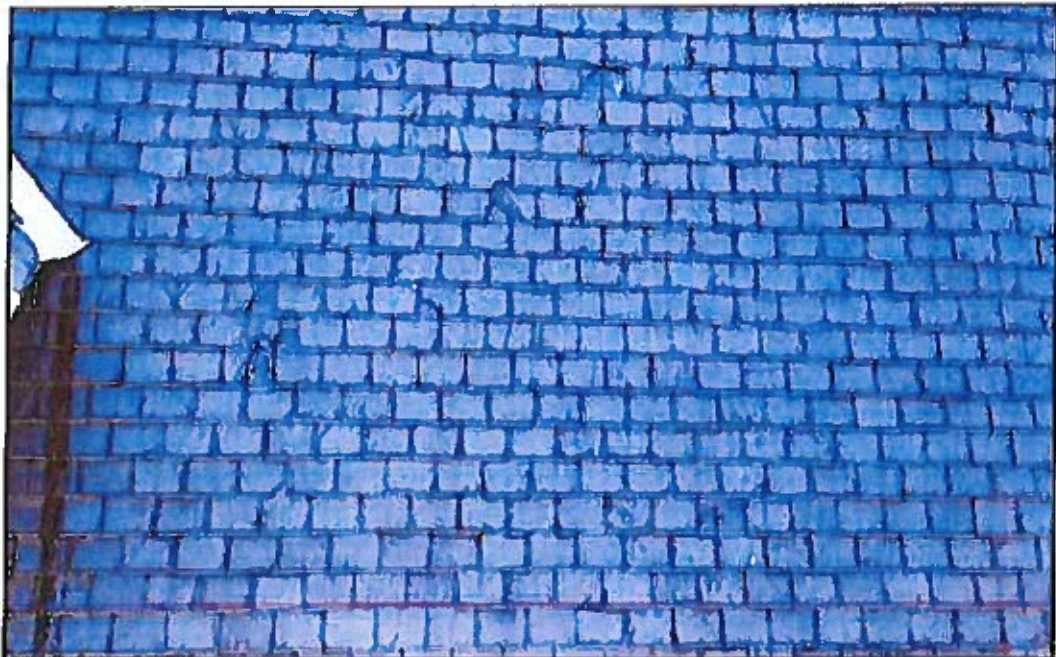
Photo 4: North pitch of main barn roof next to dormer.. This section has substantially more broken and cracked slate than other portions of the roof.

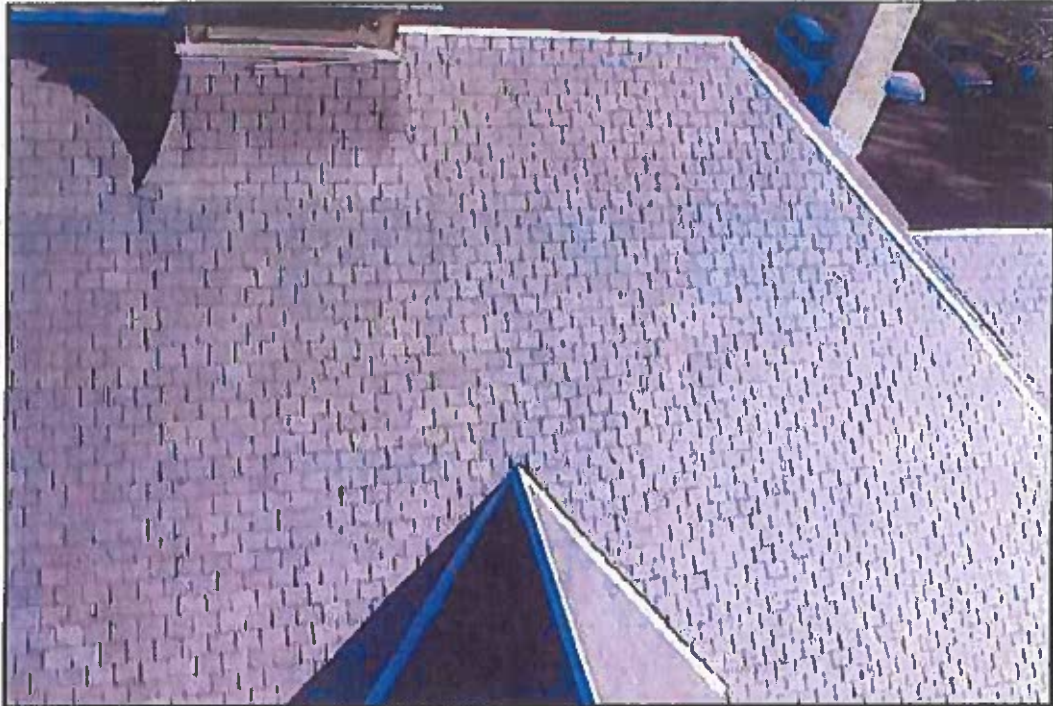
Photo 5: Southern end of west roof pitch on main barn. Only a few shingles show defects.

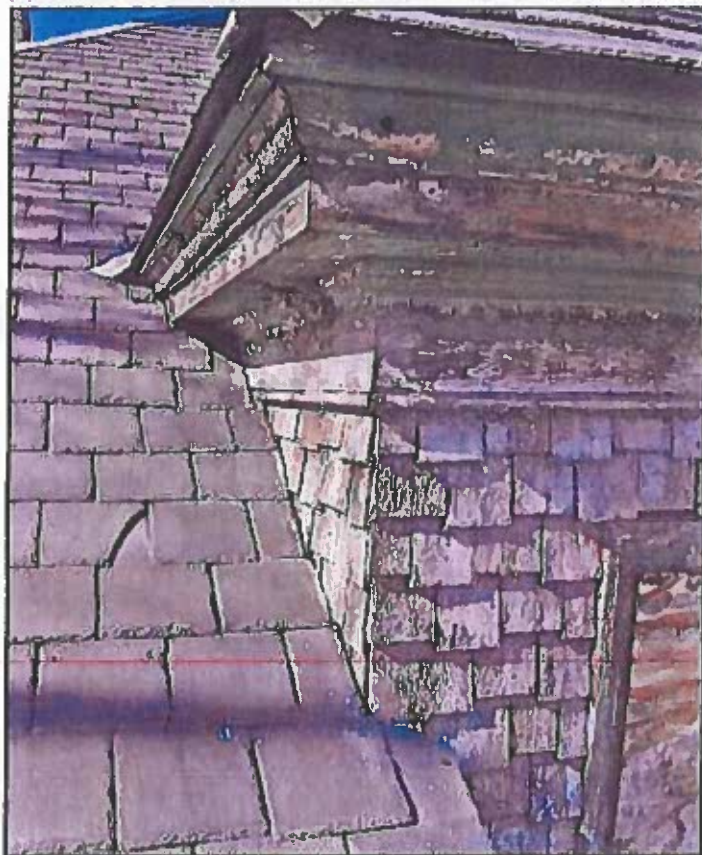
Photo 6: Detail of east pitch of main barn roof at southern dormer showing that wood shingles on dormer cheek wall extend below slate, and that the only flashings appear to be the original ones for the wood shingles under the slate.

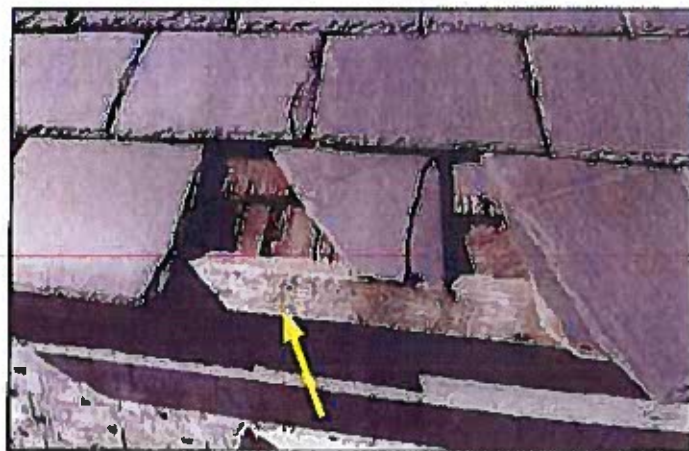
Photo 9: Roof edge at east pitch showing original wood shingles still in place under slates, and 2" high wood fillet (arrow) that was added to the crown molding when the slates were installed.

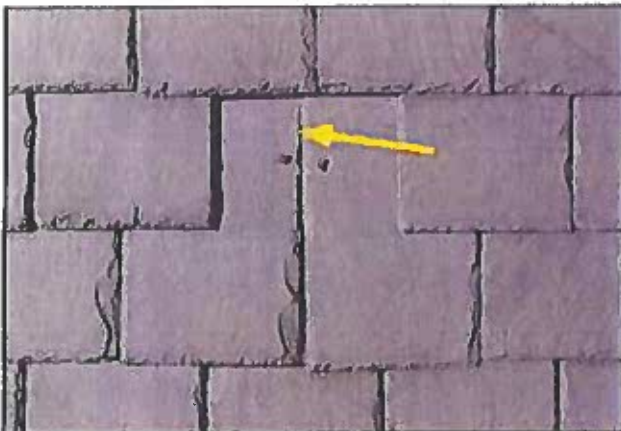
Photo 10: Slate defects - missing slate leaves joint between slates of the lower course exposed to the weather (Arrow) and potential leak. Replace missing slate.

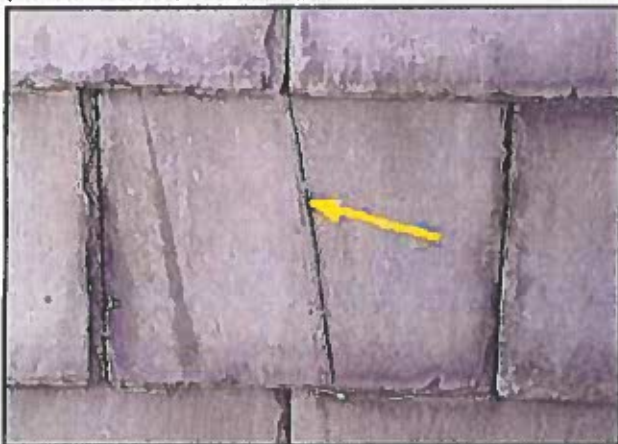
Photo 11: Slate defects - Cracked slate where crack is over or near joint of slates in the next course down is potential leak, Replace cracked slate or slip copper sheet under crack.

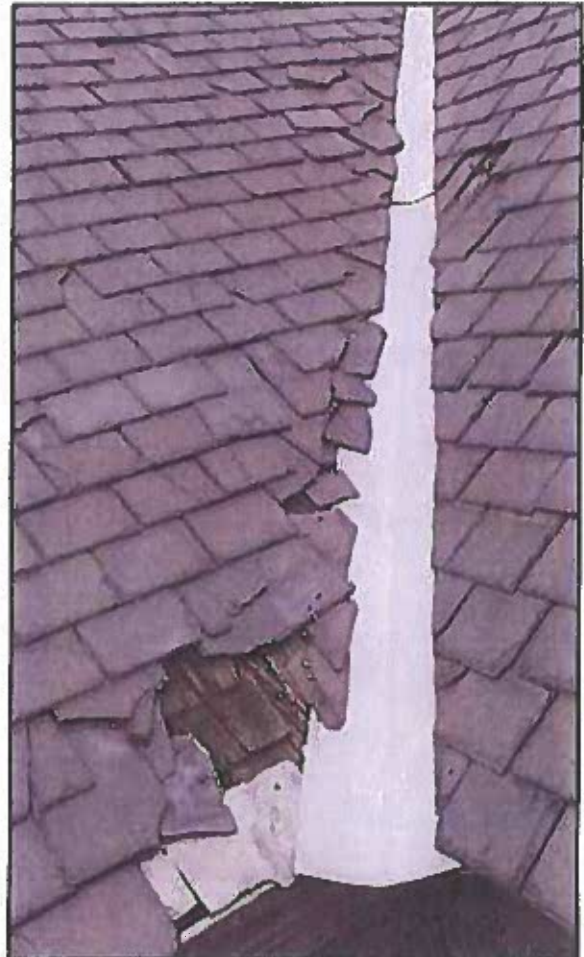
Photo 12: Slate defects - Substantial number of broken slate at south valley between ell barn and main barn roofs risks major water damage to framing below roof and should be repaired as soon as possible. Aluminum valley remains intact. Note wood shingles under missing slates.

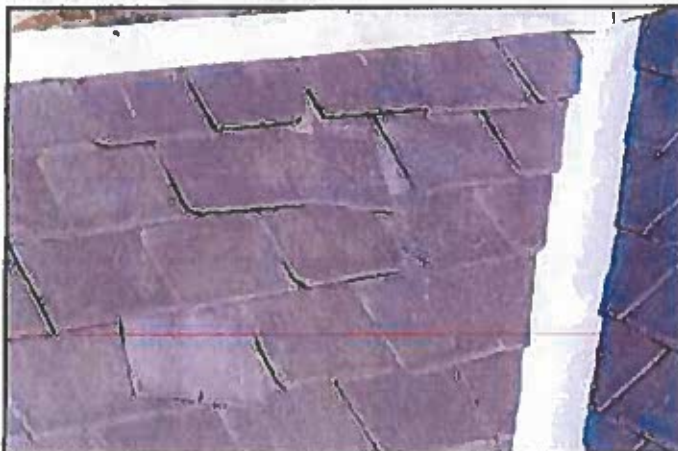
Photo 13: Slate defects - Slipped slates at top of valley shown in Photo 12 need to be refastened. This may be due to a failure of the nails to hold in the wood shingles below.

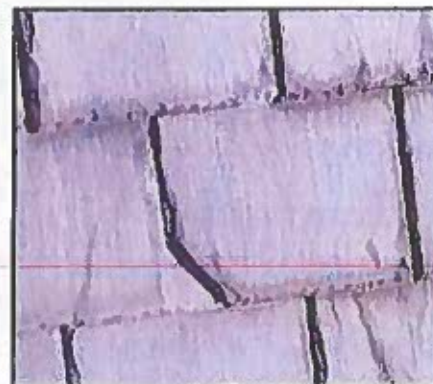
Photo 14: Slate defects - Broken corner. As break is not within 2" of joint between slates in course below, it can be left as is.

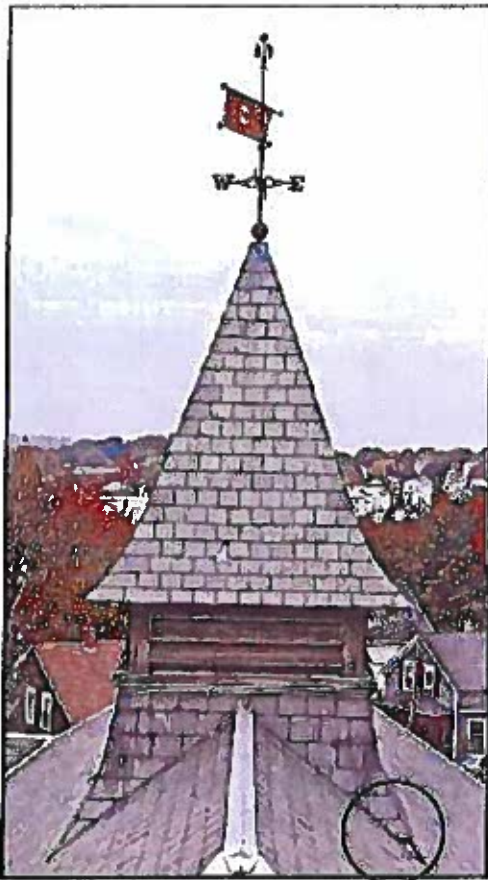
Photo 15: Overview of south side of cupola and weather vane.

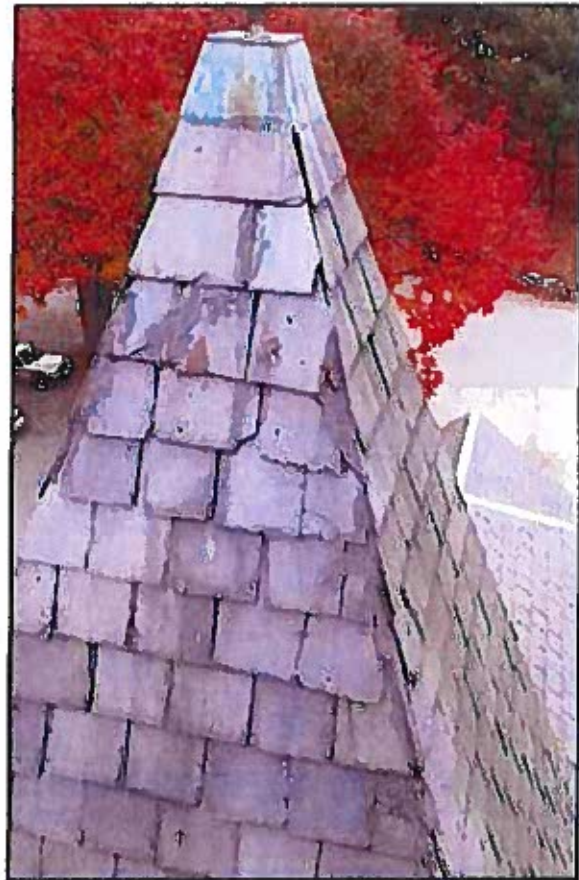
Photo 16: North side of cupola showing numerous loose or ragged slate with a number of roofing cement patches. Slates do not match the other sides. The slate on this face should be rehung, preferably with slate that is a better match to the original slate.

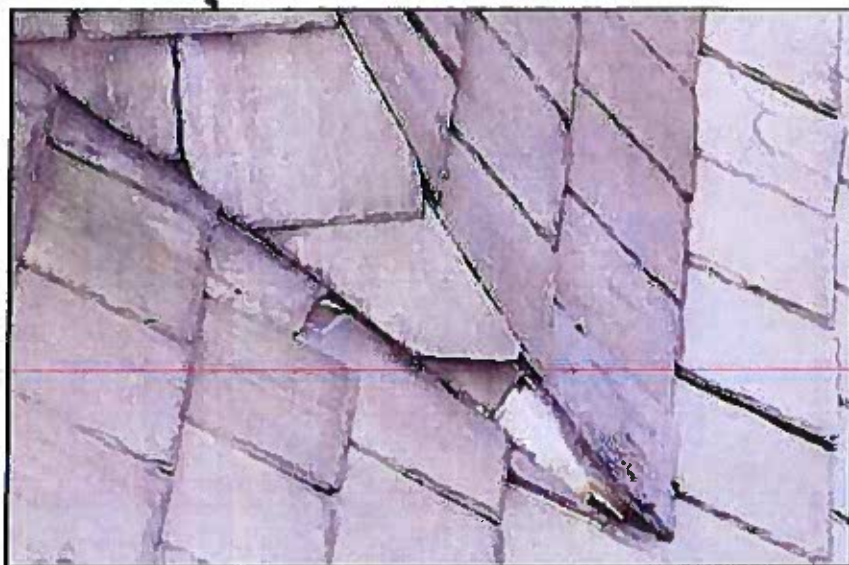
Photo 17: Flashing between cupola cheek wall and main roof is very worn where it is visible at the cupola base (arrow) and should be replaced with new copper flashings.

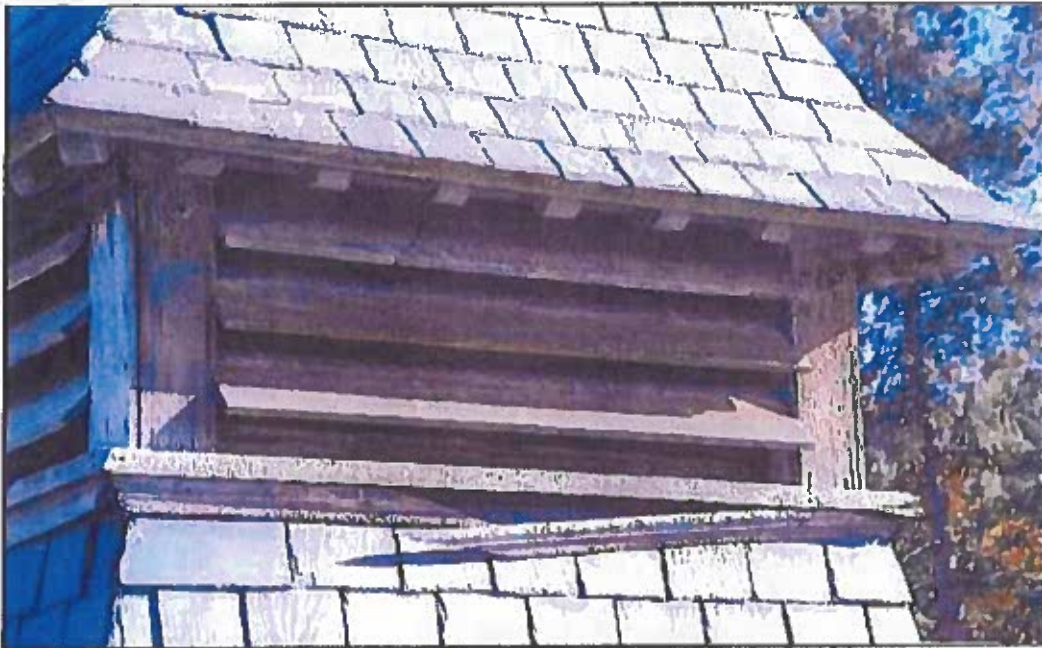
Photo 18: West face of cupola showing broken bed mold under sill. Bed mold on north face (left) is a mismatched replacement. Corner boards are weathered with small splits. Rounded modillion blocks under eaves appear to remain sound. Replace bedmolds and split cornerboards.

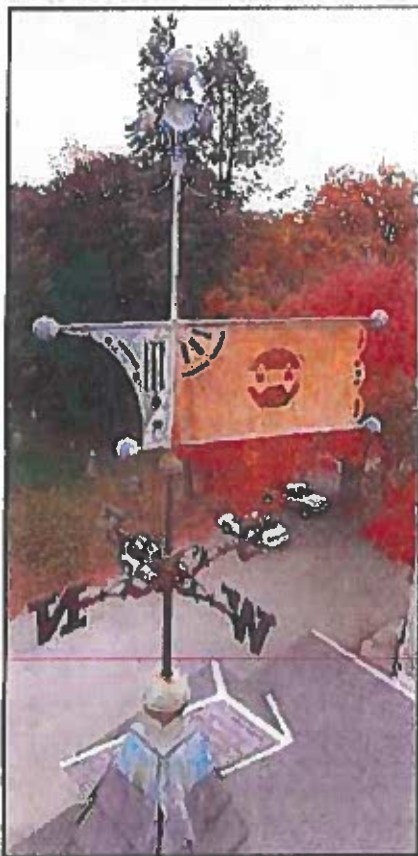
Photo 20: Overview of weather vane. Remaining gold color is probably the yellow ground for the gilding, which has worn off.

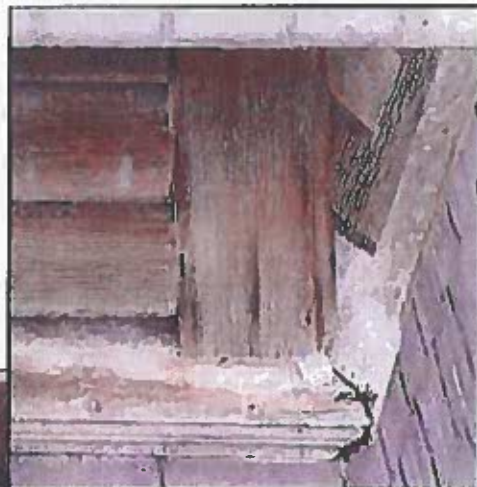
Photo 19: Detail of cupola showing gap at sill corner that was original covered with flashing, and moderate weather checking in louvers. Reflash sill corner joints. Replacement of louvers is an option, but not critical as they seem to be solid despite the weathering.

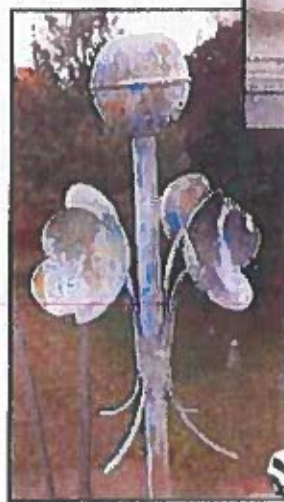
Photo 21: Detail ornament at top of vane showing traces of yellow ground indicating they were originally gilded.

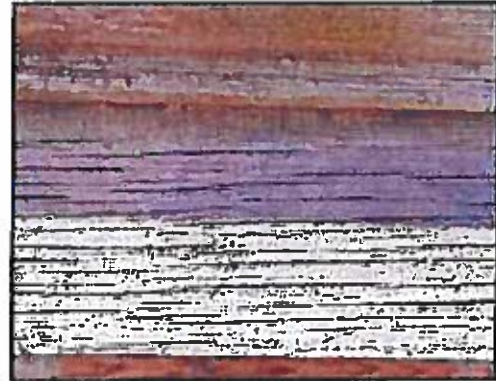
Photo 22: Detail of cornice fascia showing typical minor weather checking of otherwise sound wood. That the wood has lasted this long without rotting despite the absence of paint suggests it is more rot resistant than much modern replacement wood, and warrants retention if no other defects are present.

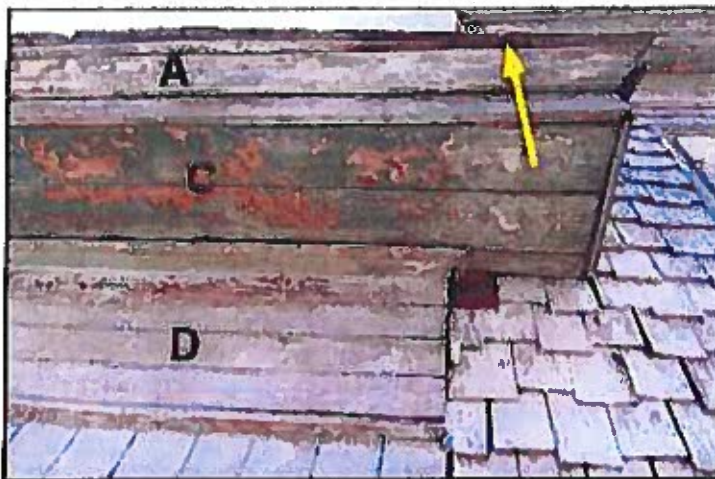
Photo 23: "C" marks soffit on underside of cornice. "D" marks entablature, and "A" marks cornice crown molding. Area shown is where former leak at dormer #4 has caused soffit boards to spread apart and edge of slate to dip due to loss of portion of support fillet (arrow). Soffit boards may need to be reset or replaced to close gaps.

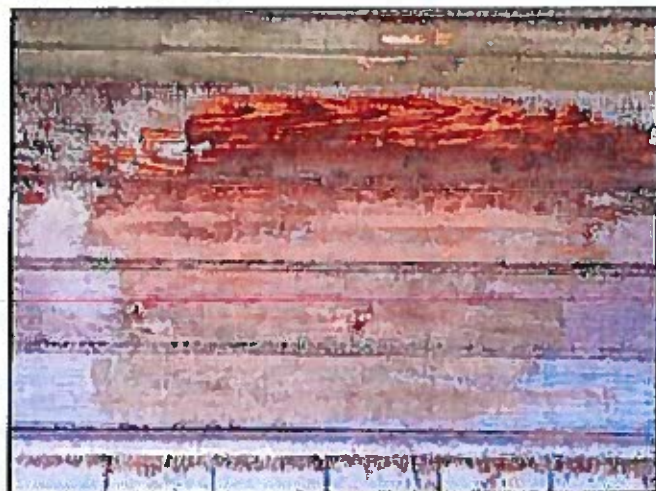
Photo 24: Entablature on east facade showing area where existing paint was easily scraped back to bare wood with a hand scraper. This indicates that paint to bare wood removal should be routine. The wood surface should be lightly sanded after scraping to remove surface weathering.

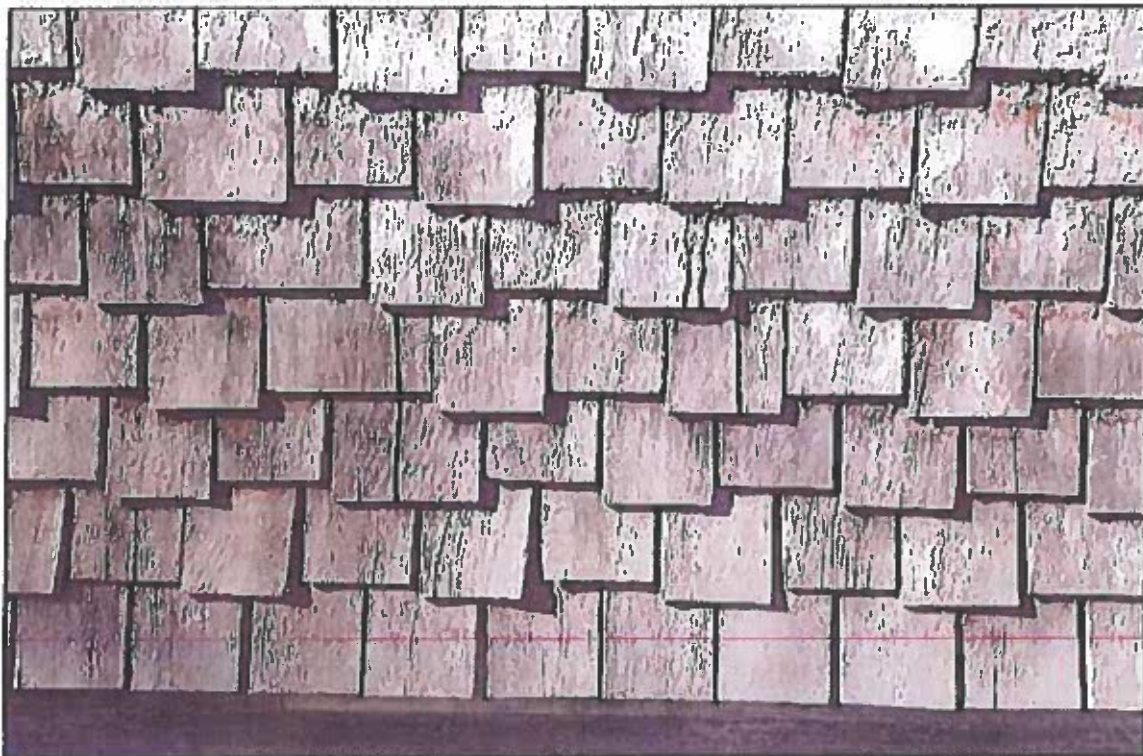
Photo 27: Section showing a few split or warped shingles. This illustrates the worst conditions observed on the east facade, and is still considered acceptable to leave as is with scraping to remove paint and repainting.

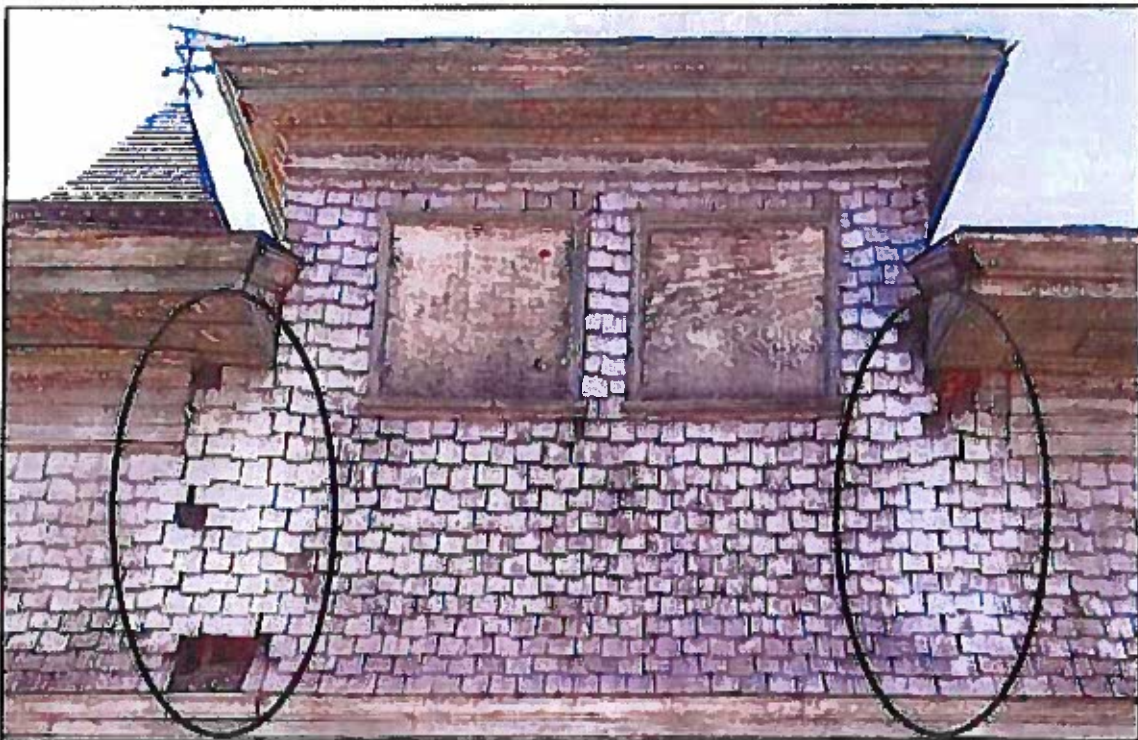
Photo 28: Shingle band below Dormer #4 on east facade showing damage to shingles from form former roof leak. Shingles in the indicated areas will require complete replacement to correct the damage and make the wall water-tight.

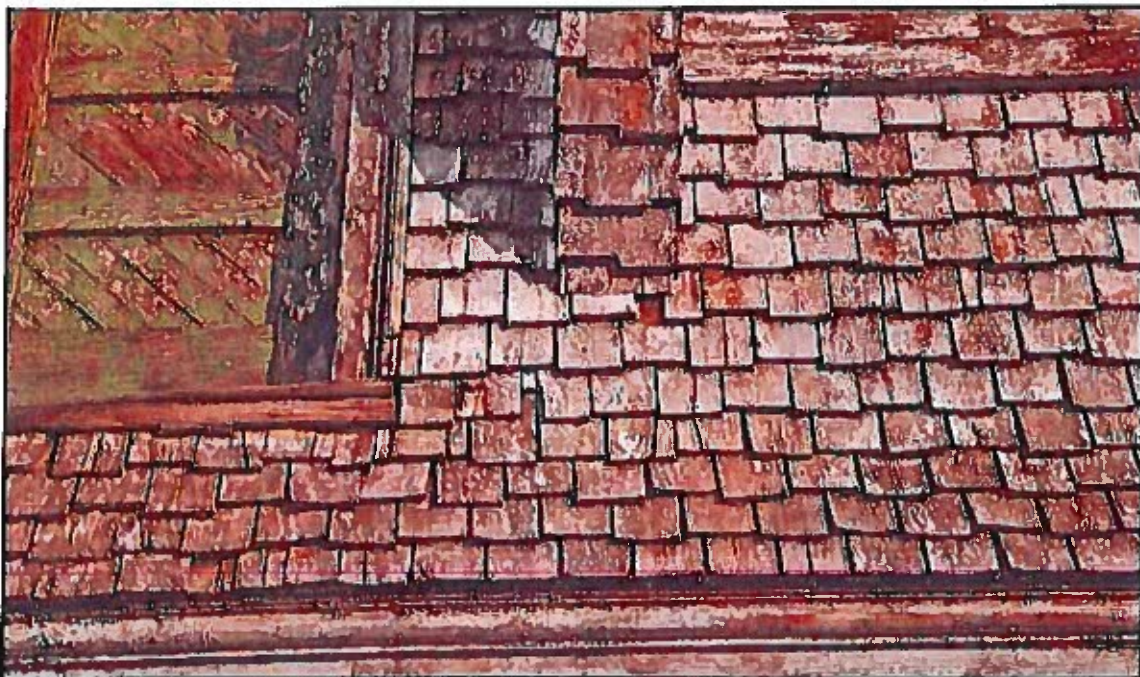
Photo 29: Shingle band adjacent to Dormer #1 on west facade showing many warped, split and missing shingles in lower portions. The extent of damaged shingles warrants complete replacement of shingles in this area, and possibly across the entire west facade.

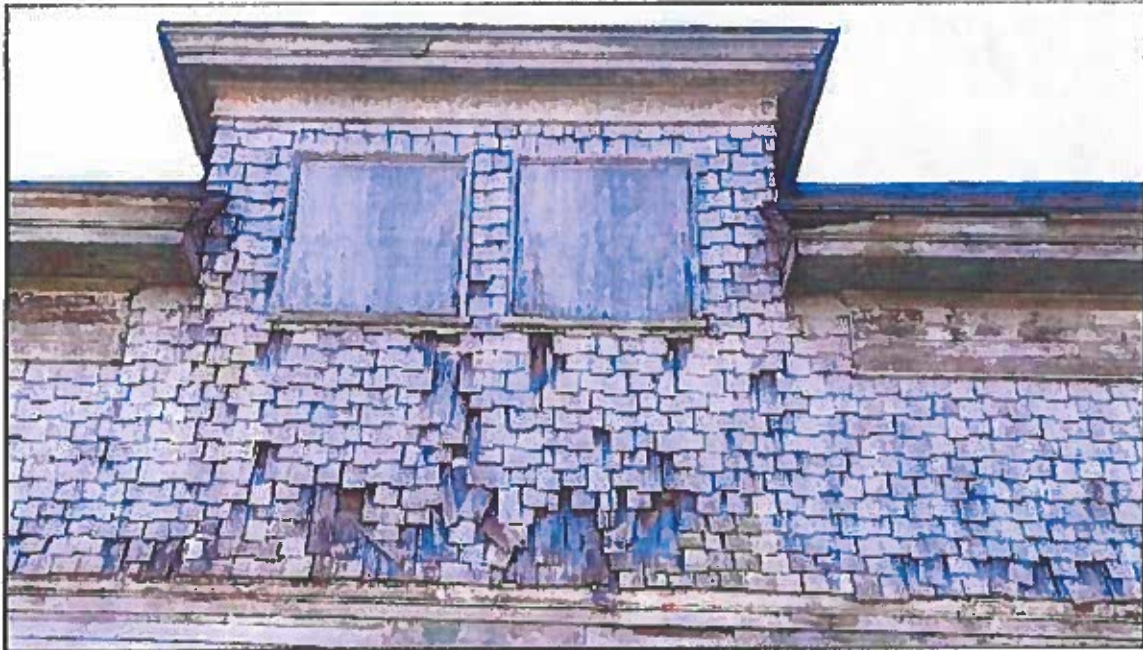
Photo 30: Shingle band adjacent to Dormer #5 on north facade showing many loose and missing shingles in lower portions. The extent of damaged shingles warrants complete replacement of shingles on this facade. Replacing only the damaged courses is not recommended as the top course of replacement shingles will not have proper cover over their nailing.

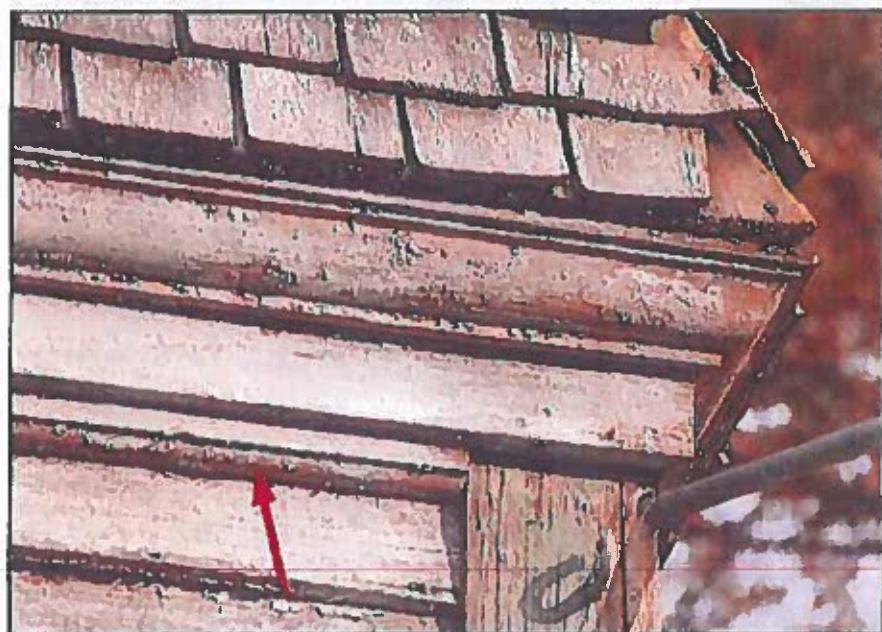
Photo 31: Detail of belt course below shingle band showing typical condition with only minor weathering. The belt course can be retained around the entire main barn (it is not present on the ell barn). However, the lowest member (arrow) and possibly other elements above it, may have to be taken off and reinstalled for proper installation of new clapboards.

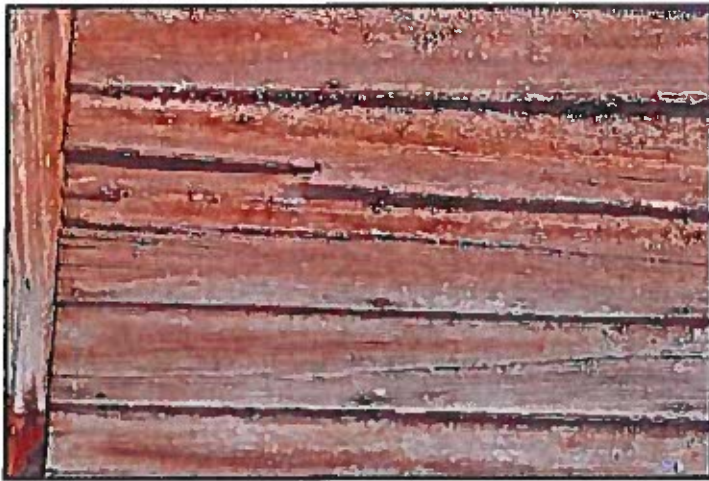
Photo 32: Typical clapboard conditions at west facade of main barn; severely weathered with extensive warping and splitting. All clapboards on the west facade should be replaced. The west facade of the ell barn and the south facade of the main barn are in similar poor condition.

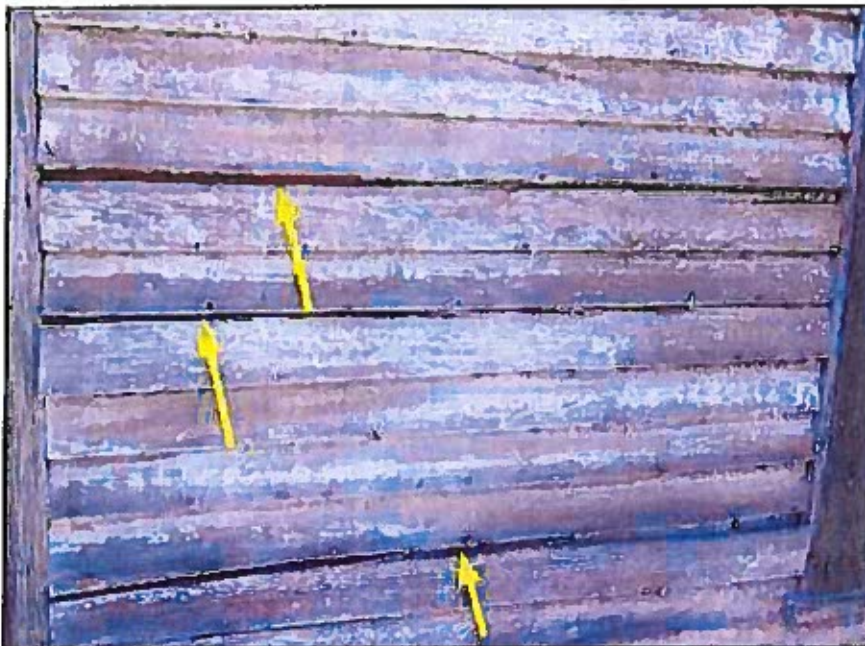
Photo 33: Typical clapboard conditions at east facade of main barn; At first glance they look better than the west facade, but a significant number have splits just under the laps (arrows) or are moderately warped. All clapboards on this facade should be replaced.

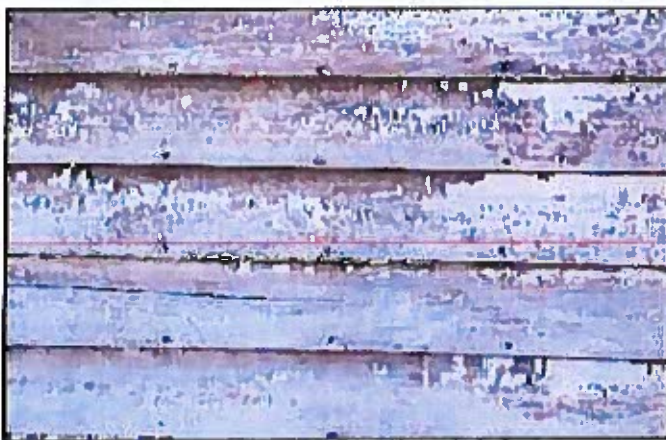
Photo 34: Typical clapboard conditions at north facade of main barn; weathering is moderate and splits are less severe and less frequent. Retaining the existing clapboards in place is feasible with replacement limited to badly split ones and the areas of missing clapboards around the windows.

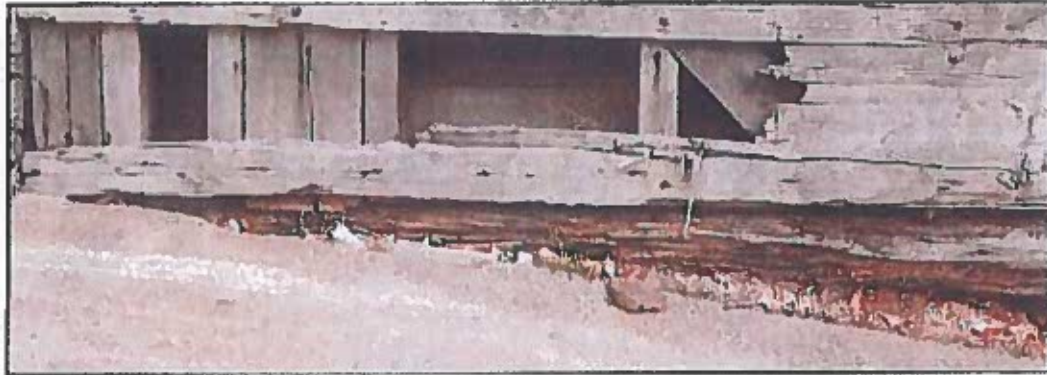
Photo 35: Sill at west facade of main barn to right of former door. The face of the sill has rotted, although the core may still be sound based on limited probing. The concrete apron aggravates the situation. At minimum repair involves splicing in new wood to replace the rot, and providing flashing for water protection. Further investigation is needed to determine the extent of rot, including the area under the door threshold.

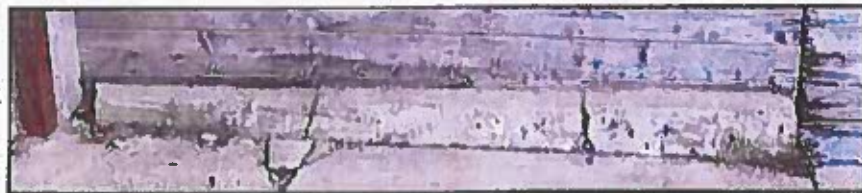
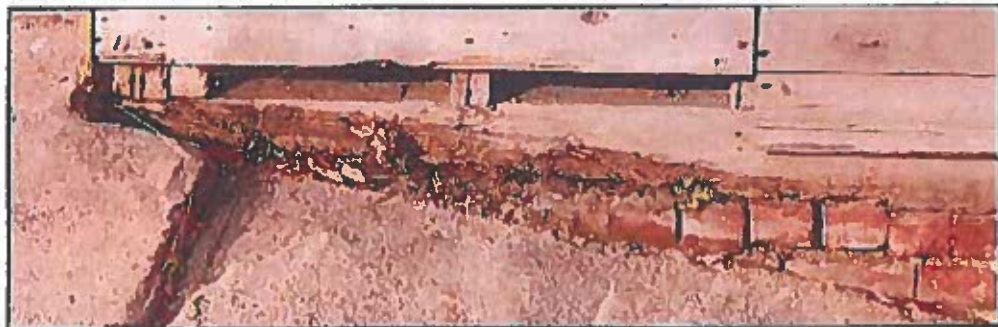
Photo 37: Sill at south facade of main barn to right of door. The face of the sill has rotted. Its condition and treatment need further investigation, similar to the sill in photo 35.

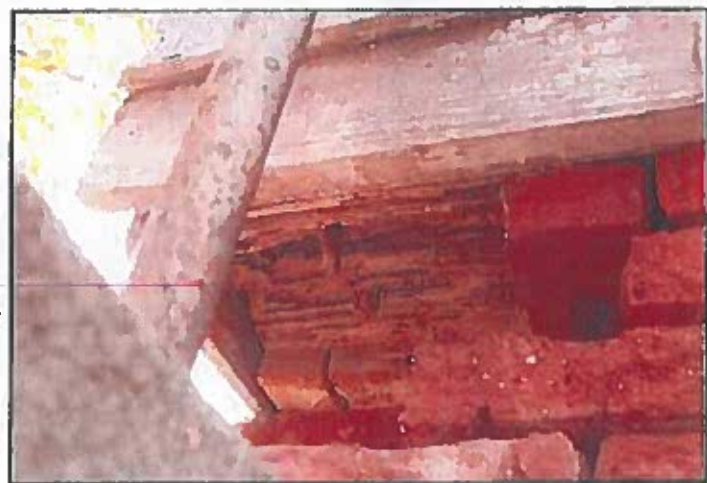
Photo 38: Sill at southeast corner of main barn. The underside of the east sill has lost several inches from insect damage and rot, while the south sill remains sound. The core of the east sill above the damage seems to be sound, and the visible damage only extends a couple of feet to the right. However, further probing should be done to verify the extent of damage. The sill needs to be repaired by piecing in sound wood to replace the deteriorated material, and the brick foundation rebuilt down to sound brick and mortar. In this case the full 12" depth of the wall need rebuilding at the top.

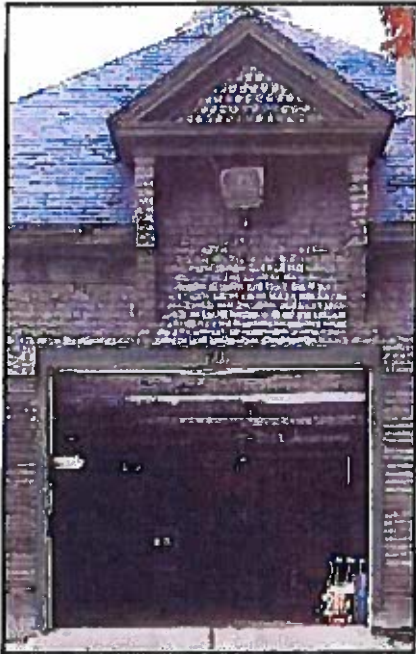
Photo 39: South facade main door. The opening has been widened to the left and increased in height to accommodate an overhead door and large vehicles. The top of the original door would likely have been below the bell course.

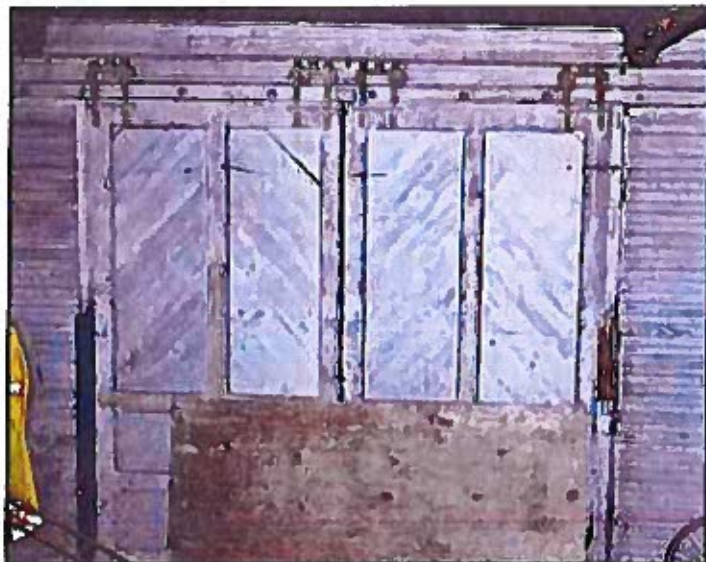
Photo 42: Original west facade main barn door with its original track and hardware remains in place behind the closed in opening. The original matched boarding that made up the panels may have been replaced with new boarding.

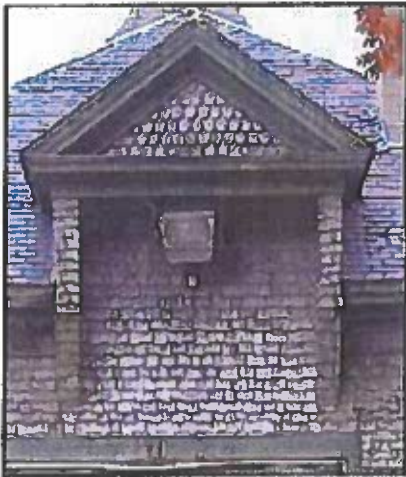
Photo 43: South facade dormer with shingled wall covering the original loft doors shown in photo 44 at right. Its original appearance matched the west facade dormer in photo 45 below.

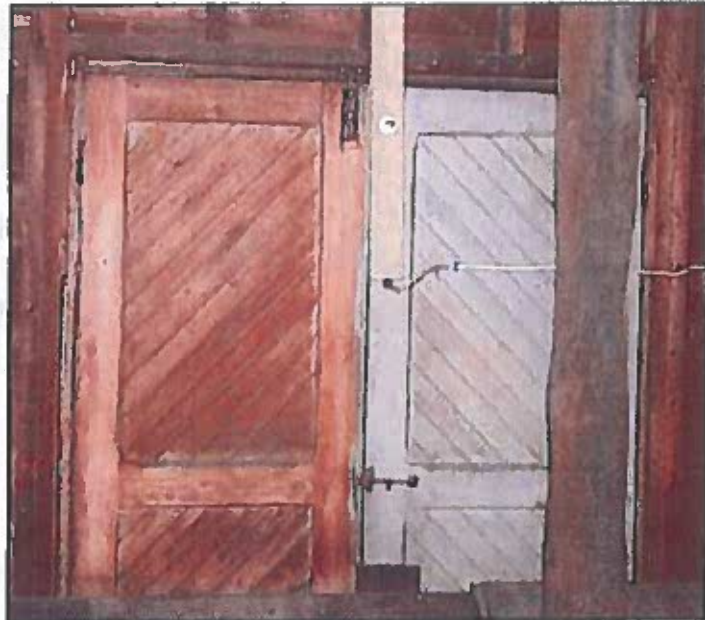
Photo 44: Original loft doors at the south facade of the main door remain intact behind the exterior shingled wall of the south dormer (see photo 39 at left). The doors should be repaired as needed and restored as a visible exterior feature of the dormer.

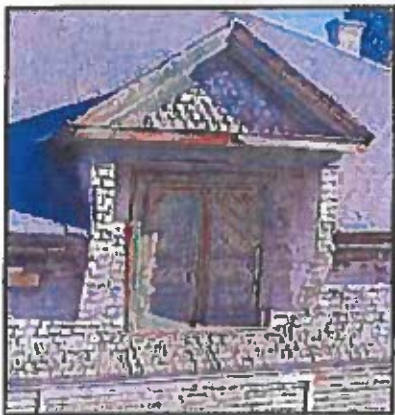
Photo 45: West facade dormer with original loft doors still in place. The doors should be retained and preserved as a significant historic feature. The trim on the dormer is extensively weathered needs to be replaced.

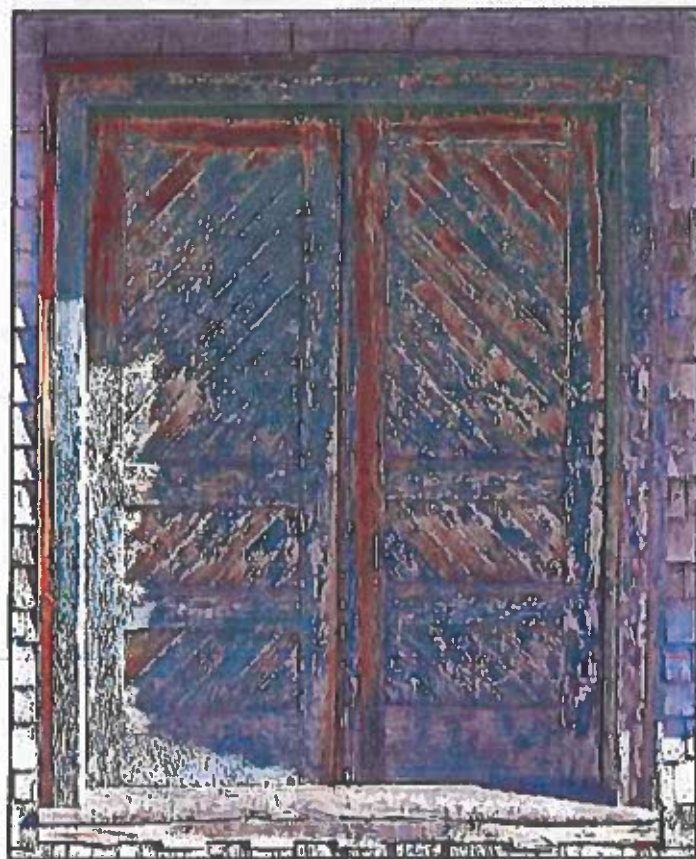
Photo 46: Original loft doors of west facade dormer. The original door and door jamb is intact. Missing moldings need to be replaced on the door frame, and some wood repairs need to be done to the rails and stiles of the doors, and the sill of the door frame may need replacement due to weathering.

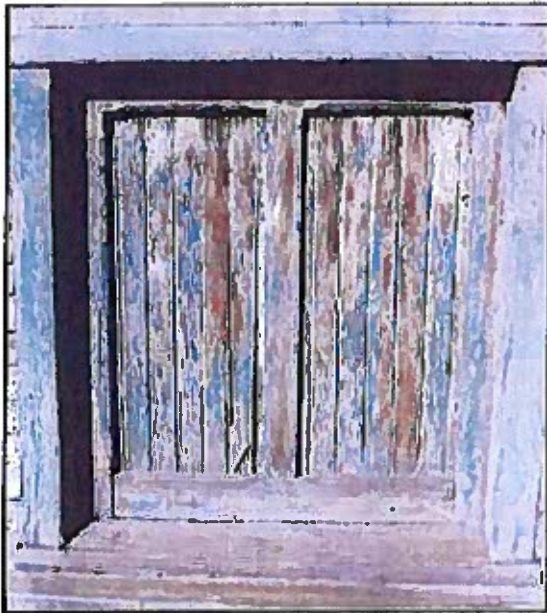
Photo 47: Original loft door of ell barn south facade. There are two original doors which should be retained and preserved. They are functional but have weathered surfaces and will need some carpentry repairs.

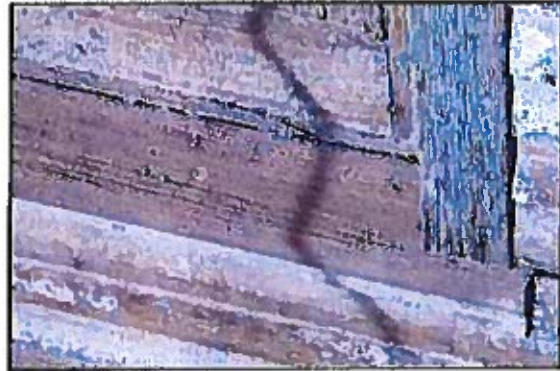
Photo 48: Deeply weathered surface of ell loft door sills will require extensive epoxy consolidation or replacement.

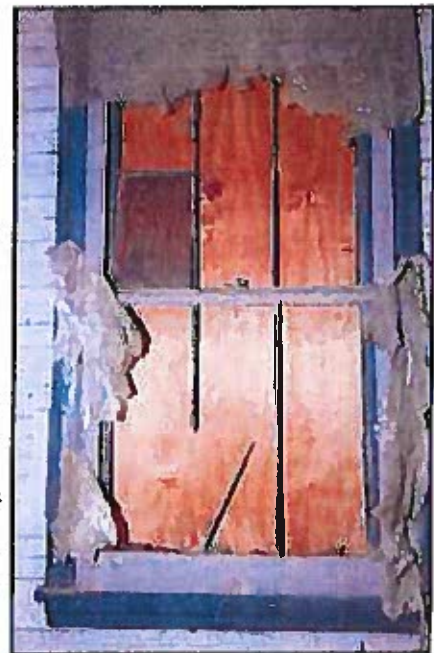
Photo 50: Interior side of first floor main barn window showing molded casings that should be retained and preserved. Sash are missing muntins (i.e., glazing bars), and should be replaced with matching new wood sash set in the existing original frame.

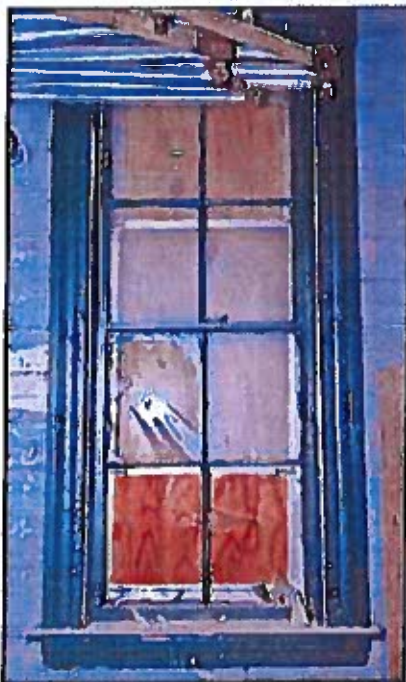
Photo 49: Interior side of first floor main barn window showing molded casings that should be retained and preserved. Sash are intact and can probably be retained with new glass and glazing.

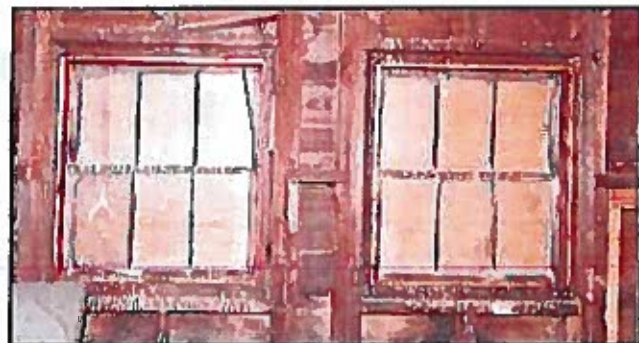
Photo 50: Interior side of first floor main barn dormer windows showing intact sash in frames without casings. The sash and frames should be retained and preserved with reglazing unless the exterior side shows severe damage.

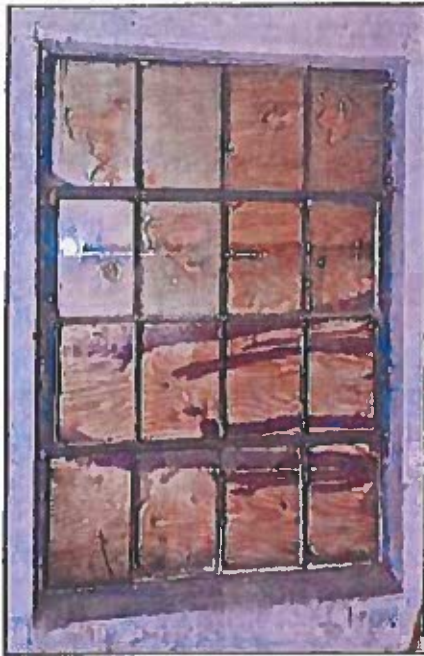
Photo 51: Interior side of old basement steel window with substantial rust. Replacement with new wood or metal window matching the size and pane configuration would be acceptable.

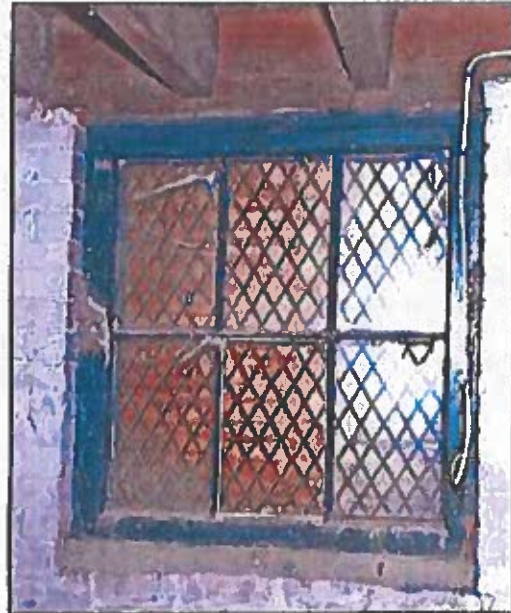
Photo 52: Interior side of main barn basement window with intact sash and old protective grill on the exterior. Both the sash and the grills should be retained when the sash is intact.
