HOPE CEMETERY COMMISSION MEETING

Monday February 12, 2024 – 4:00 P.M.

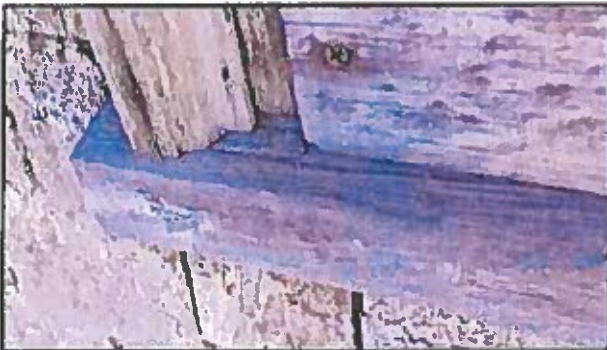
Photo 53: Exterior of main barn dormer window with moldings on the side casing. Sill has a deep crack, but can probably be saved by using epoxy consolidation and filling materials.

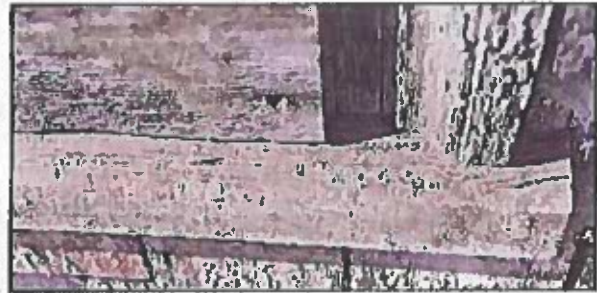
Photo 54: Another dormer sill. This one has only minor weathering and should be retained sanding and painting.

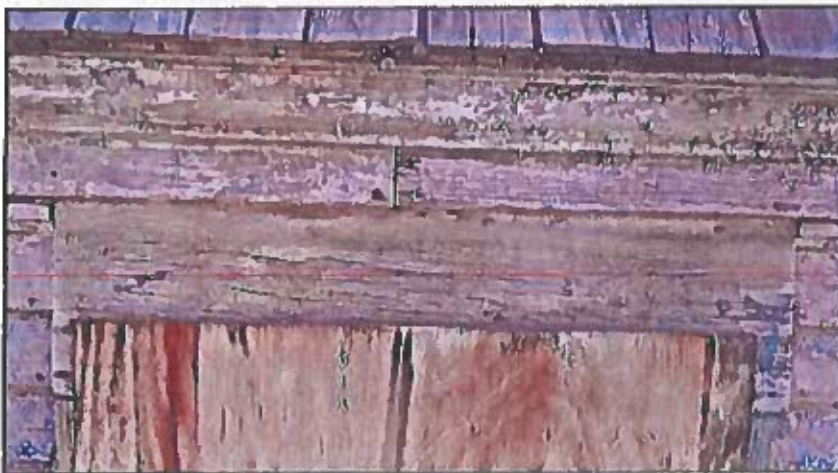
Photo 55: Typical first floor exterior window frame on main barn having moderate weather cracking on the flat surface casings. Casings in this condition can be retained, perhaps filling the cracks with epoxy fillers prior to repainting. Alternatively, they can be replaced with matching new wood, but the new wood may be less rot resistant than the existing weathered wood.

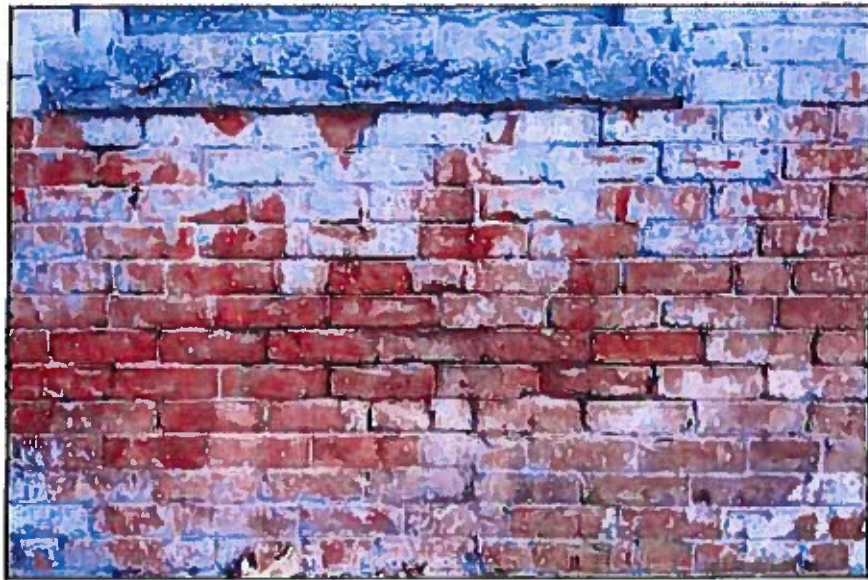
Photo 57: Brick below basement window sill of main barn east facade with open mortar joints and a number of bricks that are loose and bulging out from the wall. All the loose bricks should be taken out and reset in new mortar, and all joints in the area 100% cut and repointed using a mortar matching the relatively low strength of the existing original mortar.

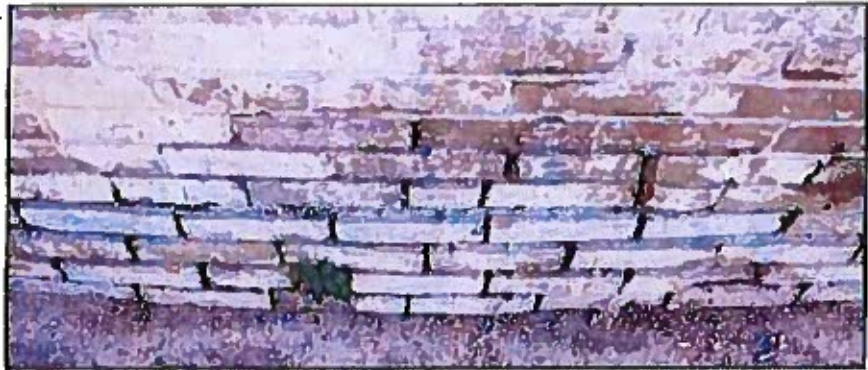
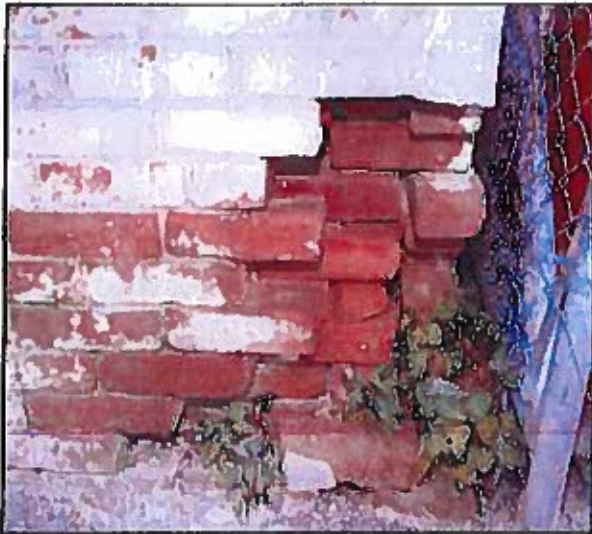
Photo 58: Foundation at northeast corner of main barn with loose and missing brick. This section should be rebuilt with matching brick.

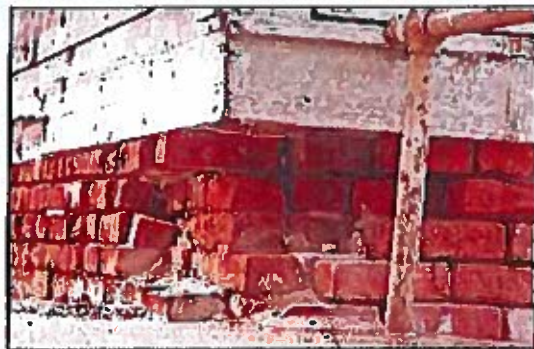
Photo 59: Foundation at southeast corner of main barn with loose and missing brick extending through the full depth of the 12" thick wall. This section should be rebuilt for the full depth of the wall with matching brick after the sill above it has been repaired.

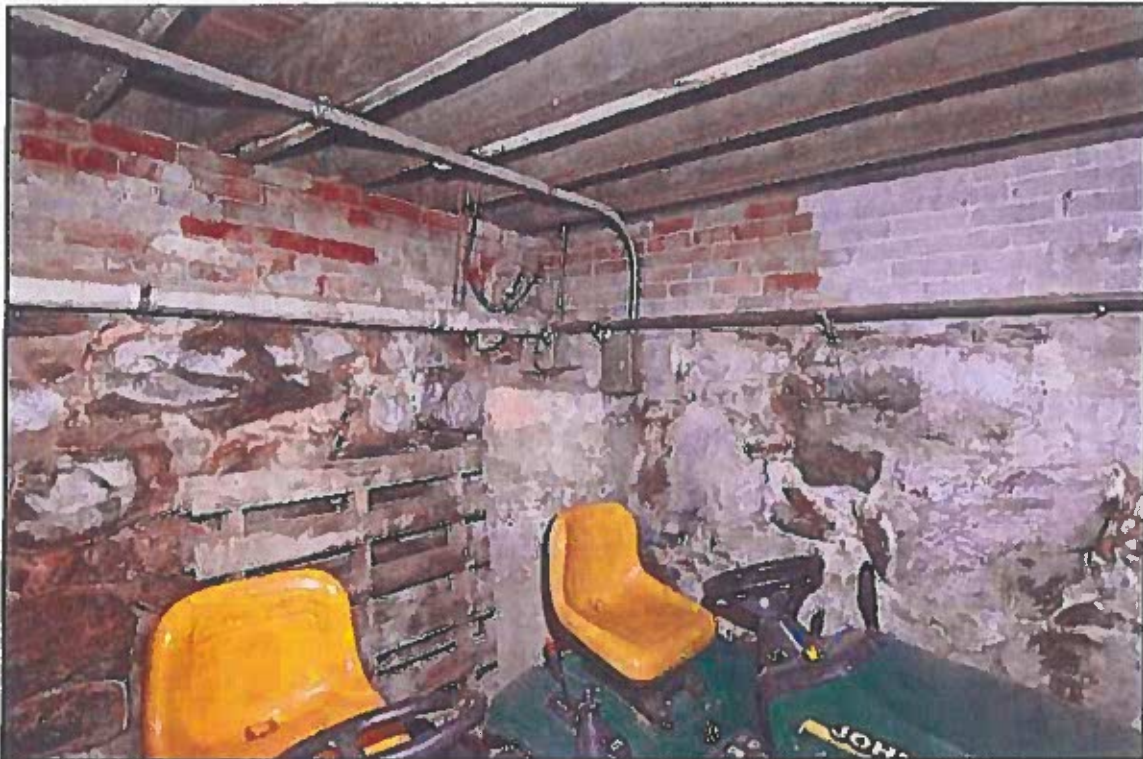
Photo 60: Interior of basement at southwest corner showing fieldstone laid in mortar below grade with brick from about 6" below grade up to the underside of the wood sills. As viewed from this side the sills generally appeared intact without visible damage.

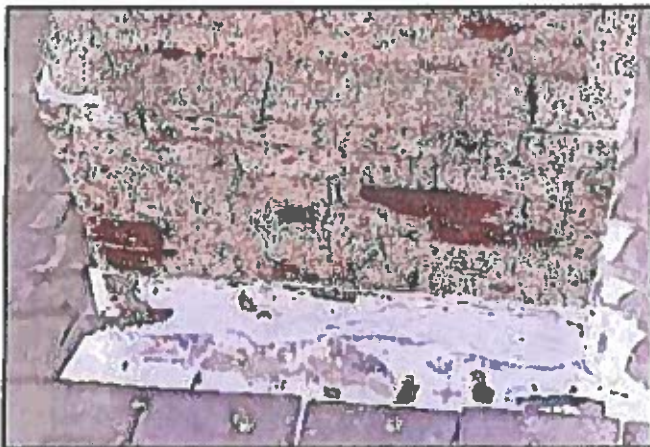
Photo 61: Chimney flashing at roof has numerous large holes that are causing leaks in the roof below.

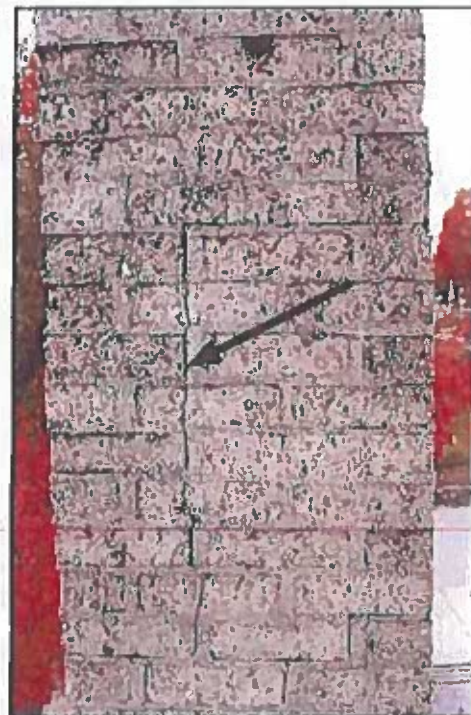
Photo 62: Chimney has numerous long cracks through both bricks and mortar joints, and is built with poor quality cement bricks that have eroded surfaces. As it is not visually important to the roof and has only minor historical value, it can be removed. If it is to be retained, it should be completely rebuilt with new brick of similar color.

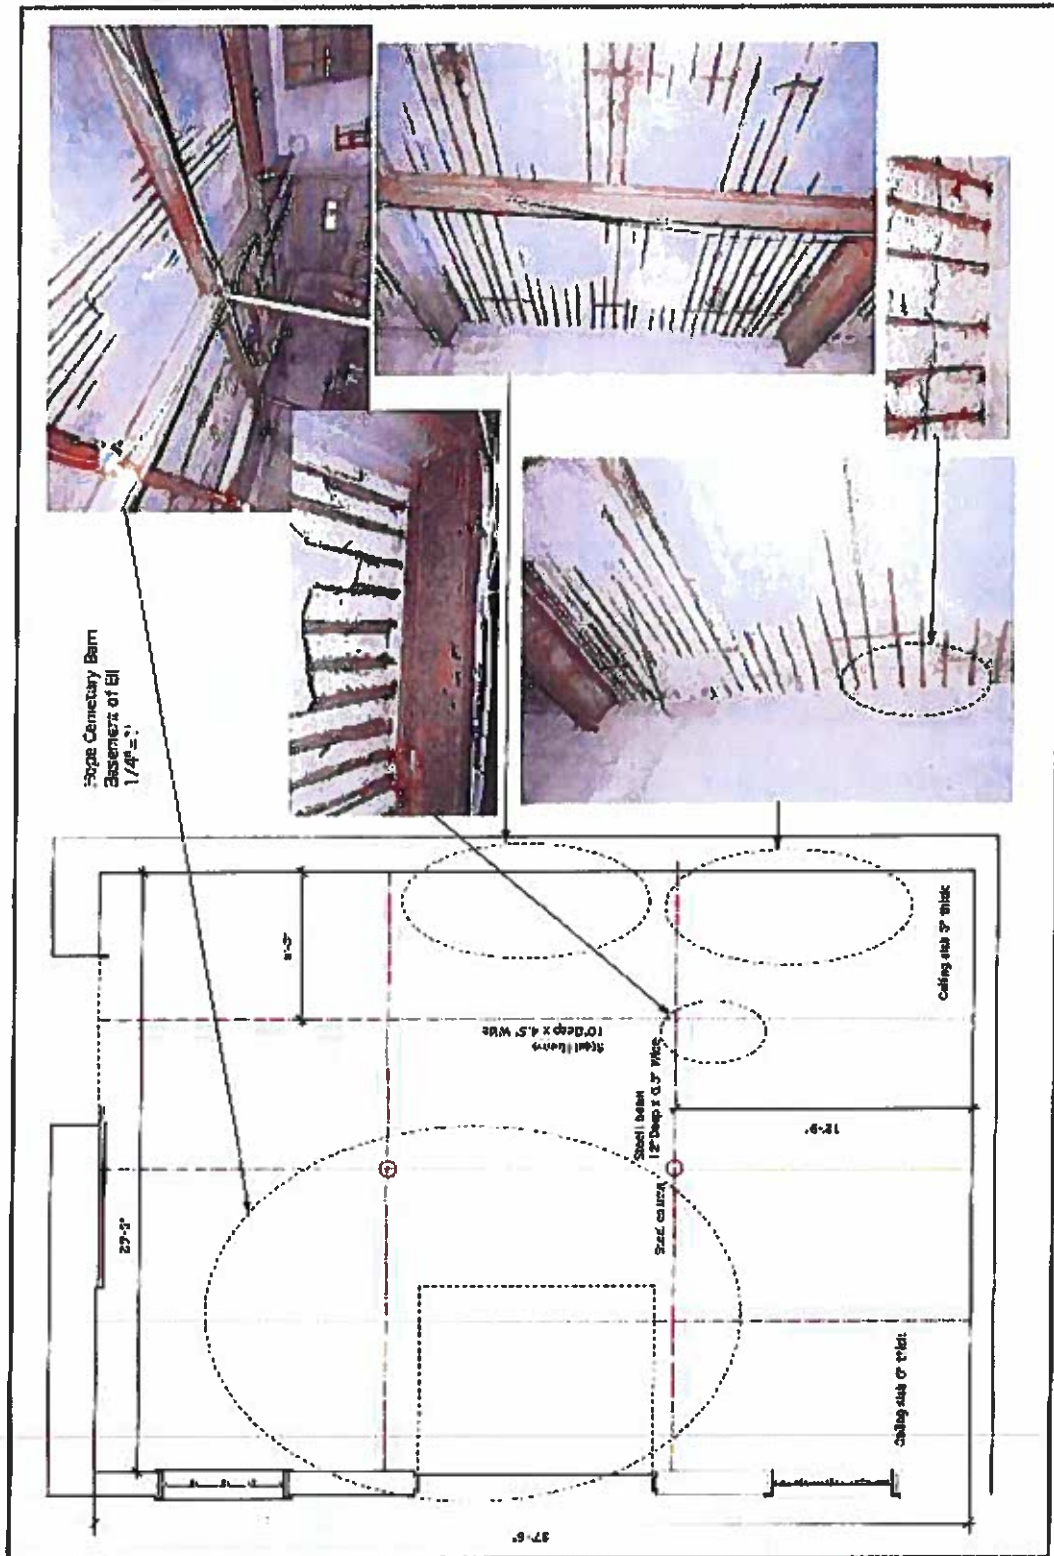
Photo 63: Photographs of ell barn basement ceiling showing spalling and severely rusting rebars. This is a significant current structural issue that needs to be evaluated by a structural engineer as a high priority.

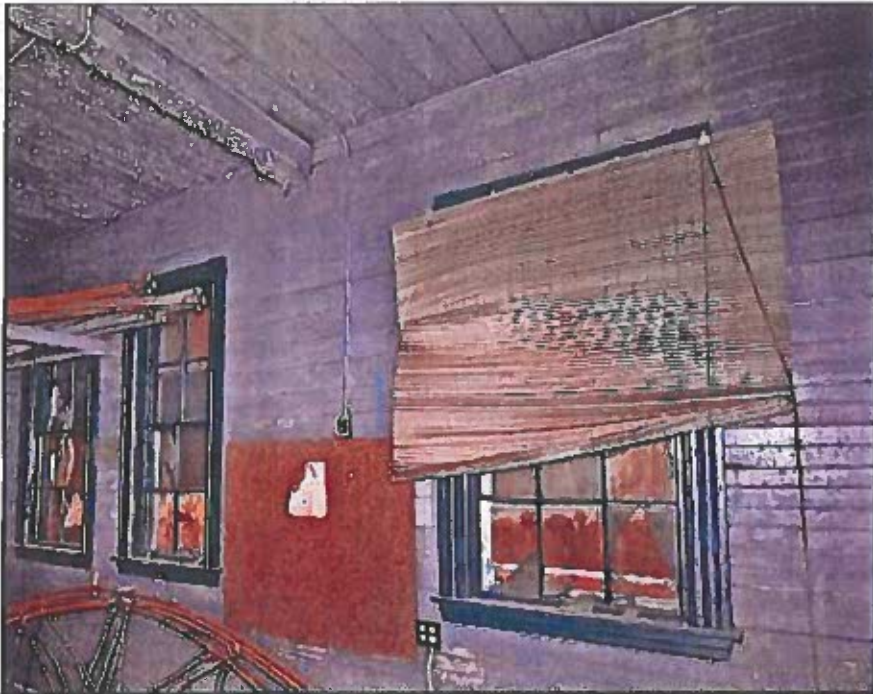
Photo 64: Interior of main barn first floor showing matched boarding on walls and ceiling that is the original interior finish and should be retained and preserved. Beam in ceiling is the bottom chord of a loft level roof truss

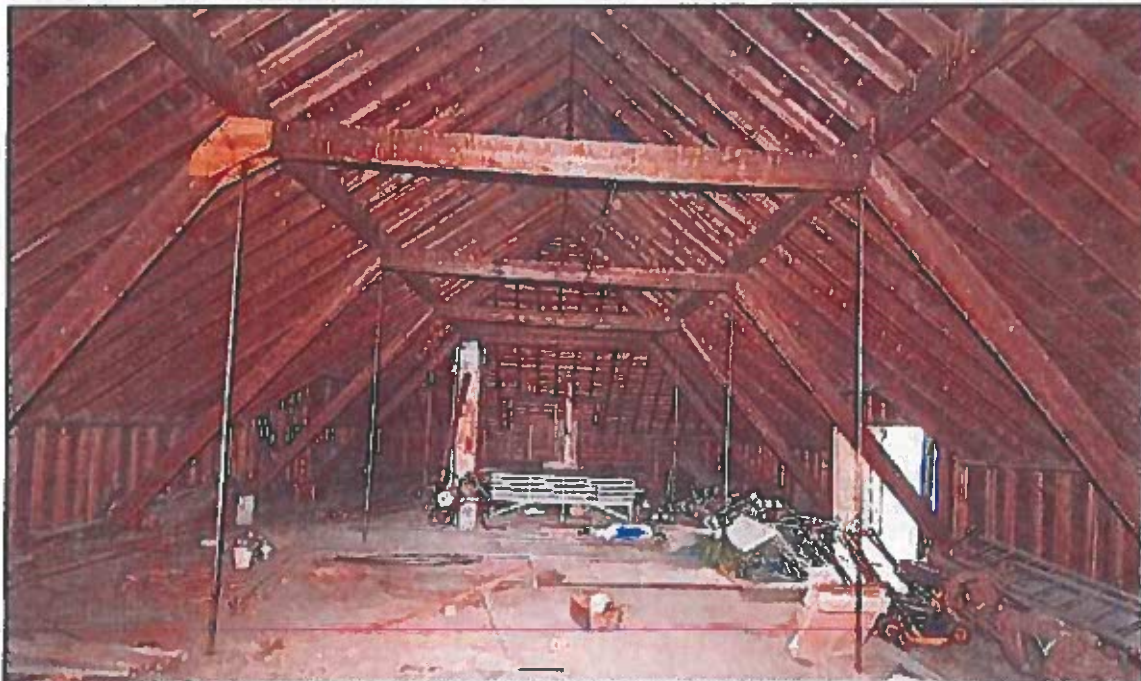
Photo 65: Interior of main barn loft floor showing queen rood roof trusses and exposed framing and sheathing. Stored items should be sorted items that are obsolete and of no historic value to the cemetery removed. There is considerable dust and fiber debris on the floor (especially at the side walls) that is a potential fire hazard and should be vacuumed out.

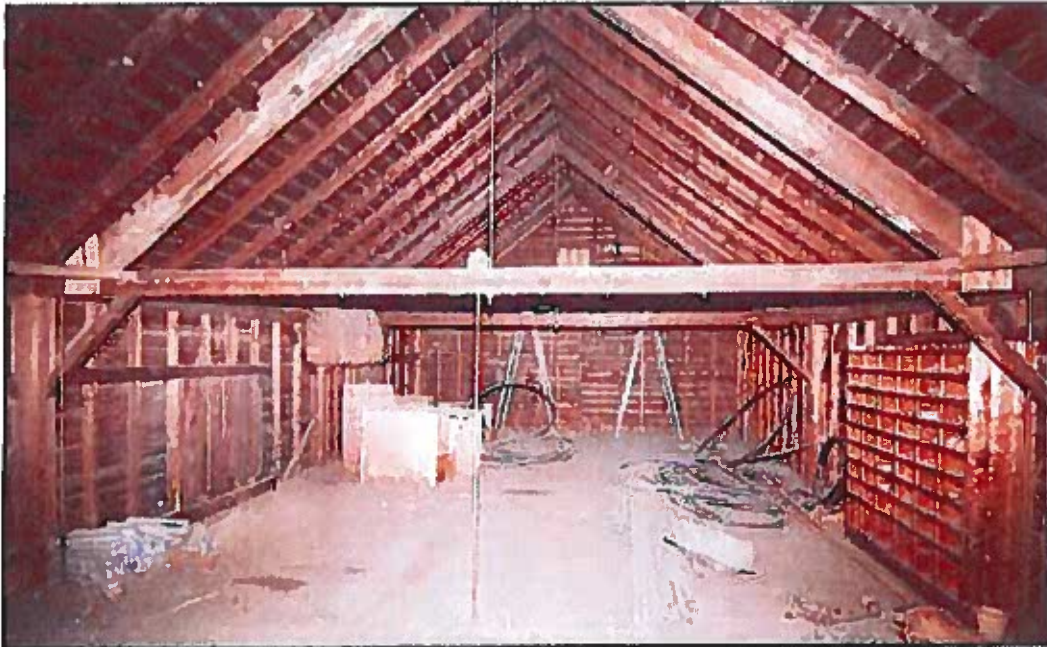
Photo 66: Interior of ell barn loft floor showing roof trusses and exposed framing. There is considerable dust and fiber debris on the floor (especially at the side walls) that is a potential fire hazard and should be vacuumed out.

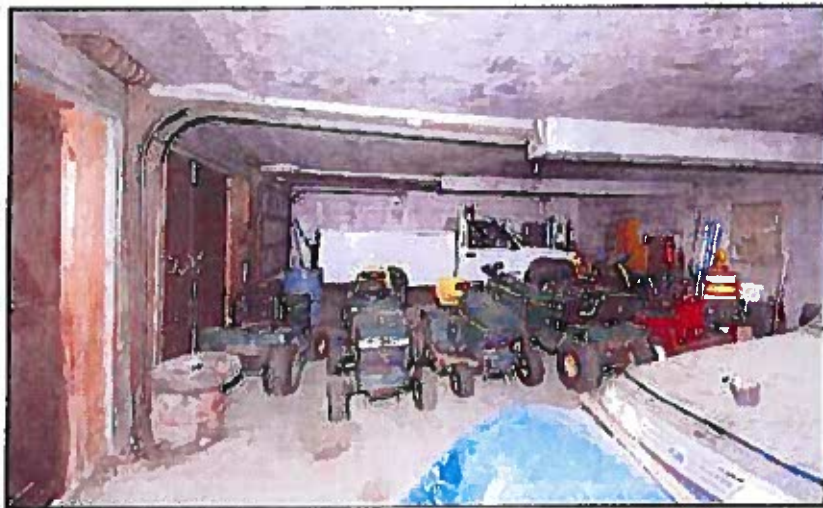
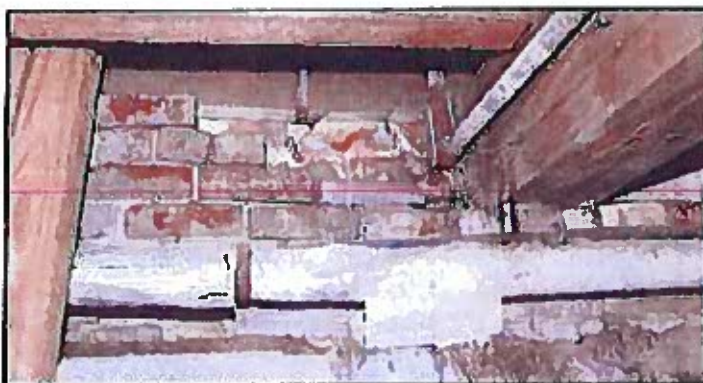
Photo 68: Basement of main barn showing obsolete steam pipes with deteriorating insulation that may contain hazardous materials. The insulation should be evaluated by a professional hazardous materials consultant and remediated as directed by the consultant.

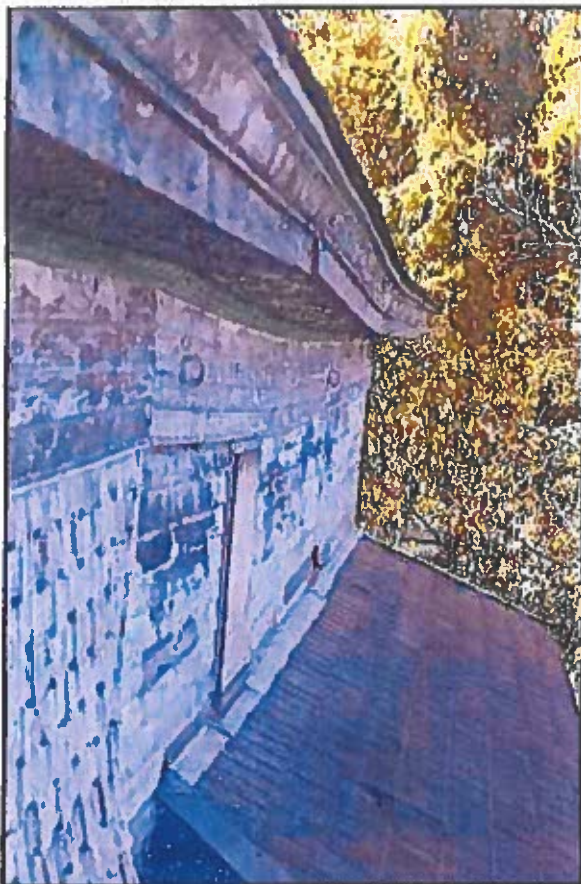
Photo 69: North facade of ell barn at loft level showing substantial sag in roof cornice and wall below. The sag does not extend into the first floor below indicating it may have been stabilized when the first floor was rebuilt c. 1930s.

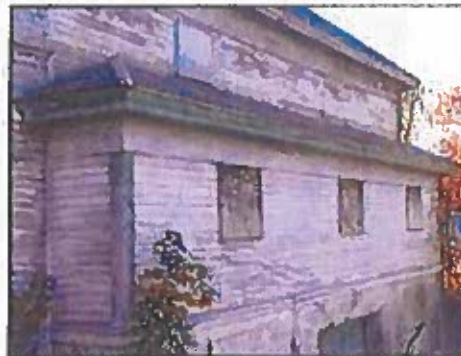
Photo 70: Overview of north ell facade showing the c. 1930s extension of the first floor. The extension does not exhibit sag of the loft wall above. However, as a precaution, the condition of sagging of the loft wall should be evaluated by a structural engineer when the basement ceiling is evaluated.

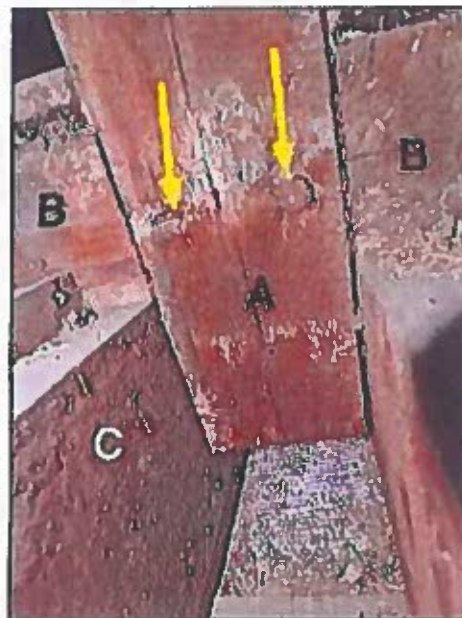
Photo 72: View of junction of ell loft wall framing with ceiling framing of first floor from within roof extension. Ceiling beam "C" apparently picks up wall loads from the original wall girt "B" and transfers the loads to the new north wall of the first floor. The original post "A" has been cut off just above the ceiling, but is joined to the girts "B" with mortise and tenon joints secured with pegs (arrows).

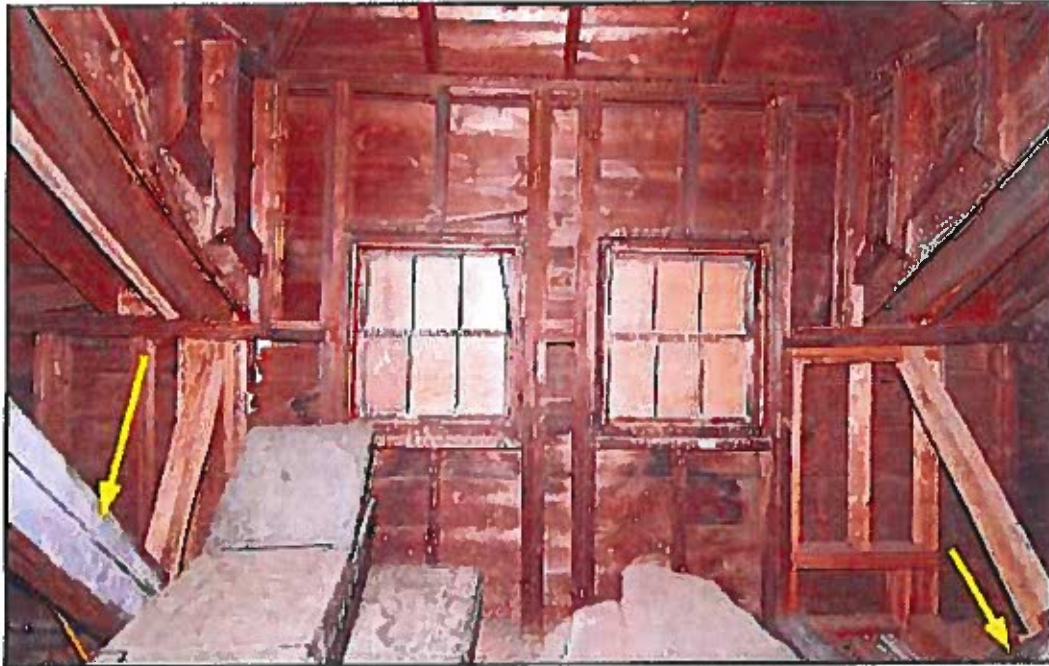
Photo 73: Interior of dormer #4 at east wall of main barn showing past repairs to stabilize framing rotted by former roof leaks. The ends of the upper truss rafter chords (arrows) appear to be rotted completely off where they were originally joined to the floor beams forming bottom truss chords.

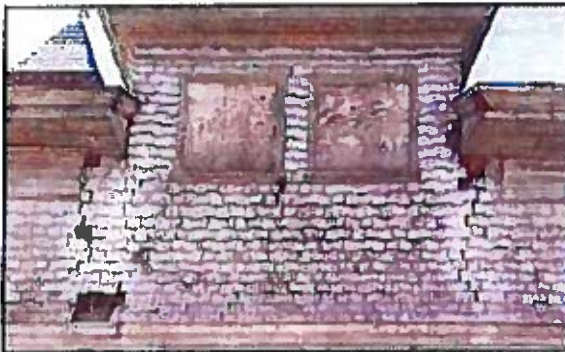
Photo 74: Exterior view of east wall at Dormer #4. Rotted truss rafter end was observed thru hole in shingles at belt course.

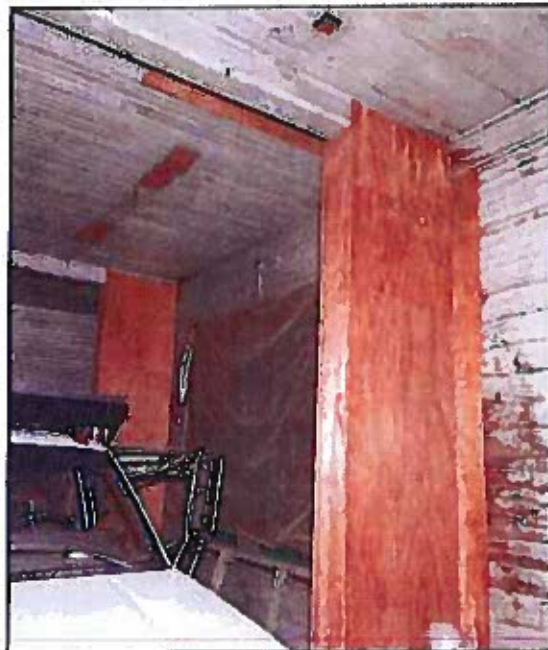
Photo 75: Past repair to stabilize rolled ceiling beam end and wall framing at first floor below dormer #4. The long term adequacy of the stabilization repairs should be evaluated by a structural engineer.

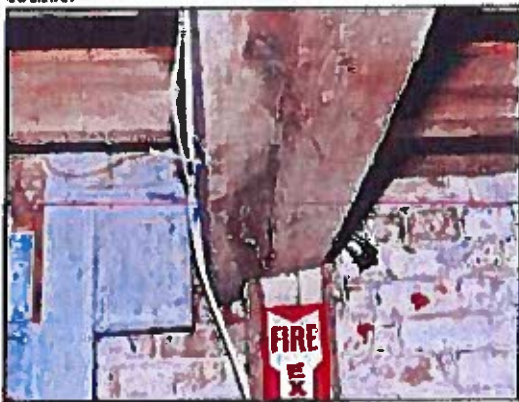
Photo 76: Twisted beam in basement directly below repairs shown in photo 75.

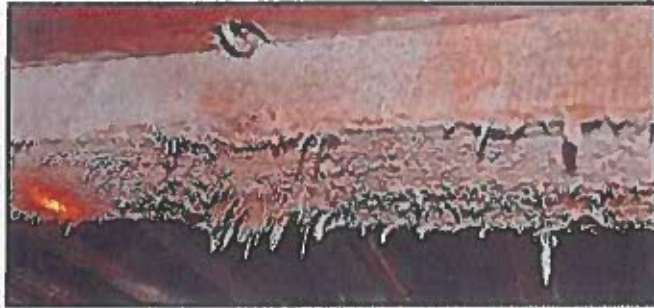
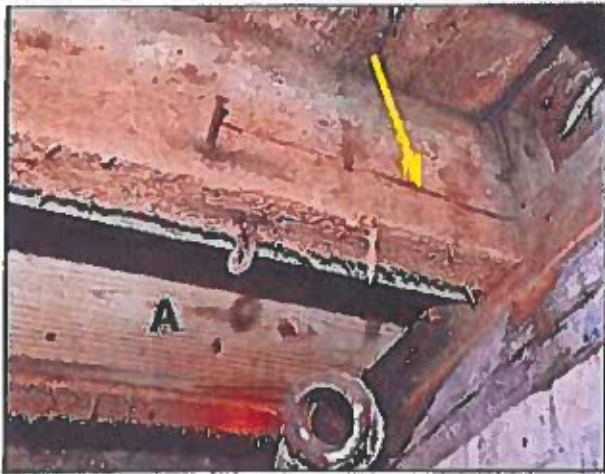
Photo 78: Ceiling joist in main barn basement with stress crack (arrow) at wall bearing. This and most other joists have been reinforced with sister joists ("B") to reduce the stress, probably after the cracks were observed.

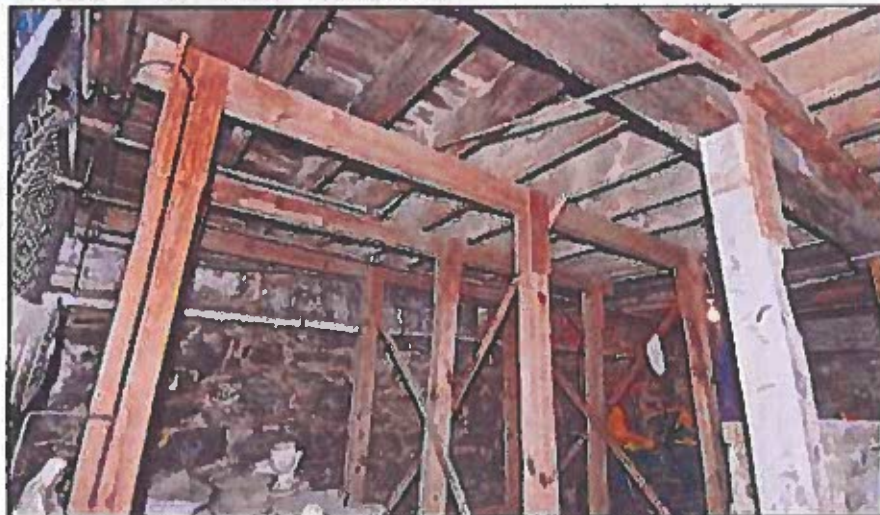
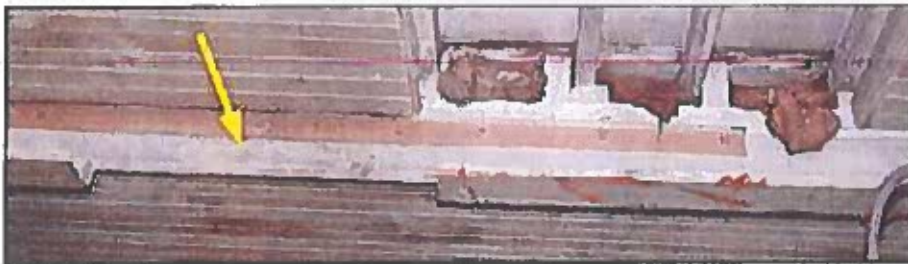
Photo 80: Bolted chord of roof trusses with section cut out (arrow). The impact of this cut on the loading capacity of the loft floor should be evaluated by a structural engineer.

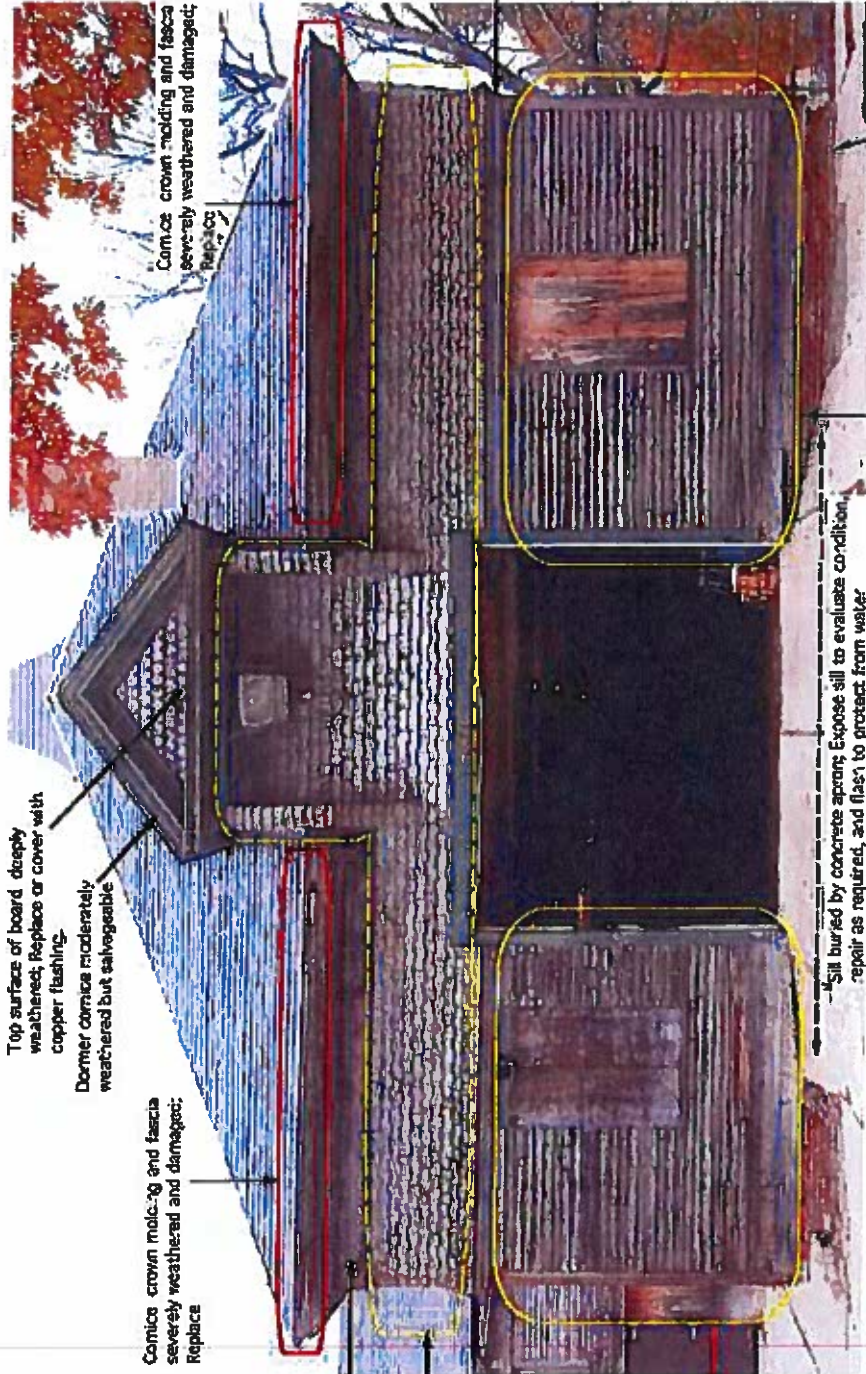
Entablature and cornice soffits appear sound enough to retain in place

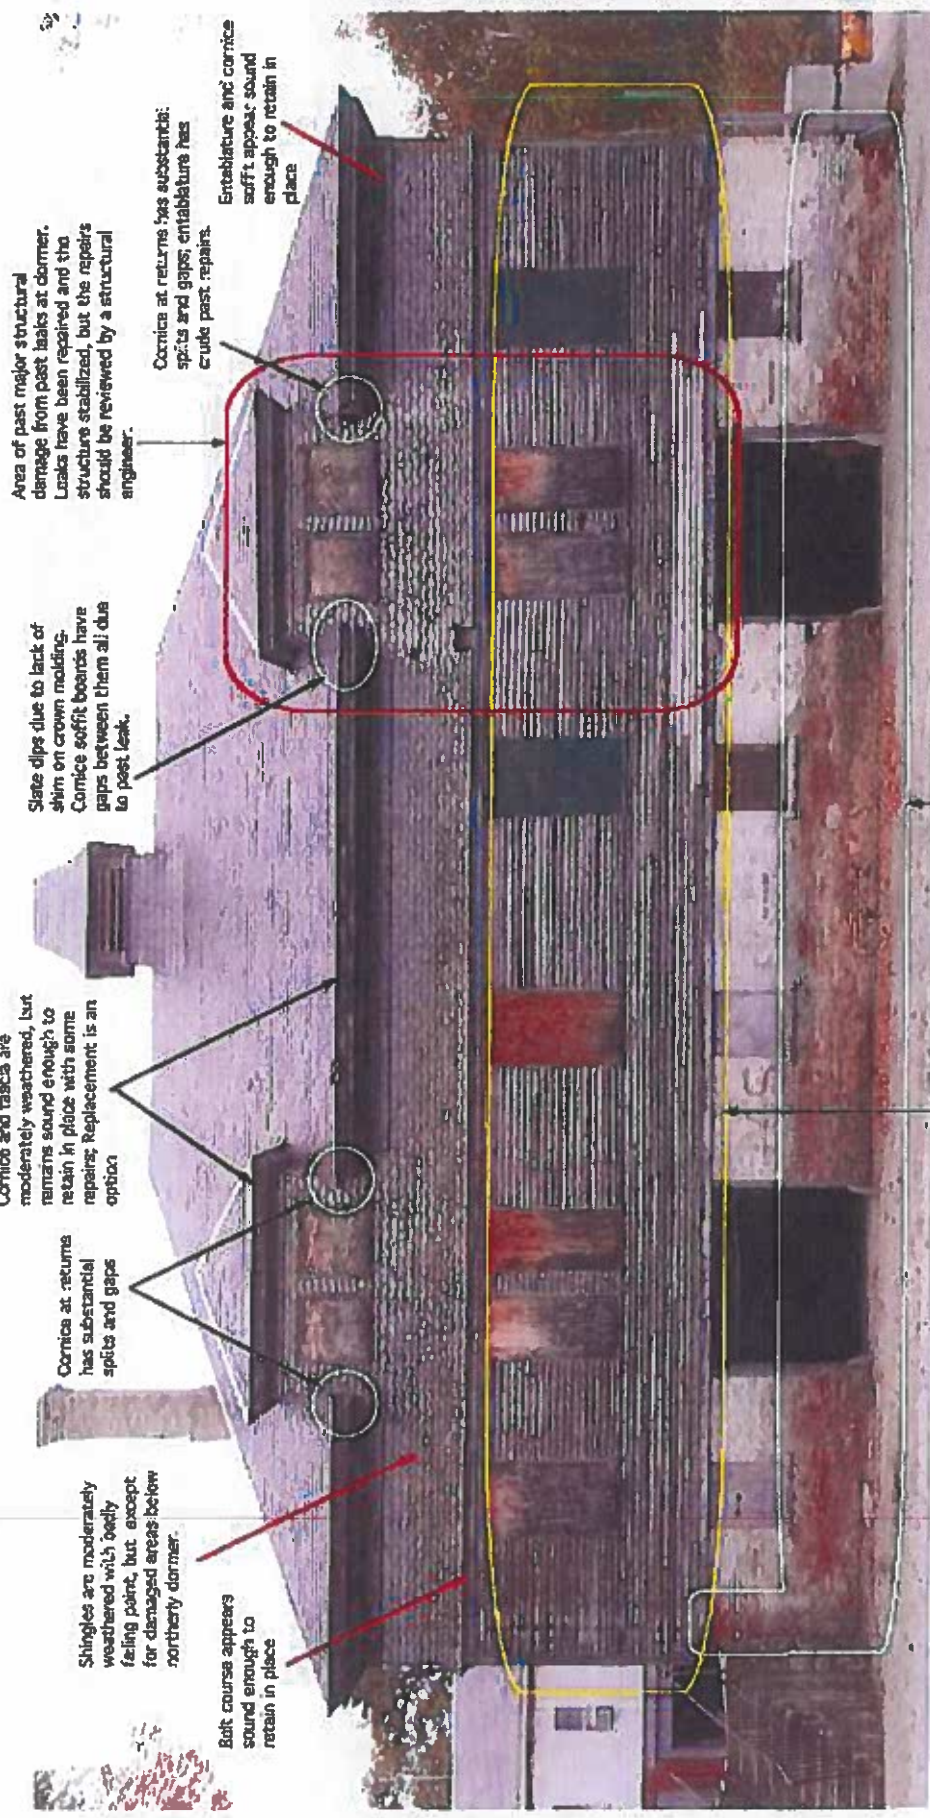
Area of past major structural damage from past leaks at dormer. Looks have been repaired and the structure stabilized, but the repairs should be reviewed by a structural engineer.

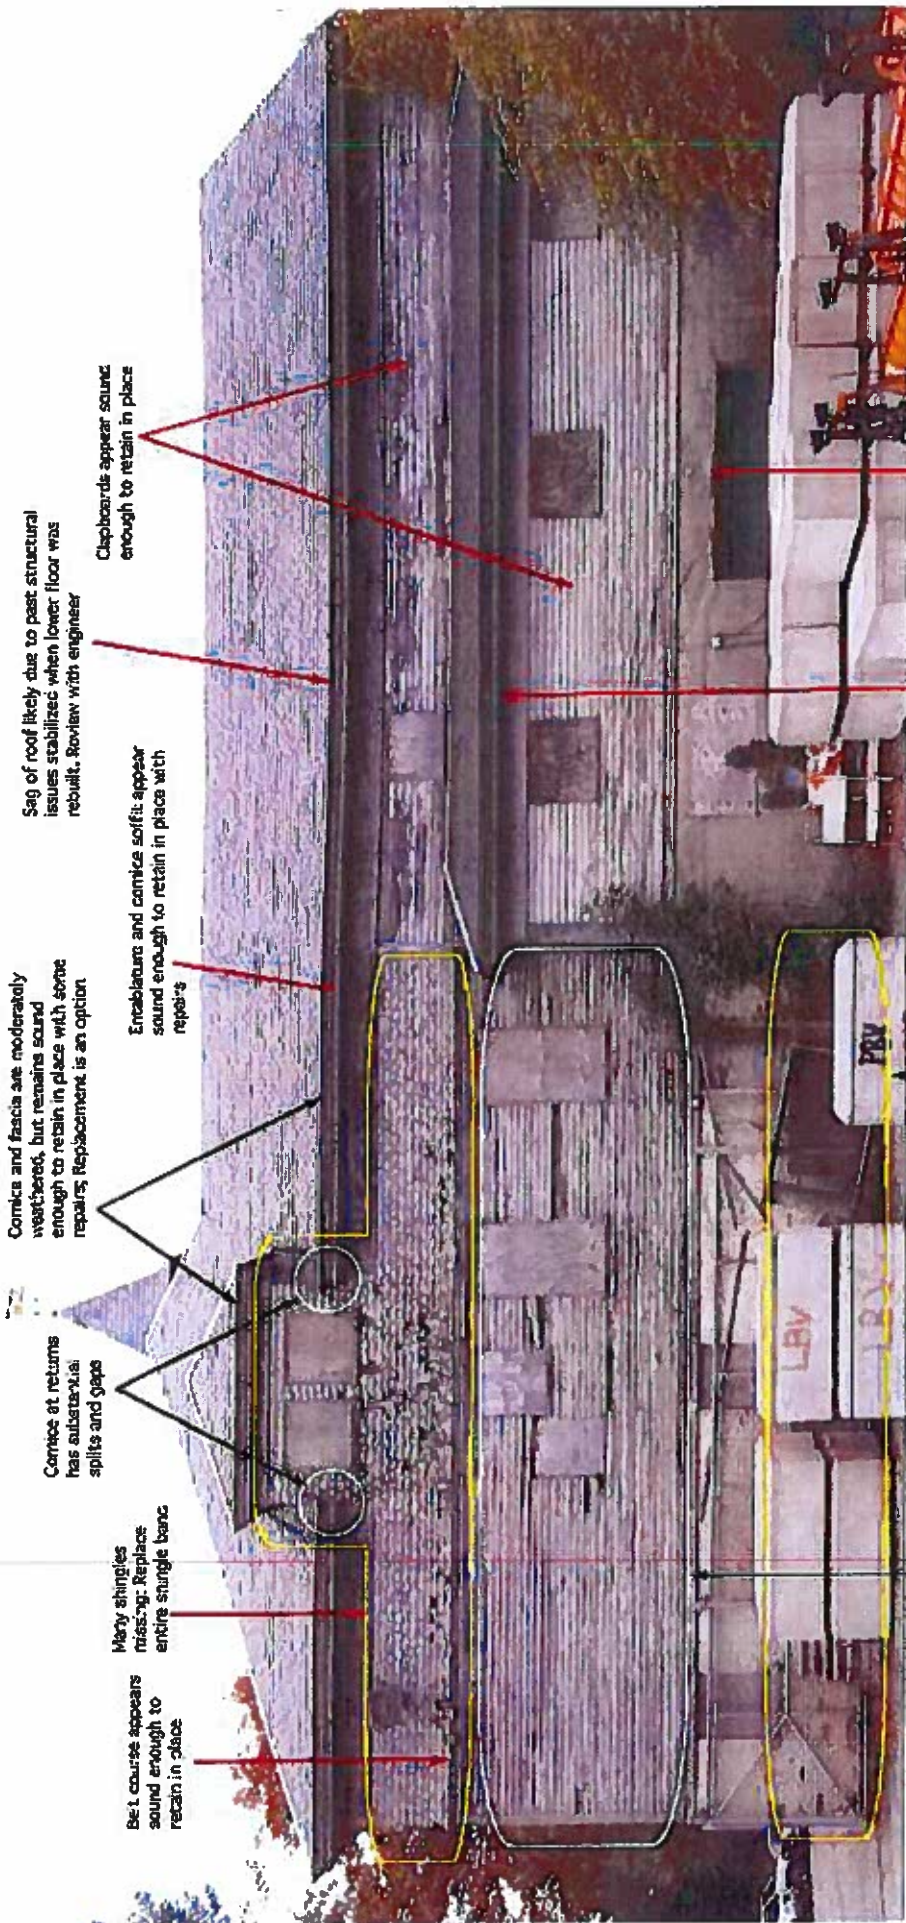
Sag of roof likely due to past structural issues stabilized when lower floor was rebuilt. Review with engineer

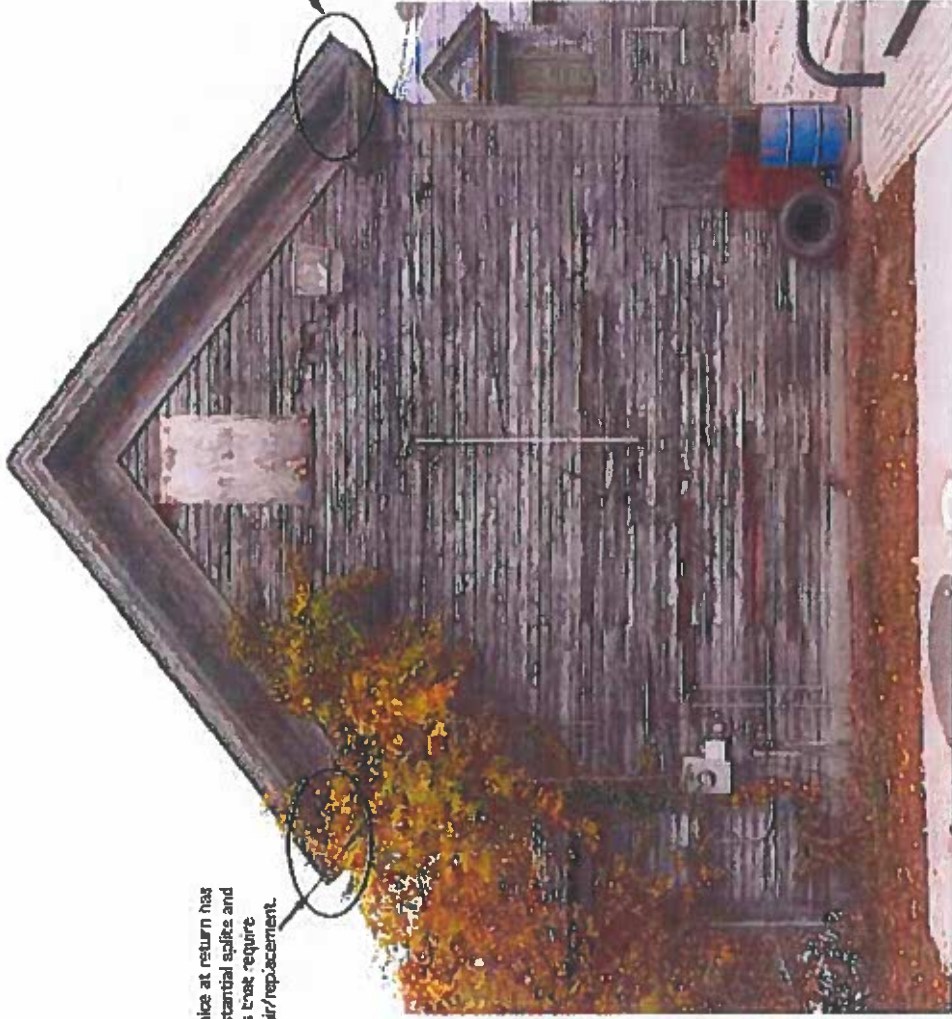
Comics at return has substantial splits and gaps that require repair/replacement.

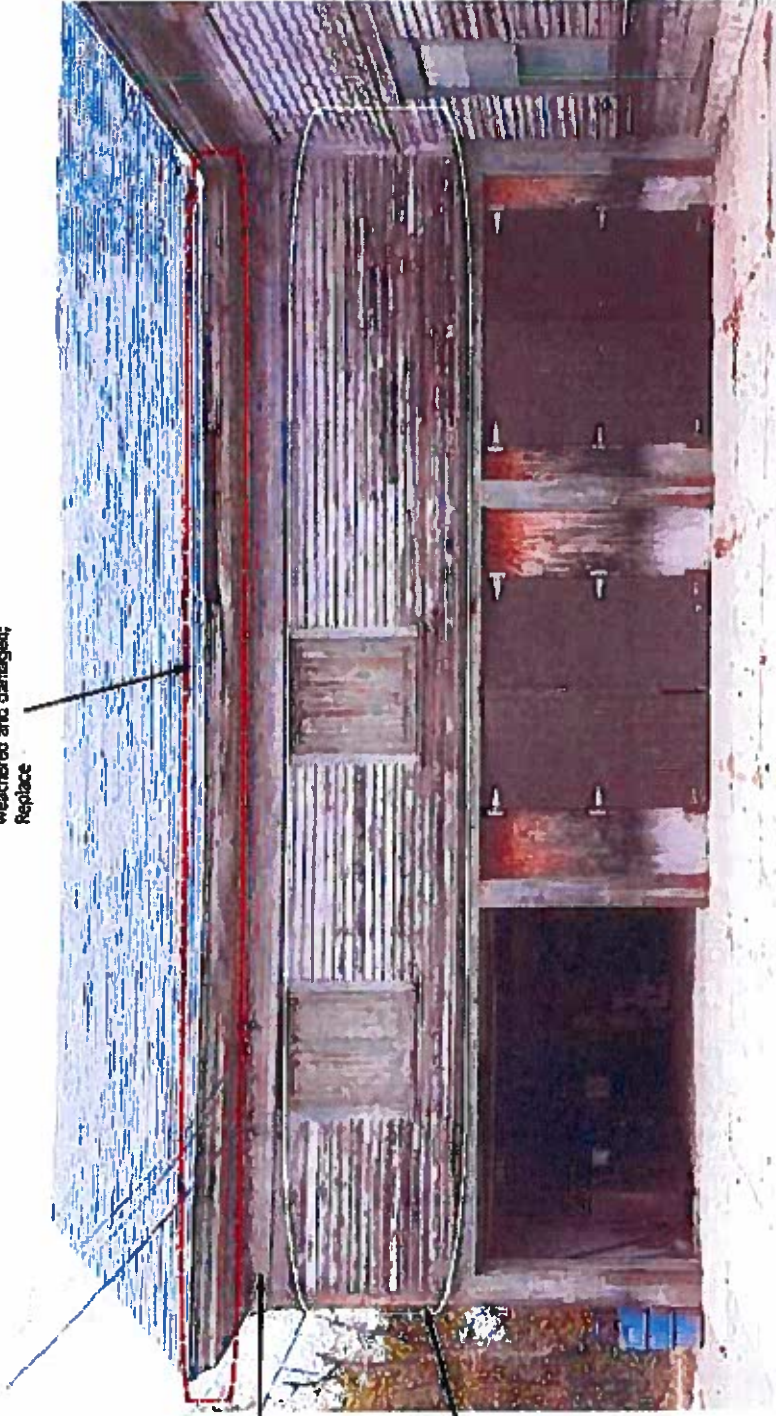
Cupboard Area (gross): 230 sq. ft., 17 courses
window area: 50 sq. ft.
Facade length: 40'6"

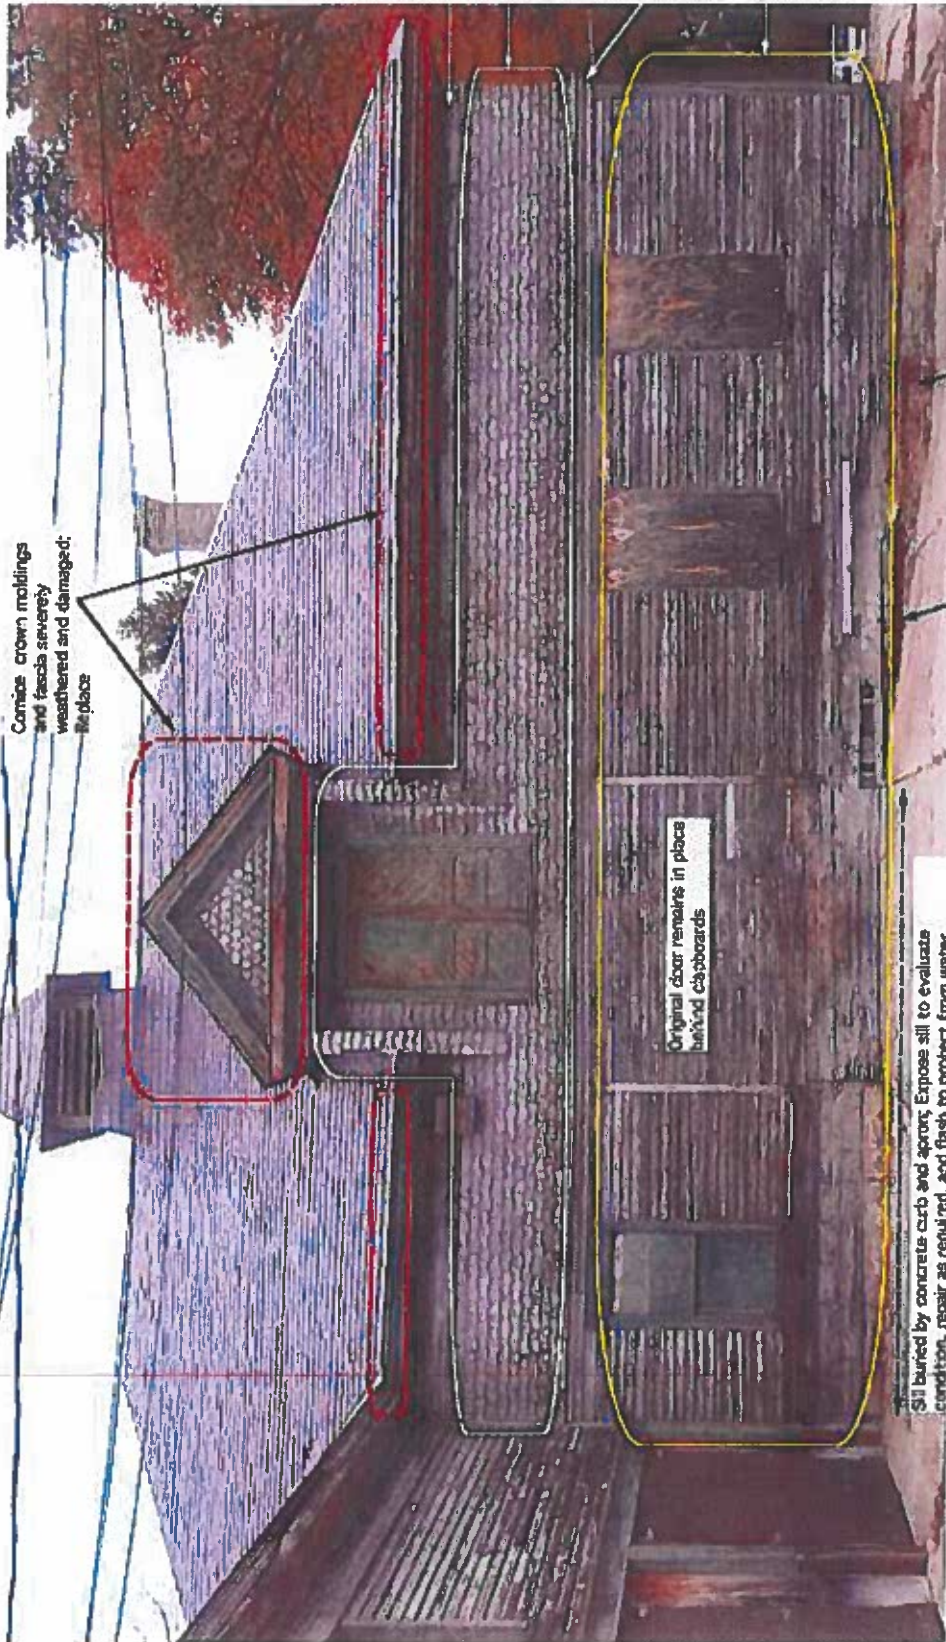
Comice crown moldings and fascia severely weathered and damaged: replace

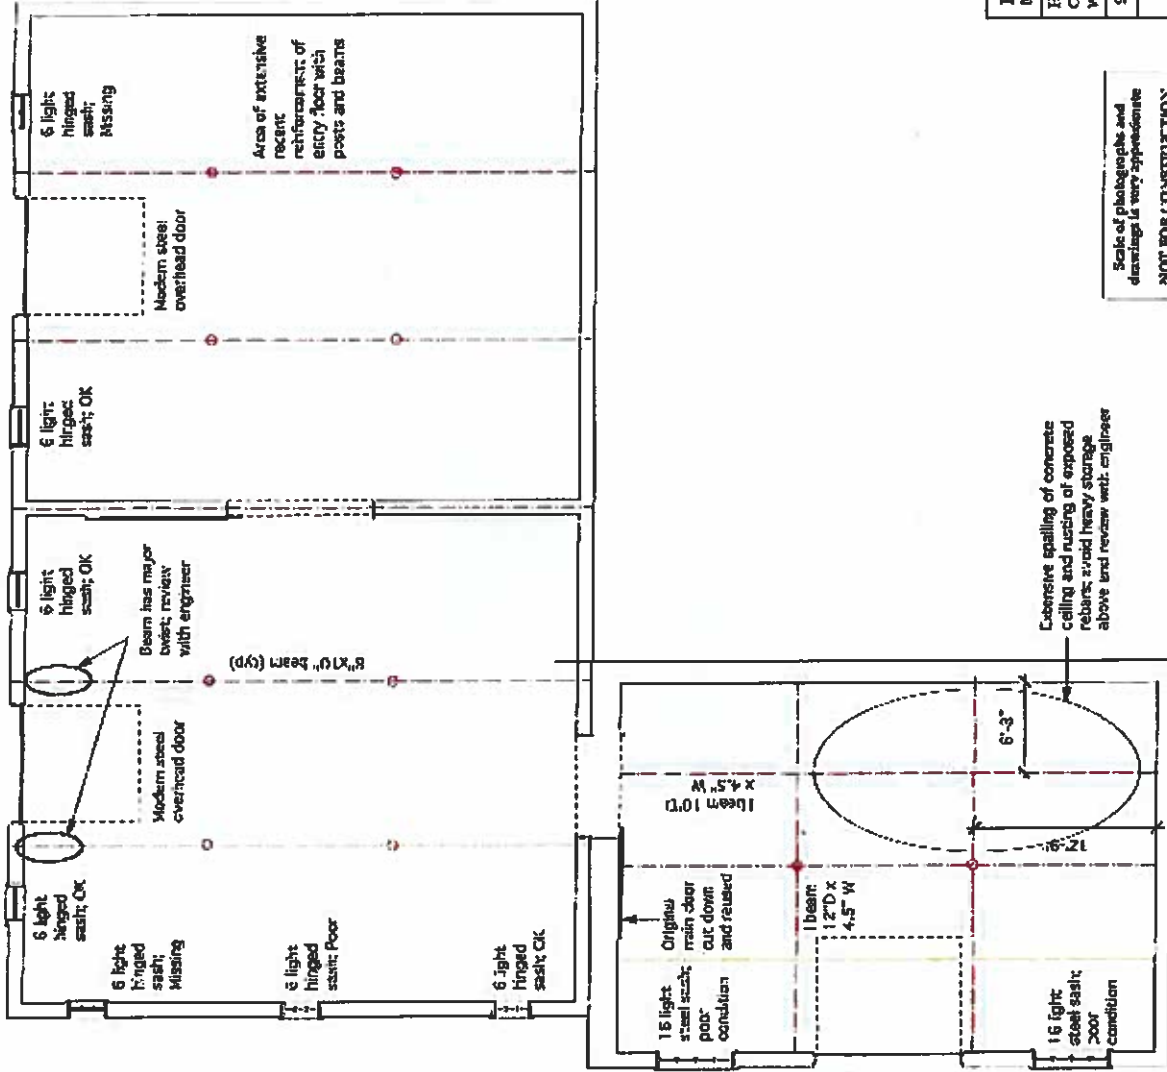
C. 1930 wood overhead door in pair corridor; concrete lintel above door spalled with rusting rebar
