HOPE CEMETERY COMMISSION MEETING

Monday February 12, 2024 – 4:00 P.M.

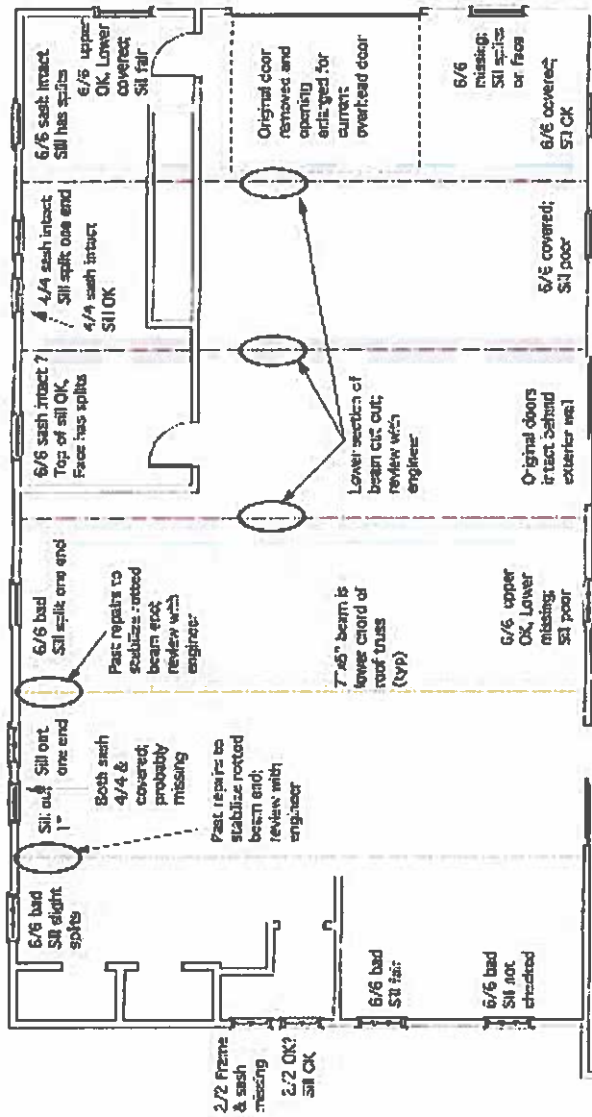
MAIN FLOOR PLAN Main Room and Full Bath	Sheet # 8
Hague Laboratory Barn Condition Study City of Worcester Worcester, MA	
Scale: 1/8" = 1'-0"	Date: February 20, 2017
FINCHARDSON 39 FRONT STREET, WENDELL, MASSACHUSETTS 01886-1128

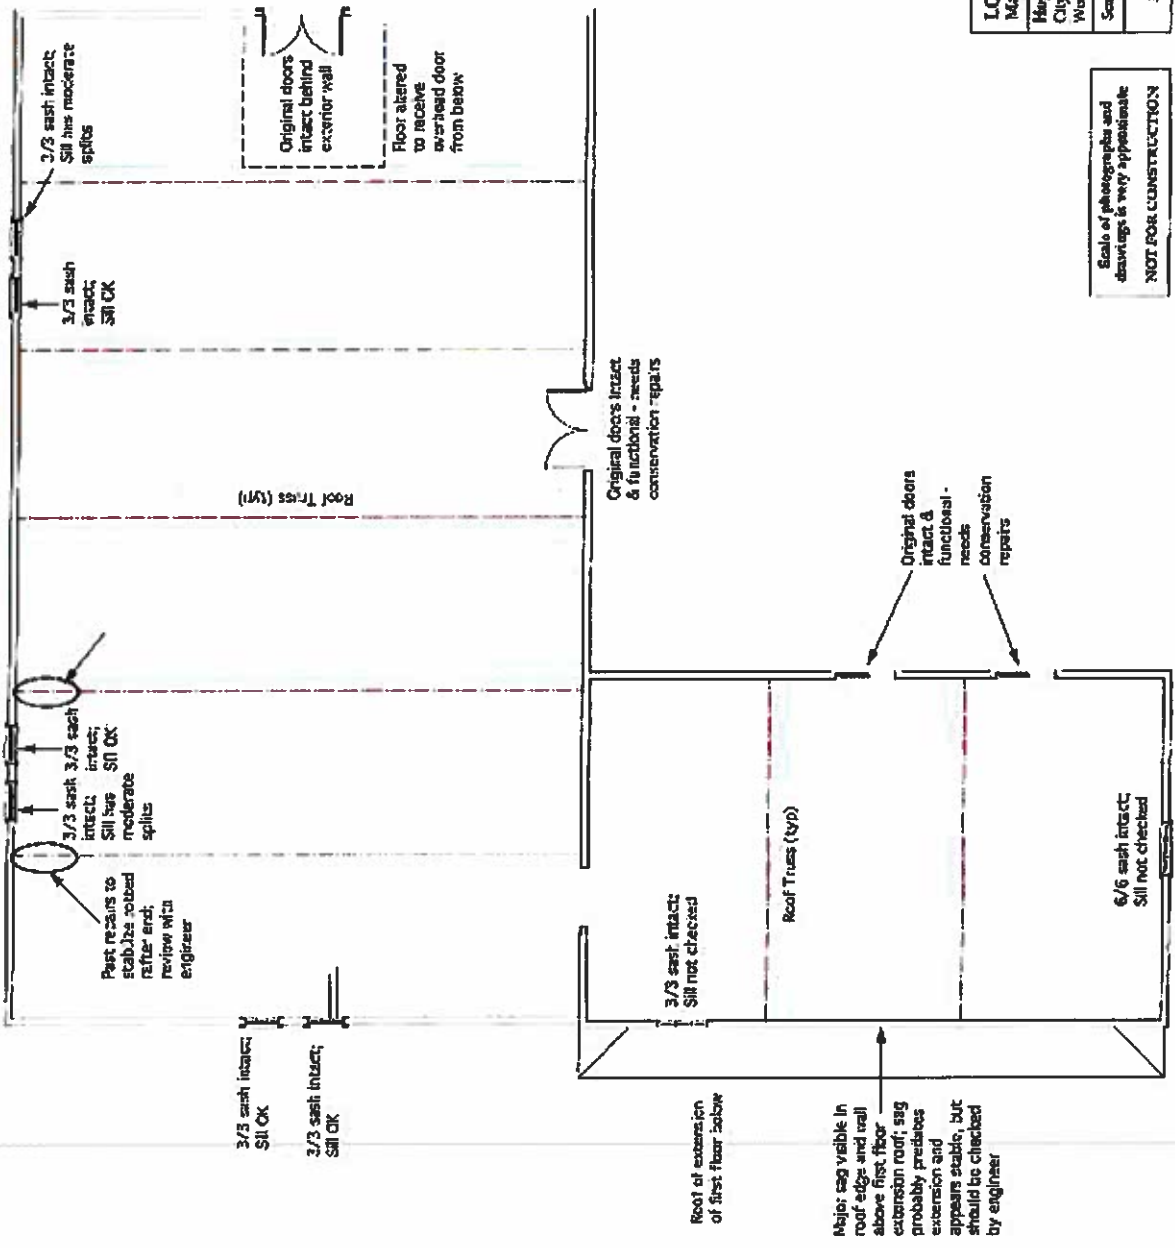
LOFT FLOOR PLAN	Sheet 9 9
Main Room and Ell Room	
Moynihan Community Barn Conditions Study	
City of Worcester	
Worcester, MA	
Scale: 1/8" = 1'	Date: February 14, 2007
MINDENKORSE	
30 HAZARD STREET, WORCESTER, MA 01602 • 508-853-8100

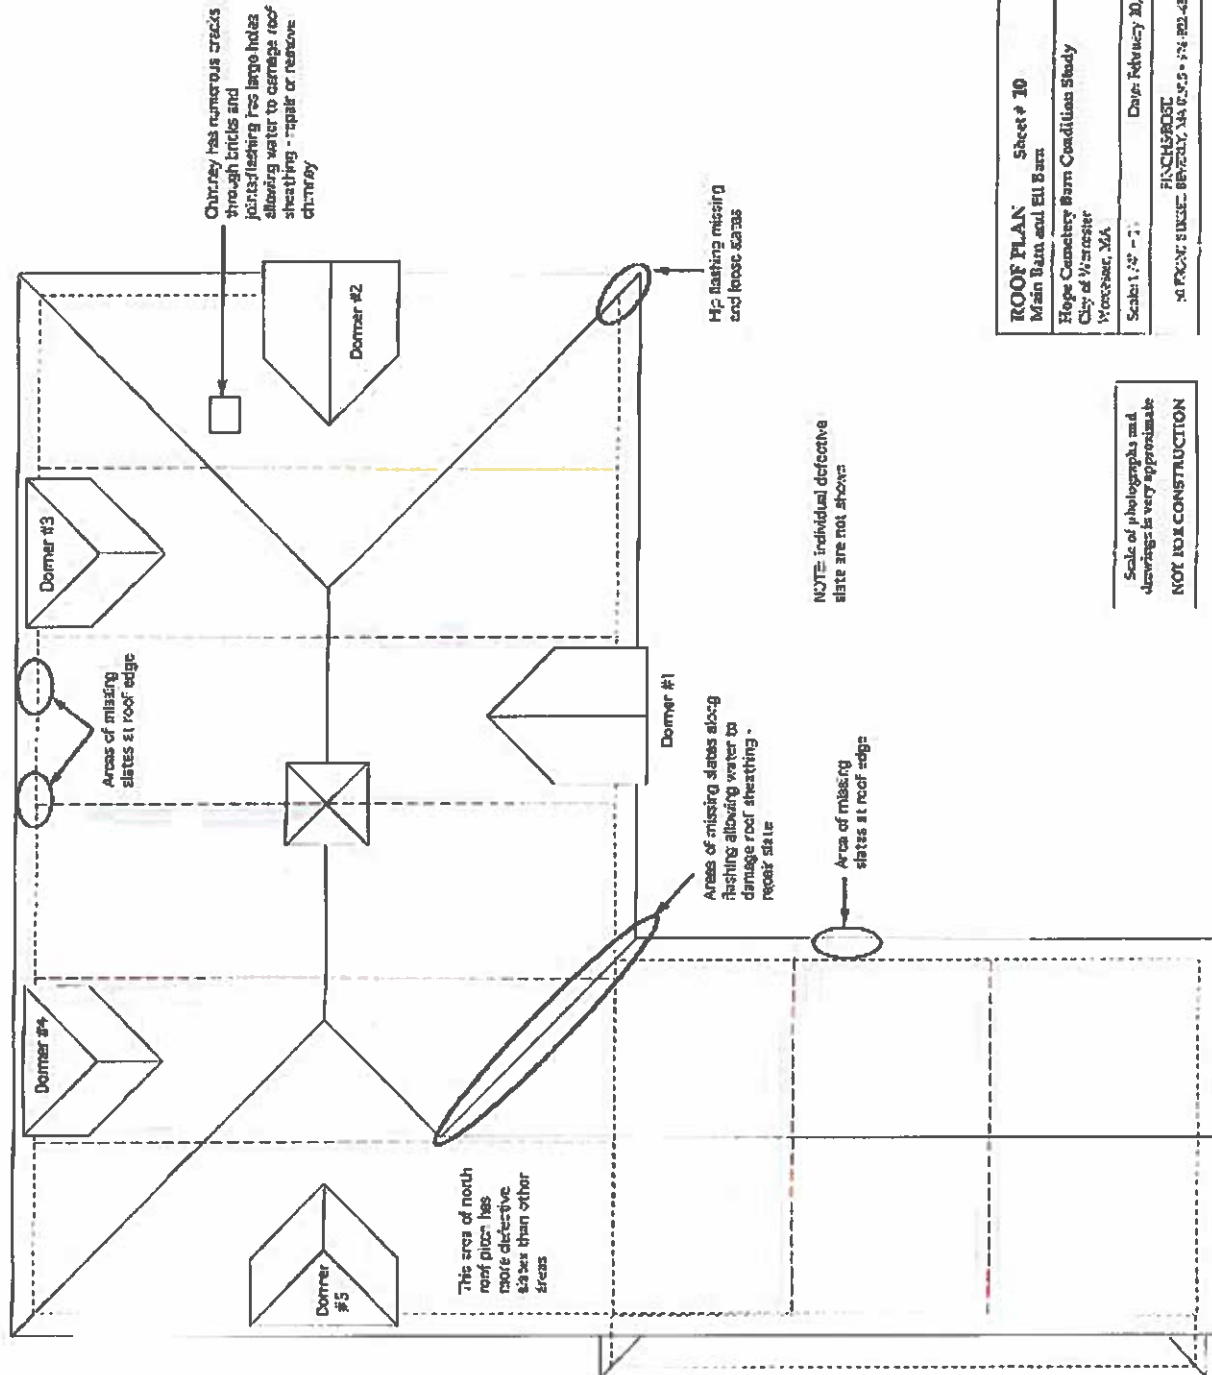
ROOF PLAN	Sheet # 10
Main Barn and Ell Barn	
Hedge Cemetery Barn Condition Study	
City of Worcester	
Worcester, MA	
Scale: 1/8" = 1'	Date: February 10, 2007
FINCHUS ROSE	
30 PARK STREET, SUITE 200, WORCESTER, MA 01602 • TEL: 860-485-
