# Lake Quinsigamond

## 2022 Water Quality Report

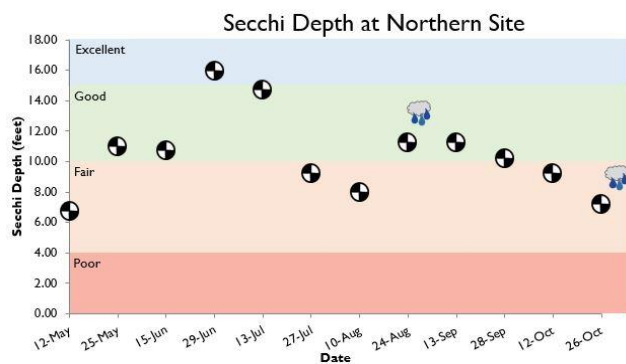
**Figure 3** - Secchi depth ranged from the "Good" to "Fair" categories with depths of 6.75-16 feet.

**Water Clarity at Lake Quinsigamond.** Water clarity at Lake Quinsigamond is considered generally higher than other area lakes. In 2022, Secchi depth at the northern and southern in-lake sites ranged between 6.75 feet and 17.00 feet, with most results falling between 4 and 10 feet, or in the range considered, “Fair” (see *Figures 3 and 4*). The season’s highest recorded Secchi depth for each site was observed on 29-Jun, from which point most readings were in the “Fair” range. Surface TSS results at the northern and southern sites were consistently low, ranging between below the laboratory reporting limit and 3 mg/l, and were within the range considered “Excellent”. At the bottom of the Northern Site TSS results were similar, ranging between 2 and 4 mg/l. However, at the bottom of the southern site, there were three higher results, between 10 and 25 mg/l, or in the range considered “Good”, toward the end of the sampling season, in the fall. L&P rates water clarity at Lake Quinsigamond at “Good” for 2022.

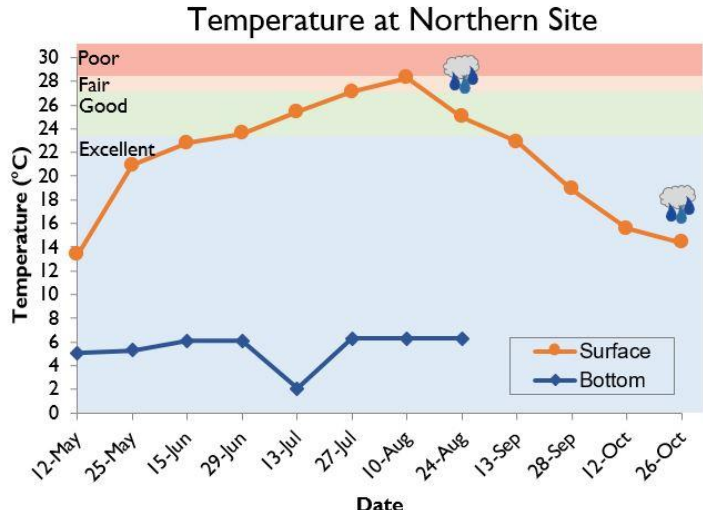
Figure 5 - Bottom temperature was consistently 6°C or below. Surface temperature steadily increased until early August, reaching 28°C before beginning to decrease.

Surface temperature at the northern and southern sites ranged between 13.4°C and 28.3°C, following the expected seasonal distribution (see Figures 5 and 6). Maximum recorded temperature for the season was observed at each site on 10-Aug; 28.3°C at the northern site and 28.1°C at the southern site, right at the edge of what is considered “Poor” for water temperature. Surface water temperature in 2022 was on average about 0.9°C warmer than in 2021. As Lake Quinsigamond experiences stratification during the summer months, temperatures on the bottom of each site were relatively stable, ranging between 2.1°C and 7.0°C, in the range considered “Excellent”. However, this data must be observed with caution because difficulties with the long probe cable that allows for deep readings to be taken at these sites, made us unable to collect temperature data on the bottom of the lake after 24-Aug.

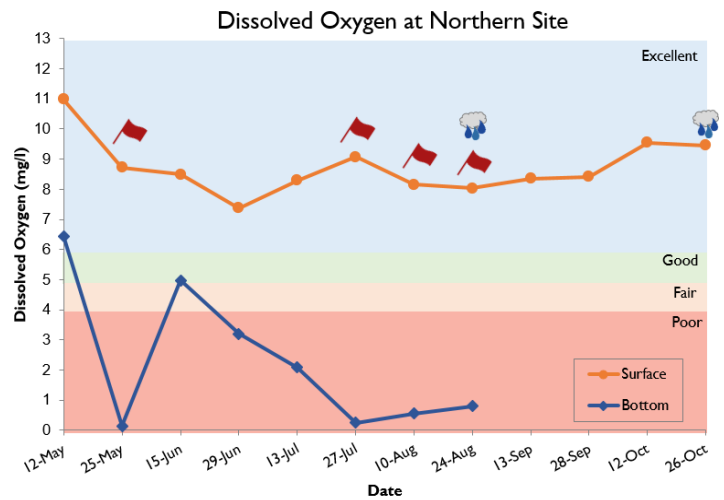
**Figure 7** - DO stayed in the "Excellent" rating category at the surface all season and was generally in the "Poor" category at the bottom of the lake, demonstrating anoxic conditions.

**Dissolved Oxygen at Lake Quinsigamond.** Surface DO at the in-lake sites ranged between 7.4 and 11.0 mg/l, consistently within the range considered "Excellent" (see Figures 7 and 8). On the bottom DO ranged between 0.0 and 8.9 mg/l with readings above 4 mg/l common early in the season. After 29-Jun, all deep DO readings were below 4 mg/l, or hypoxic, as the lake became stratified. It is notable that difficulties with the long probe cable that allows for deep readings to be taken at these sites, made it unable to collect DO data on the bottom after 24-Aug.

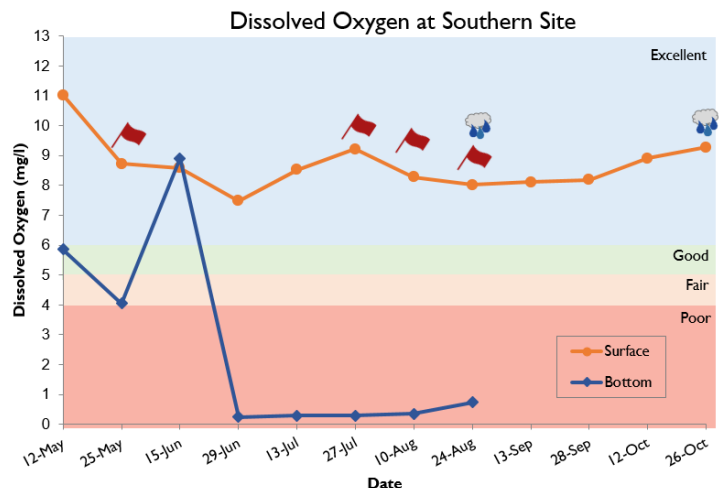
**Figure 8** - DO stayed in the "Excellent" rating category at the surface during all sampling events and was generally in the "Poor" category at the bottom.

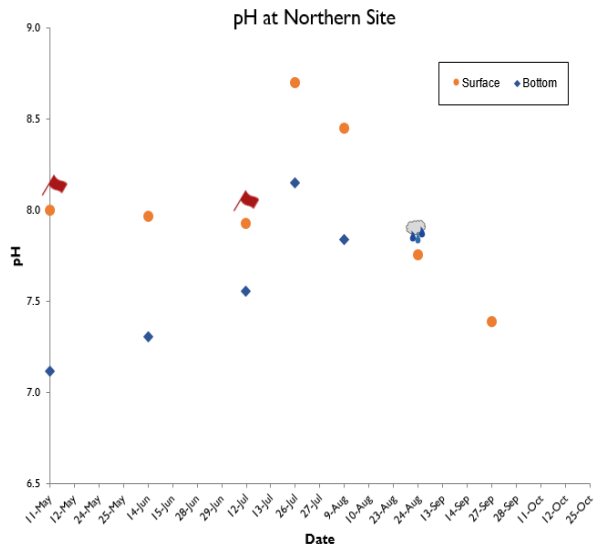
**Figure 9** - Bottom pH ranged from 7.1-8.2. Surface pH ranged from 7.4-8.7.

**pH at Lake Quinsigamond.** Surface pH at the in-lake sites ranged between 7.3 and 8.7 (see *Figures 9 and 10*). pH at the bottom was always lower than the surface. However, a combination of difficulties with the long probe cable and two instances in which data had to be censored only left 5 viable data points out of the planned 12, so it is difficult to draw conclusions from the limited set of data from the bottom of the in-lake sites.

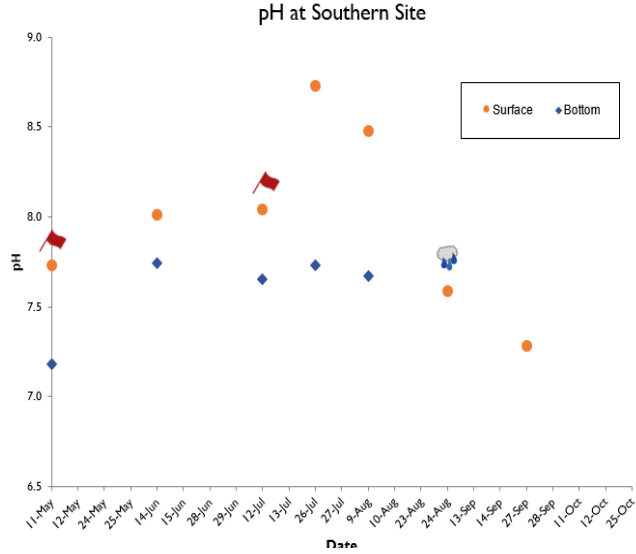
**Figure 10** - Bottom pH ranged from 7.2-7.7. Surface pH ranged from 7.3-8.7.

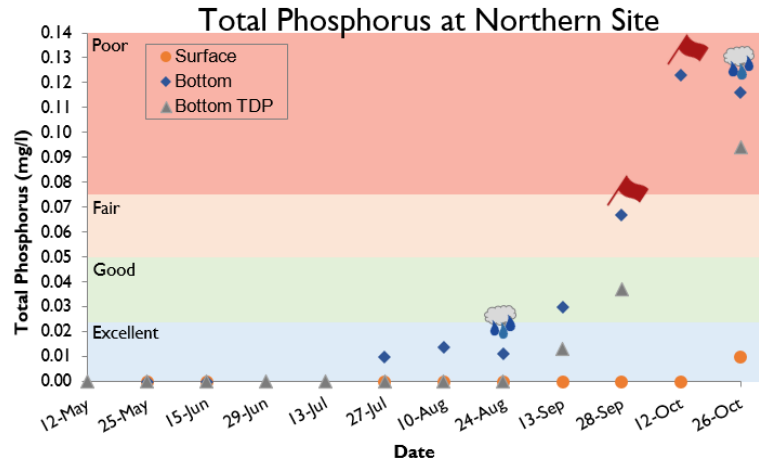
**Figure 11** - TP results at the surface primarily fell in the “Excellent” category. Bottom TP increased in concentration and reached the “Poor” category by the end of the season.

**Nutrients at Lake Quinsigamond.** Surface TP at the two in-lake sampling sites was generally very low, at or below the laboratory reporting limit of 0.010 mg/l (see *Figures 11* and *12*). Bottom TP concentrations increased over the course of the season, with the highest results on the final sampling event, 26-Oct, at 0.408 mg/l at the southern site. Bottom TP was generally higher at the southern site, with an average value of 0.166 mg/l over the course of the season compared to 0.043 mg/l at the northern site. TDP results from bottom samples ranged between below the laboratory reporting limit and 0.205 mg/l. The southern site also exhibited higher TDP concentrations than the northern site. While TP at the surface was generally very healthy, L&P will continue to monitor phosphorus concentrations at the bottom of the lake.

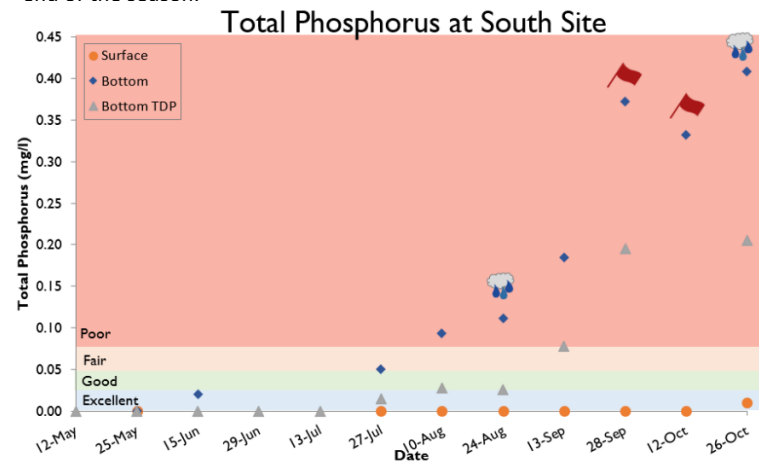
**Figure 12** - TP results at the surface primarily fell in the “Excellent” category. Bottom TP increased in concentration and reached the “Poor” category by the end of the season, with concentrations reaching higher levels than at the northern site.

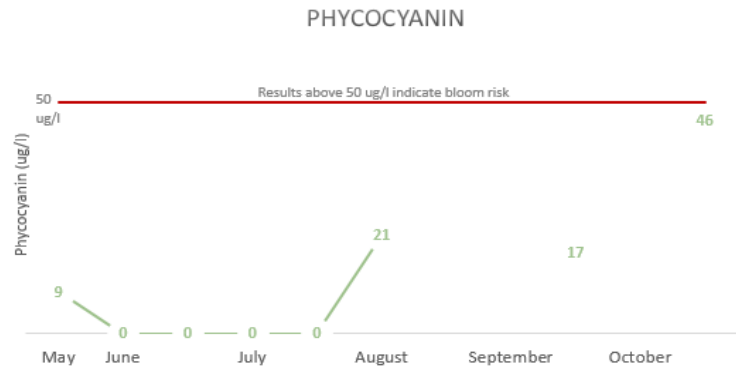
**Figure 13** - Phycocyanin measured in samples collected by the WCMC was low until the end of the season when it reached 46 ug/l.

At Lake Quinsigamond, WCMC samples were taken near the Regatta Point swimming area, just north of the Route 9 bridge. Over the course of the 2022 season, phycocyanin was detected 4 of the 8 sampling sessions but never exceeded 50 ug/l, the concentration that would indicate bloom conditions (see *Figure 13*). Phycocyanin concentration was generally higher in the second half of the season, with the highest result approaching the level

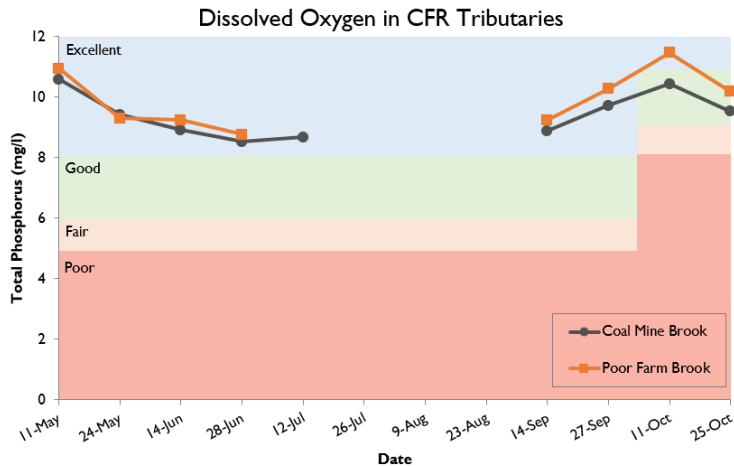
**Figure 14** - DO was above 8 mg/l in CFR streams for the entire season. During the Summer months, this was considered “Excellent”.

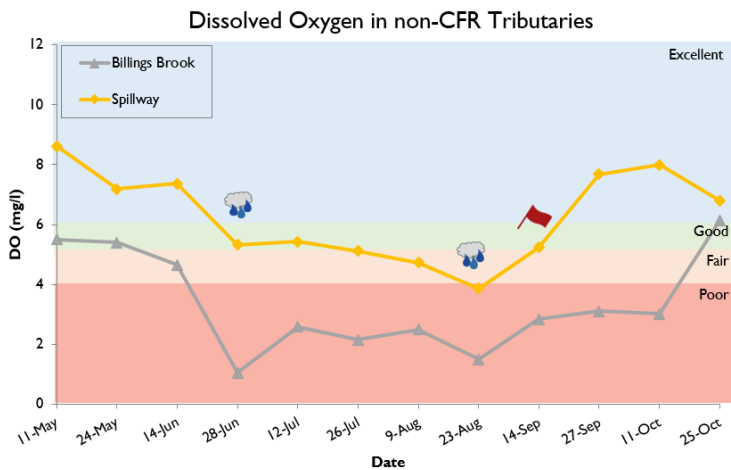
**Figure 15** – DO was in the “Fair” and “Poor” rating category for at the Spillway and Billings Brook for most of the season.

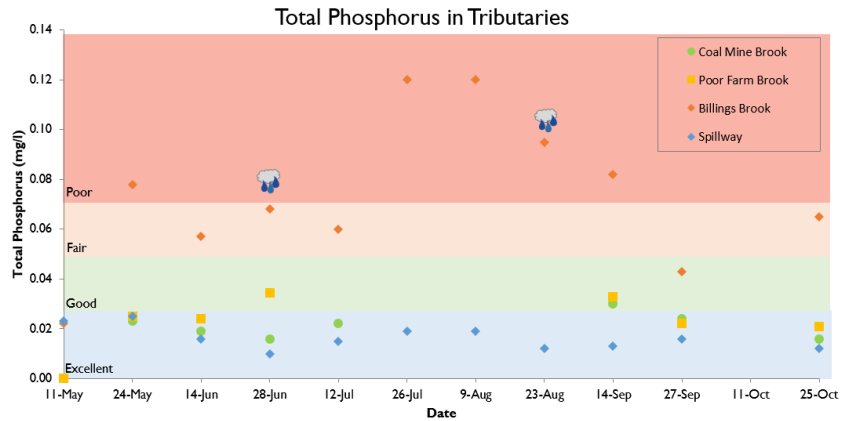
Figure 16 – TP was generally low in tributaries and at the spillway, apart from Billings Brook, which had “Poor” results even on dry weather days.

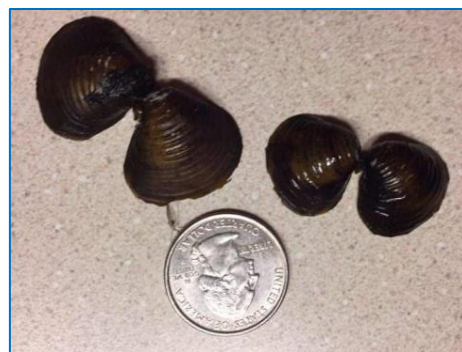
Much like invasive plants, invasive animals can severely alter the aesthetics and functioning of a lake. In 2018, an invasive mollusk, *Corbicula fluminea*, was identified in several areas of the lake. *Corbicula fluminea* has a small light brown or green shell and is native to Southeast Asia (see *Figure 18*). It is an aggressive invasive that has been known to proliferate to the exclusion of other shellfish, altering the terrain by coating the lake bottom with sharp jagged shells. They are efficient filter feeders that can reduce the food available to juvenile fish. They can also clog water intake valves. *Corbicula fluminea* can spread from one waterbody to another when they are attached to boats or equipment, but also via the bilge water of boats in their larval stage. Over the past few years, residents have found the shells of the *Corbicula fluminea* and have plotted their location in order to better understand the extent of the problem. However, to date, no live specimen has been collected. More information is needed to determine the threat level of the infestation.

**Figure 18** - The invasive mollusk (*Corbicula fluminea*).

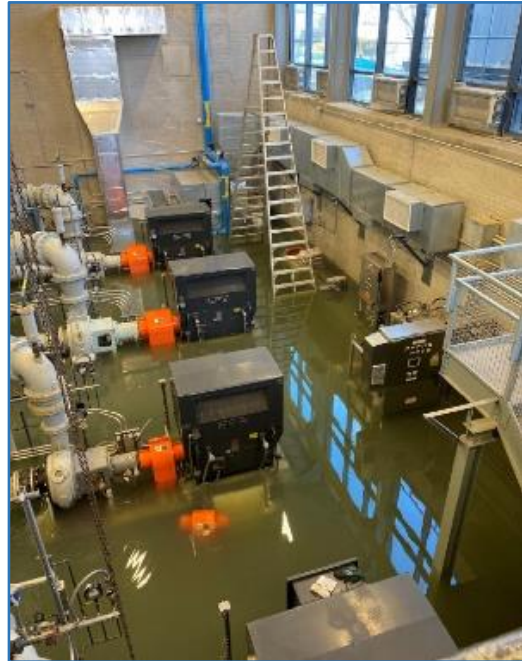
**Lake Ave Sewer Pump Station Overflow Event.** On Sunday February 6<sup>th</sup> 2022, one of the pumps at the Worcester Sewer Pump Station on Lake Ave experienced a catastrophic failure, causing the flooding the building and overflow of 5.75 million gallons of untreated sewage over 36 hours into the Lake Quinsigamond (see Figure 20). While crews worked around the clock to resolve the issue The City of Worcester Department of Inspectional Services (DIS) released a Recreational Contact Advisory for the portion of the lake south of the Route 9 bridge. For more information on the nature of the failure, a full report can be found on the City of Worcester webpage. L&P quickly created a water quality monitoring plan to monitor threats to the ecosystem and public health risks in the lake. Wastewater contains three elements that may be harmful to humans and lake wildlife: (1) fecal bacteria, (2) organic materials, and (3) other compounds of concern that people send down the drain. A sampling plan was therefore created to evaluate the parameters for E. coli, nutrients (TP, NO<sub>3</sub>, NH<sub>3</sub>), DO, metals and VOCs. Sampling was

**Figure 20** – A pump failure at the Lake Ave Sewer Pump station in February flooded the station and released 5.75 million gallons of untreated wastewater into Lake Quinsigamond.

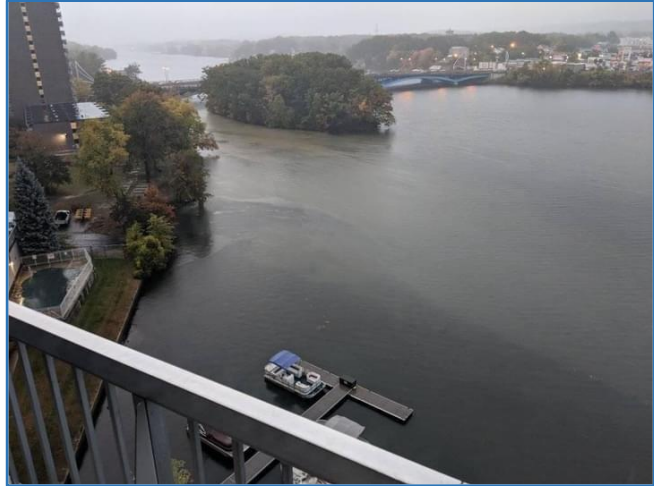
**Repeated Sediment Runoff from Belmont Street Construction Activities.** Starting in October of 2020, during periods of heavy rainfall, residents on Lake Quinsigamond noticed sediment plumes emanating from the stormwater outfall under the Route 9 bridge in Worcester (see Figure 21), creating concern among community members and city officials about water quality. Thanks to commitment by the Worcester Conservation Commission, several active construction sites along Belmont Street & Hospital Drive were identified as major contributors to the sedimentation in the stormwater system. Multiple sites in this area were undergoing construction and had large areas of open soil. These soils are primarily fine sediment, and when large rain events occurred, the sediment was not adequately filtered out by erosion controls, entered the surface drainage system turbid, and emptied into Lake Quinsigamond. Between October of 2020 and April of 2022, this occurred a minimum of six times.

*Figure 21* – During periods of rainfall, residents on Lake Quinsigamond noticed sediment plumes coming from the stormwater Outfall under Rt. 9 in Worcester.

Thanks to the combined efforts of the Conservation Commission, Mass DEP, EPA, L&P, and concerned community members, appropriate sediment control measures were enforced on the construction site, and eventually the sites were stabilized. To understand possible long-term effects of this sediment loading, the continuous monitoring buoy that was previously deployed at the southern in-lake site was relocated to the area just south of Ramshorn Island. Additionally, Secchi depth readings were attempted

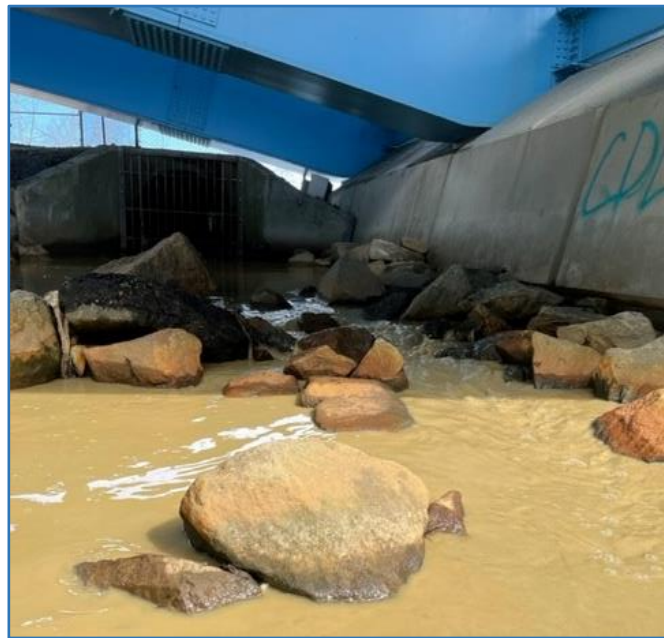
Sediments are concerning to lake water quality because they carry nutrients such as phosphorus, adding to nutrient loading that is already detrimental to water quality, and potentially stimulating the growth of cyanobacteria and invasive aquatic plants. They can also harm fish gill structures and egg masses, and physically shallow a waterbody. Because of these potential detrimental effects, L&P attempted to quantify the impact of the erosion events.

*Figure 22* – Fine sediments from construction sites off Belmont Street greatly reduced water clarity and contributed nutrients to Lake Quinsigamond.

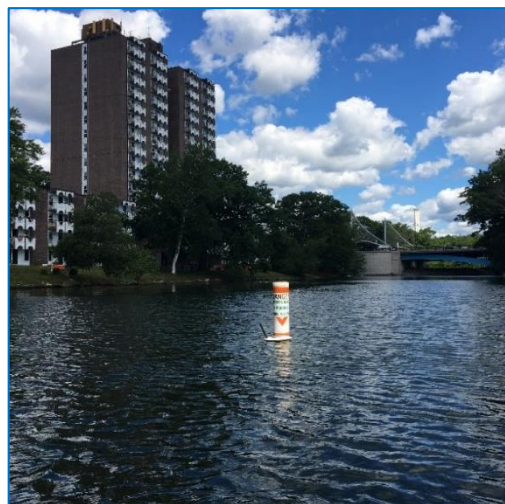
*Figure 23* – A continuous monitoring buoy was relocated just south of the Route 9 Outfall to track possible effects from increased disturbances over the past year.

The Lakes and Ponds Program visits Lake Quinsigamond twice a month to collect water quality data, but because of the size of the lake, it can be a challenge to capture all the changes that are happening during these two visits alone. In 2021, the Lakes and Ponds Program installed solar powered continuous remote monitoring buoys to collect data related to cyanobacteria (see *Figure 23*). These buoys contain probes that track phycocyanin, chlorophyll, turbidity, and temperature, and remotely upload them to an online database every 30 minutes, 24 hours a day. These data can be viewed in real time L&P and even have alarms if results are above certain preset thresholds. Previously, the buoys were situated at the northern and southern in-lake sampling sites. For the 2022 season, the southern buoy was relocated to in between Ramshorn Island and the Worcester shoreline, south of the Route 9 outfall to better track possible effects from increased disturbances over the past year. The hope is to eventually deploy these devices in more locations to complement other monitoring efforts and make the data available to the public in real time.

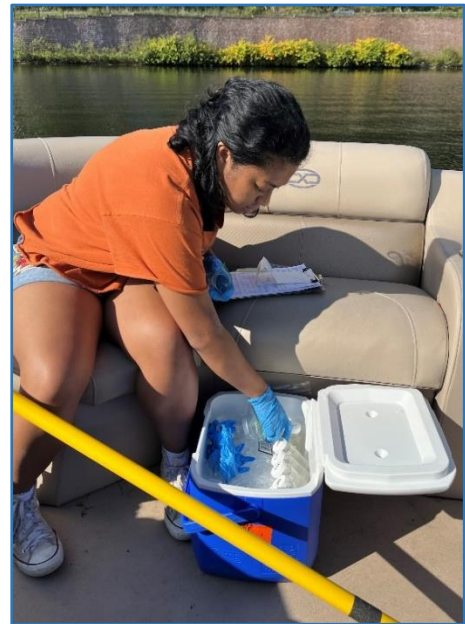
**Figure 25** – Volunteers and an intern from LQWA collected samples for *E. coli* from 10 locations in and around Lake Quinsigamond to assess potential inputs to the lake.

In 2022, Samples were collected on 8 days, 20-Jun, 11-Jul, 26-Jul, 9-Aug, 24-Aug, 9-Sep, 23-Sep, and 7-Oct. Results above the recreational threshold of 235 cells/100 ml were commonly seen in 5 of the 10 locations: Belmont St. Outfall, Coal Mine Brook, Billings Brook, O Hara Brook, and Fitzgerald Brook. Similar to the findings of L&P, bacteria was not found in concerning concentrations in the middle of the lake. For a full report on LQWA's findings, see their website at [lqwa.org](http://lqwa.org).
