# Coes Reservoir

## 2023 Water Quality Report

### Summary

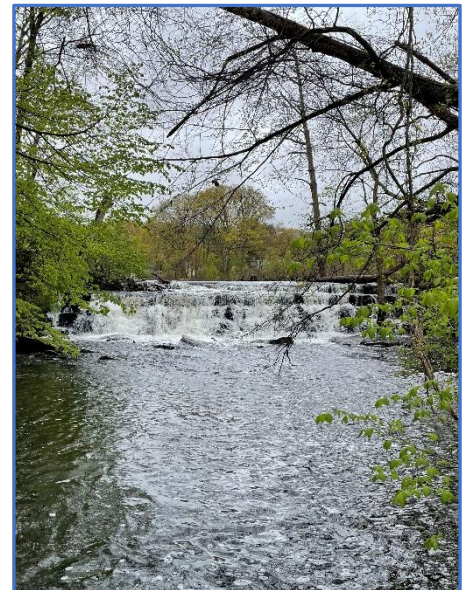
**Figure 2** - Coes Reservoir's sole tributary, Tatnuck Brook exhibited periods of high flow through the 2023 sampling season.

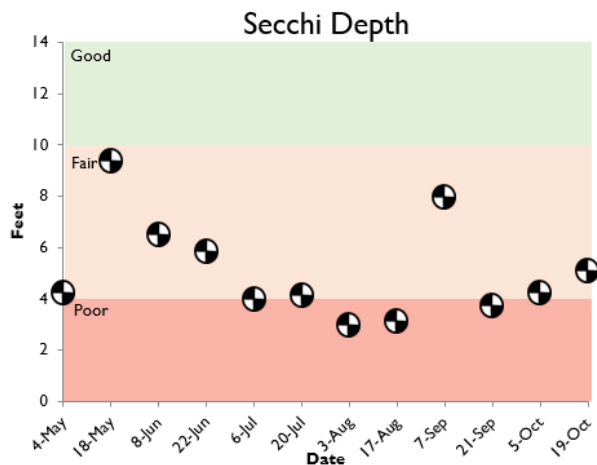
**Water Clarity at Coes Reservoir.** Secchi clarity at the two in-lake sites in Coes Reservoir ranged between 3 ft and 9.5 ft (see *Figure 4*). Most readings fell between 4 and 10 ft, or in the range considered “Fair” although several results were lower than 4 ft, or in the range considered “Poor”. Clarity readings were highest at the beginning of the season and lowest in August and September. Surface TSS at Coes Reservoir ranged between 2.5 and 6.0 mg/L, consistently falling below 10 mg/L, or in the range considered “Excellent”. Results at the bottom ranged between 3.3 and 11 mg/L, and were generally lower than 10 mg/L. In Tatnuck Brook, TSS results were lower, ranging between 2.2 and 3.9 mg/L. At the outlet, TSS ranged between 2.9 and 5.9 mg/L, with all results falling below 10 mg/L. In 2023, the majority of Secchi depth readings were considered "Fair". Because of this, water clarity in Coes Reservoir received a rating of “Fair” in 2023.

**Figure 4** - Secchi depth was ranged from the "poor" to "fair" categories throughout the season. "Poor" secchi depth was seen generally later in the season.

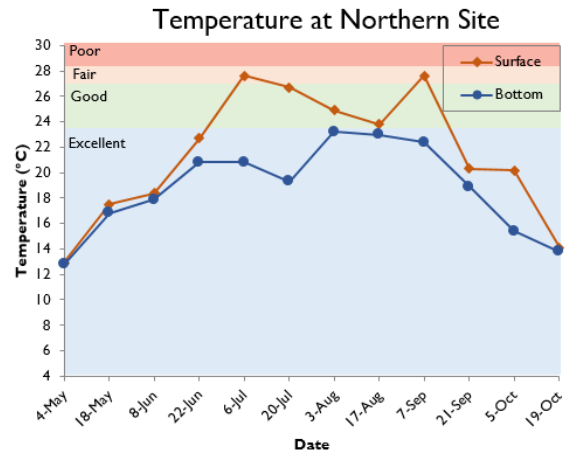
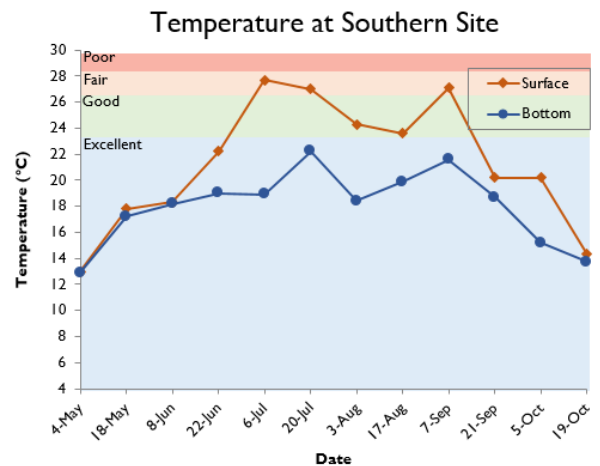
**Temperature at Coes Reservoir.** Surface water temperature at the in-lake sites rose at the beginning of the season, reaching the maximum recorded temperature on 6-Jul and generally decreasing into the fall, with one abnormally warm day on 7-Sep (see *Figures 5 and 6*). Maximum recorded surface temperatures in 2023 were on par with the last few years; 27.6°C at the Northern Site and 27.7° in the Southern Site. As expected, bottom temperature at the Northern and Southern Sites were always lower than the surface but followed the same seasonal fluctuations. This season L&P rates temperature in Coes Reservoir as "Good".

**Figures 5 and 6** - Bottom temperatures were considered "excellent" all season. Surface temperatures were in the "good" to "excellent" categories except for three dates that were considered "fair".

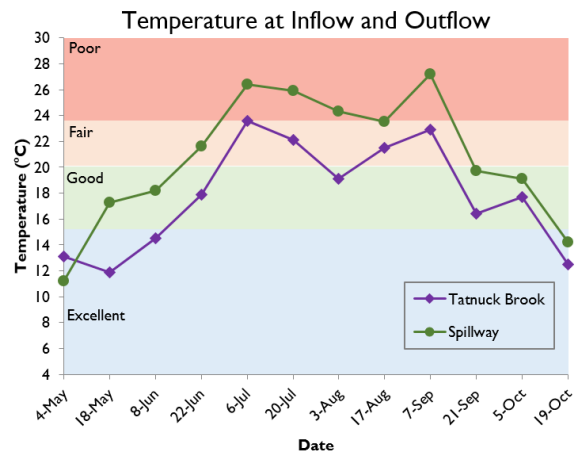
Tatnuck Brook is the major tributary to Coes Reservoir. It is a designated Coldwater Fisheries Resource, a special designation given to waterways that support cold water fish species such as trout. These fish require higher quality water than warm water species. The outlet of Coes Reservoir is the spillway at its southern end. Water temperature in Tatnuck Brook was warmer than ideal (see *Figure 7*). Most temperature readings were above 15°C, and during the warmest parts of summer the brook entered the "Fair" category for temperature. Four readings were recorded above 20°C, the upper avoidance limit for cold water fish. The temperature at the lake outlet was on average 3°C higher than in Tatnuck Brook, demonstrating how much the brook warms after passing through Coes Reservoir.

**Figure 7** - The temperature at the lake outlet was on average 3°C higher than in Tatnuck Brook, demonstrating how much the brook warms after passing through Coes Reservoir

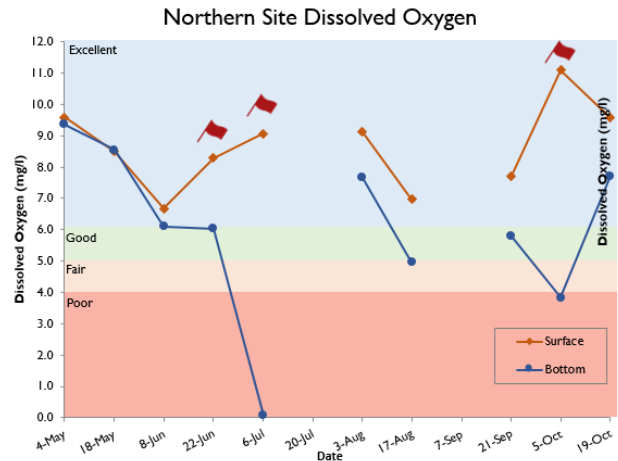
**Dissolved Oxygen at Coes Reservoir.** Surface DO at the in-lake sites was above 6 mg/L, or in the range considered "Excellent", in all but one instance (see Figures 8 and 9). Other than one low outlier reading on 17-Aug (5.43 mg/L), surface DO ranged between 6.68 and 11.33 mg/L and followed a similar pattern throughout the season at the Northern and Southern Sites. Measurements on the bottom had a large range, between 0.07 and 9.80 mg/L. At the Northern and Southern Sites, DO was highest at the beginning and end of the season. In the southern site DO was below 4 mg/L, considered "Poor" between 22-Jun and 17-Aug. Due to censored data points on 20-Jul and 7-Sep, it is difficult to determine a clear pattern in bottom DO at the Northern Site.

**Figure 8** - Dissolved oxygen at the surface was categorized as "excellent" throughout the season. Bottom dissolved oxygen ranged from the "excellent" to "poor" categories, "poor" conditions were seen mid-summer.

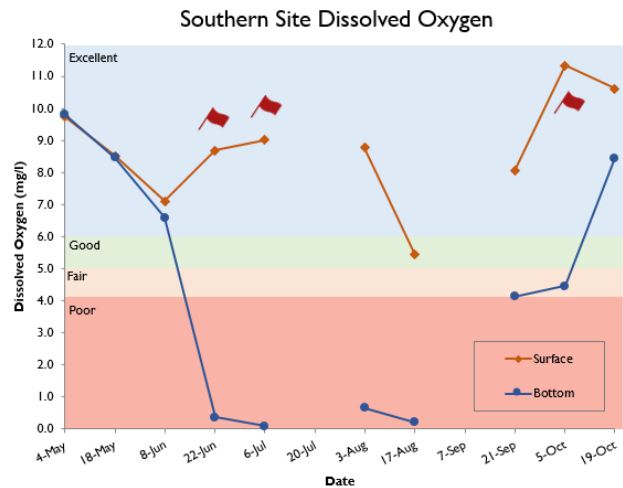
**Figure 9** - Dissolved oxygen at the surface was categorized as "excellent" except for one day when it was "good". Bottom dissolved oxygen ranged from the "excellent" to "poor" categories, "poor" conditions were seen mid-summer.

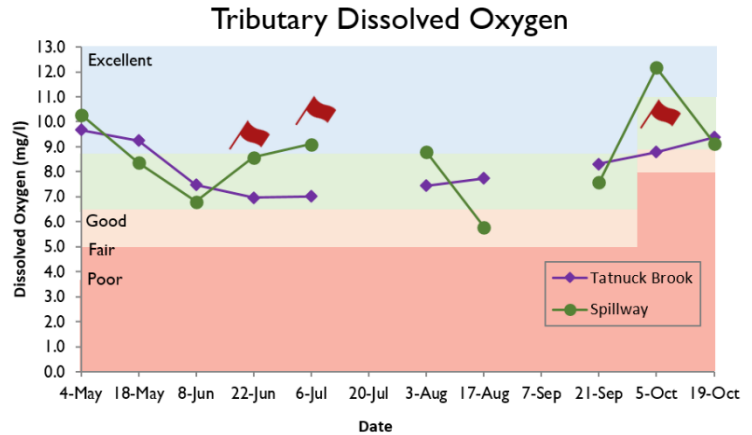
DO in Tatnuck Brook ranged between 6.96 and 9.67 mg/L, with most readings in the range considered "Good" (see Figure 10). In the spillway, ranged between 5.79 and 12.16 mg/L, with all but one reading above 6 mg/L, or in the range considered "Excellent".

**Figure 10** – DO in Tatnuck Brook ranged between 6.96 and 9.67 mg/L, with most readings in the range considered "Good". In the spillway, ranged between 5.79 and 12.16 mg/L, with all but one reading above 6 mg/L, or in the range considered "Excellent".

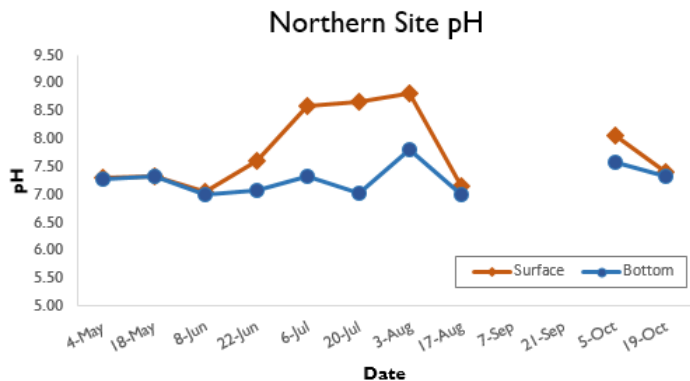
**Figure 11**- North Site: pH ranged from 7.05 - 8.82 at the surface and 6.99 - 7.79 at the bottom.

**pH at Coes Reservoir.** Surface pH at the in-lake sites ranged between 7.40 and 8.21 over the course of the season (see Figures 11 and 12). The highest recorded pH at the Northern and Southern Sites was recorded on 20-Jul and 3-Aug, concurrent with some of the season's highest cyanobacteria counts. Bottom pH readings at each site had a smaller range, 6.65 to 7.79, with no discernible pattern throughout the season. At Tatnuck Brook, pH ranged between 6.67 and 8.64, also not showing a pattern through the season. At the outlet, pH between 7.11 and 8.75, and more closely followed the in-lake distribution.

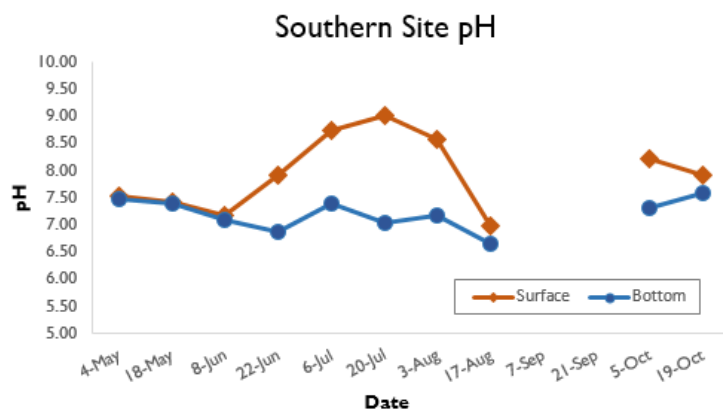
**Figure 12**- South Site: pH ranged from 6.97 - 9.01 at the surface and 6.65 - 7.58 at the bottom.

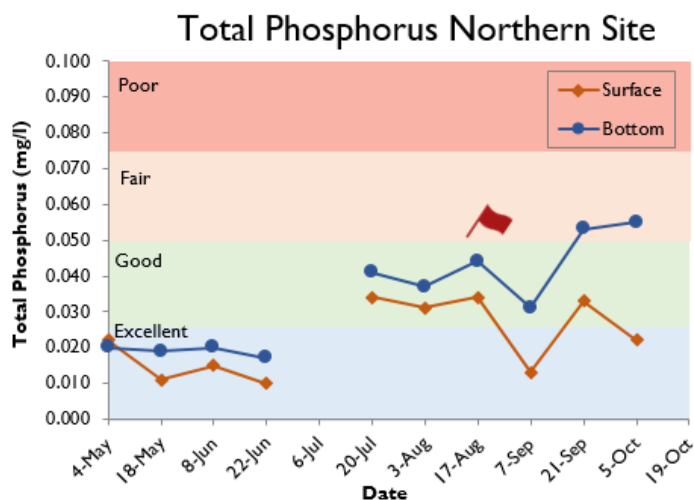
**Figure 13** - Surface total phosphorus in the Northern site was considered "excellent" at the beginning of the season and end of the season, with several results in the "good" category between July and September. Bottom Total Phosphorus started in the "excellent" category, with more results in the "good" and "fair" categories as the season went on.

**Nutrients at Coes Reservoir.** At the in-lake sites, TP on the surface ranged from 0.010 to 0.034 mg/L, with some results considered “Excellent” and most within the “Good” range (see *Figures 13 and 14*). Recorded surface TP generally increased over the course of the season at both sites. Bottom TP was almost always higher and ranged from 0.015 to 0.163 mg/L, generally increasing as the season went on. Samples were also collected for TDP at the bottom in the Northern and Southern Sites. Results were generally in the ranges considered “Excellent” and “Good”, however on 17-Aug the result from the Southern Site was 0.153 mg/L, in the category considered “Poor”.

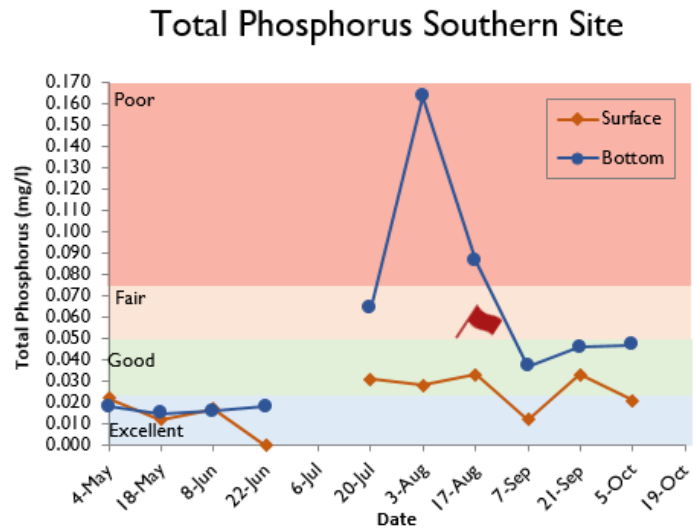
**Figure 14** - Surface total phosphorus in the Southern site was considered “excellent” at the beginning of the season and end of the season, with several results in the “good” category between July and September. Bottom Total Phosphorous started in the “excellent” category, with more results in the “good”, “fair”, and poor categories as the season went on.

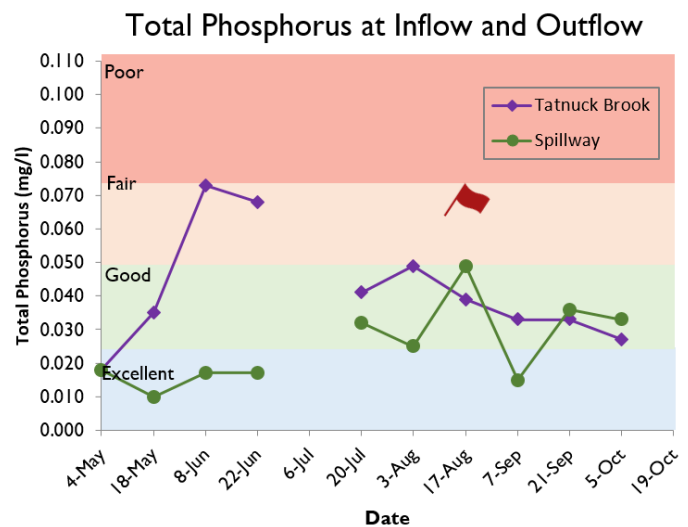
TP results in Tatnuck Brook ranged between 0.018 and 0.073 mg/L, although most results were between 0.025 mg/L and 0.050 mg/L, the range considered “Good” (see *Figure 15*). The “Fair” results did not occur on wet weather days. At the outflow results were generally lower, ranging between 0.010 and 0.049 mg/L, with results in the categories considered “Excellent” and “Good”.

**Figure 15** - Total phosphorus results in Tatnuck Brook were in the “good” and “fair” categories. Total phosphorus measured at the spillway was considered “excellent” to “good”.

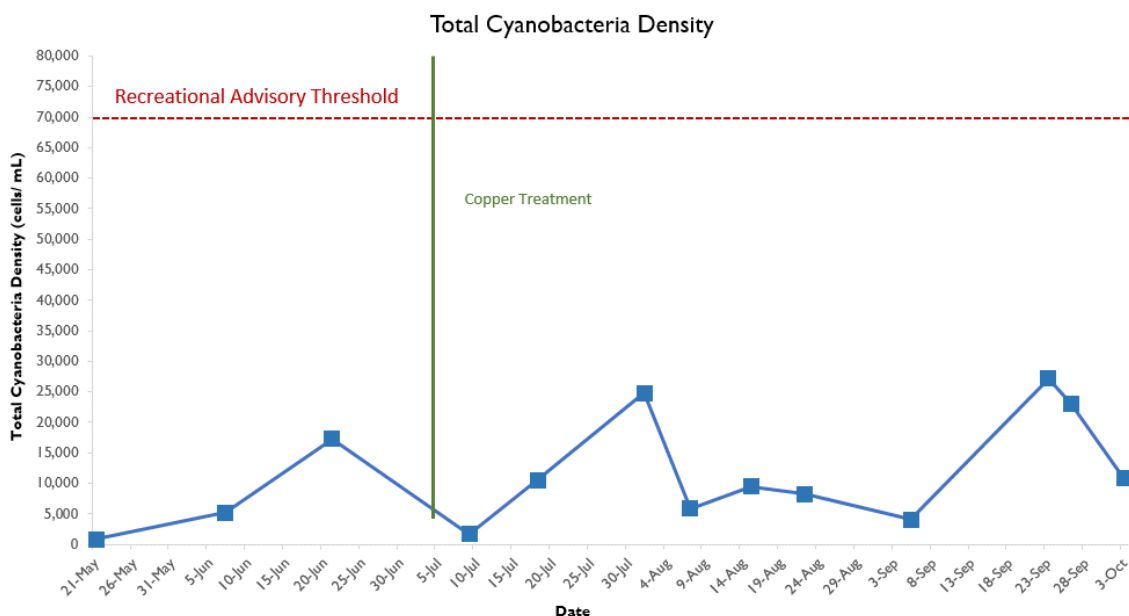
**Cyanobacteria at Coes Reservoir.** There were no closures due to cyanobacteria exceedances at Coes Reservoir in 2023. Cyanobacteria cell counts remained low in the early season, beginning to increase in late June (see *Figure 16*). Due to a count of 17,300 indicating potential exponential growth, a preventative algaecide treatment was conducted on 7-Jul. Results from a test on the same day indicated that numbers had naturally fallen on their own. Though cell count results rose and fell two more times, no more treatments were required to avoid bloom conditions. Despite the implementation of a copper sulfate treatment on 7-Jul in response to rising cyanobacteria cell counts, Coes Reservoir was never closed due

**Figure 16** – Cyanobacteria cell density over the course of 2023 at Coes Reservoir. Results over 70,000 cells/ml trigger a recreational advisory and lake closure.

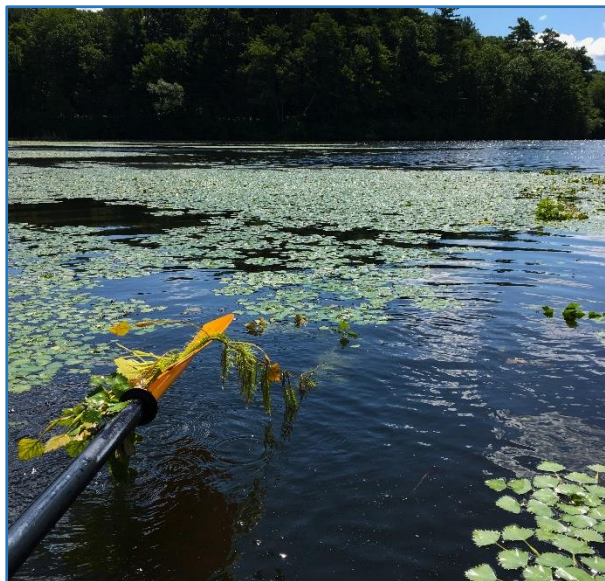
**Figure 17** – Invasive Water Chestnut in Coes Reservoir’s Northern cove.

***Invasive Aquatic Plants and Animals at Coes Reservoir.*** Coes Reservoir is managed for three invasive aquatic plants: Water Chestnut (*Trapa natans*) (see Figure 17), Fanwort (*Cabomba caroliniana*), and Eurasian Milfoil (*Microphyllum spicatum*). Before the utilization of chemical treatments, milfoil and water chestnut threatened to overtake the entire reservoir. To address populations of these plants, the Lakes and Ponds Program uses a combination of physical removal and herbicide strategies. A successful systemic herbicide treatment of Fluoridone (trade name: Sonar) took place in 2019 and significantly reduced the fanwort and milfoil density through the present. As in 2022, plant management in 2023 focused on continuing to eradicate water chestnut. Imazamox (trade name: Clearcast) was applied to the northern portion of the lake on 7-Jul and 2-Aug of 2023. To address water chestnut plants that were not covered by herbicide treatment, Tatnuck Brook Watershed Association (TBWA) organized a volunteer hand pulling event in early August, in which community members collected plants and trash in kayaks over the course of a morning. Together, these activities were successful in reducing the density of the invasive plant during the season. Unfortunately, due to its unique reproductive strategy, it may be many more years before the water chestnut will be completely eradicated.

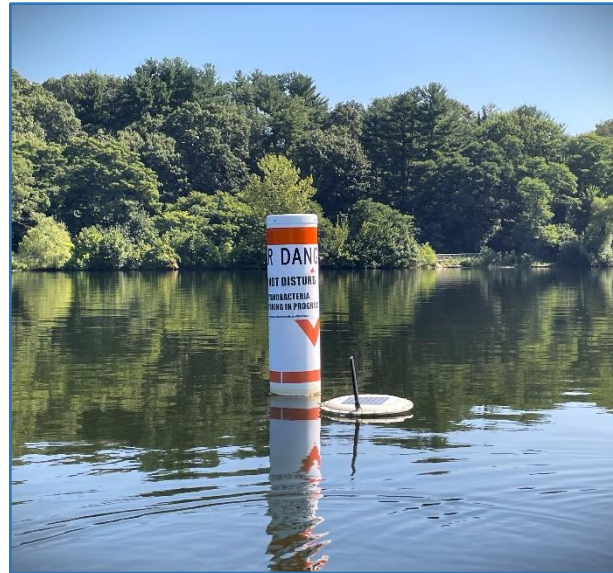
**Figure 18** – A continuous monitoring buoy was deployed at Coes Reservoir in 2023 to collect parameters associated with cyanobacteria activity.

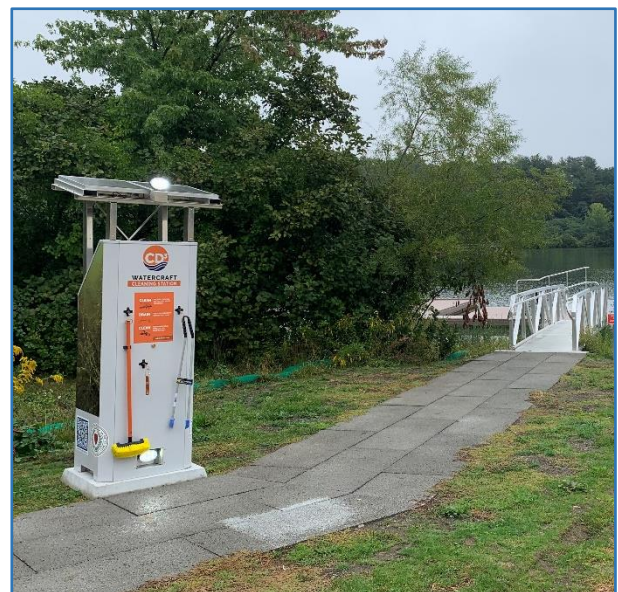
**Figure 19** - Solar powered boat decontamination stations were installed at Coes Reservoir to help enable boaters to stop invasive plants at the source by decontaminating watercraft before and after use.

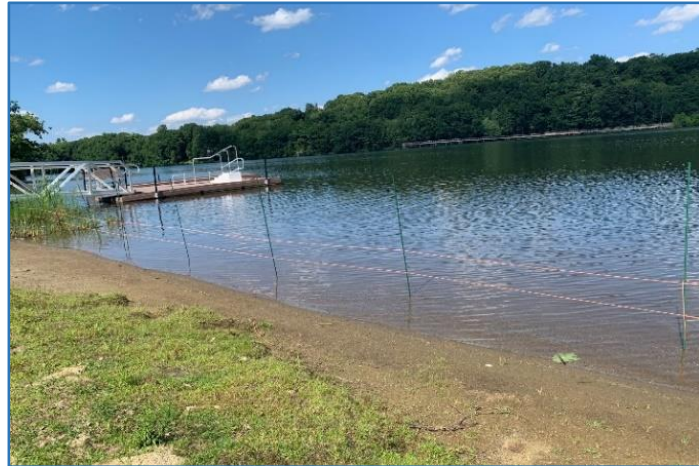
**Figure 20** – Goose fencing at Coes Reservoir was successful in deterring geese from the beach area.

**Goose Fencing.** In 2021, the Lakes and Ponds Program implemented a Goose Fencing Pilot Project that aimed to reduce the number of beach closures at Indian Lake and Coes Reservoir due to fecal bacteria exceedances by humanely keeping geese away from the beach (see Figure 20). Geese usually enter the beach from the water and cannot easily get over low fences. They are uncomfortable when there are barriers between the beach and the water because the water is their escape route from land predators. After City lifeguards erected small fences between the shore and water during the evening hours, L&P found the use of the beach by the geese was significantly reduced, and beach closures due to *E. coli* also seemed to be reduced. In 2023, lifeguard staffing challenges led to minimal implementation of fencing. In 2024, as lifeguard staffing is available, L&P plans to continue the use of goose fencing at the Mill St. beach.

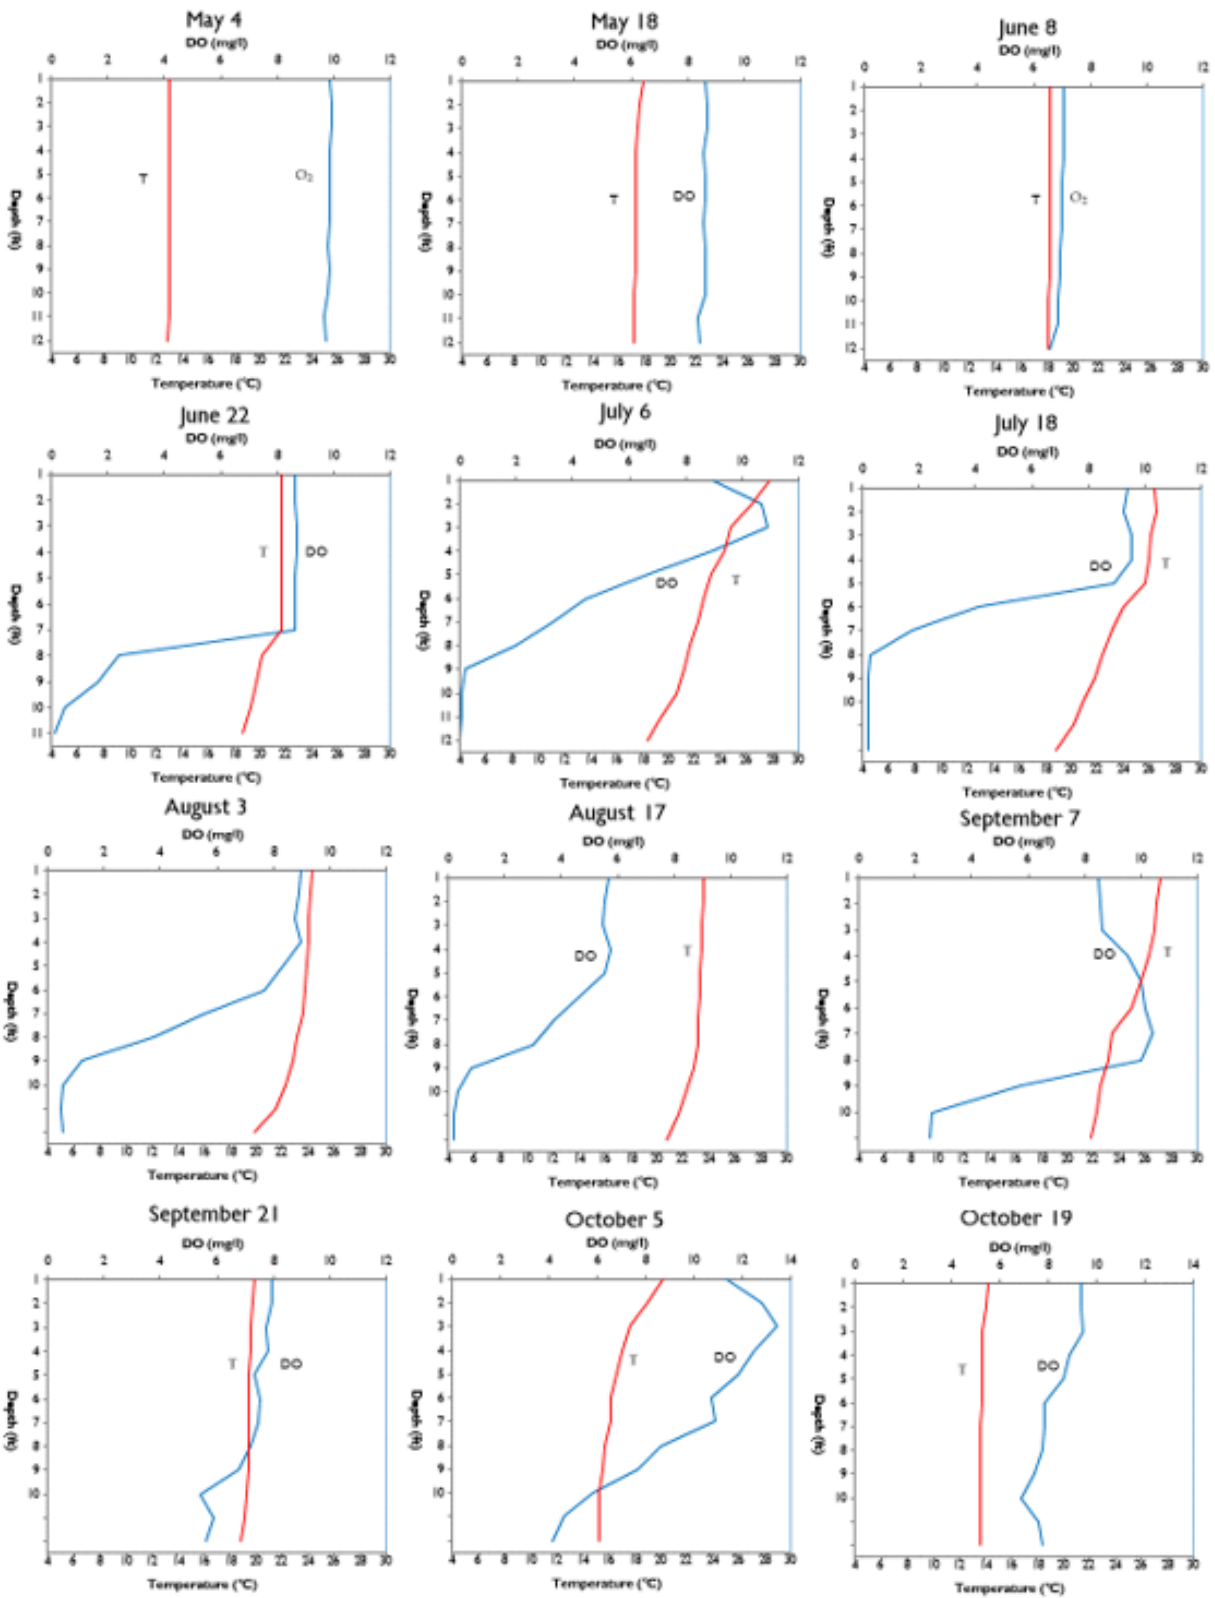
## Appendix: Depth Profiles

Increased algal growth followed by excessive decomposition of organic material can also lead to low oxygen (hypoxic) conditions, potentially causing fish kills. DO was measured using a galvanic DO sensor on a handheld probe at the water's surface, and two feet from the bottom at the in-lake locations. To form a more complete picture of how DO changes through the water column, depth profiles were created by taking measurements at 1-ft increments through the water column.

To determine whether oxygen depletion occurs in the water column, lake profiles were taken in which DO readings were measured at 1 ft intervals. The water column was uniformly oxygenated during the first sampling session (see Appendix). Beginning in the end of June, a distinct oxycline developed in which DO concentration fell below 4 mg/L, at 8 ft and below. From July through early September, a clear oxycline was observed in which water above 8 ft was fully oxygenated, and water below was hypoxic. By the end of September, the water column was fully oxygenated to the end of the season. In 2023, L&P observed more extreme hypoxia than in the past. Additional seasonal depth profiles are needed to determine whether this is a unique case or indicative of a trend. Though surface DO was consistently considered "Excellent", depth profiles indicated that notable portions of the water column were hypoxic between late June and early September. However, as the surface was always fully oxygenated, there was space for aquatic organisms to find refuge. This season L&P rates DO in Coes Reservoir as "Fair".
