Wetland Resource Area Restoration Protocol and Compliance Assessment

Proposed Single Family Home Project

6 Lanesboro Road

June 10, 2024

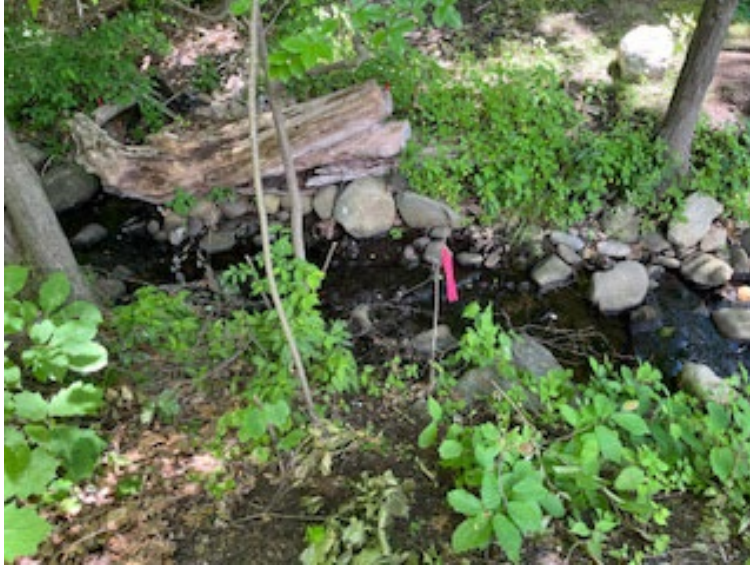
The stream Banks within the proposed impact area are abrupt and consist of boulders and cobbles. Sparse vegetation was observed upon the Banks and one northern spicebush (*Lindera benzoin*) shrub shall be removed from the westerly Bank during construction. No BVW is present above the Banks which are proposed to be temporarily impacted. A representative photo of the proposed Bank impact area is provided below:

View looking eastward showing intermittent stream Bank to be temporarily Impacted. Note wetland Bank flag BA6 in center of photo.

6. The stones, boulders and subgrade material along the stream Banks and stream bed shall be excavated within the sewer pipe layout and placed aside within the temporary stockpile area. The trench shall be excavated with a mini excavator to the specified depth (approximately 1.5 feet below channel bottom).

8. The 6" sewer pipe shall then be installed, flowable fill placed as necessary to minimize inflow and leakage, and the trench backfilled.
9. The stream channel and stream Banks shall be immediately reconstructed with the stockpiled, indigenous materials under the supervision of the Wetland Scientist. If necessary, additional stones from the site may be utilized for the stream bed and Bank repair.

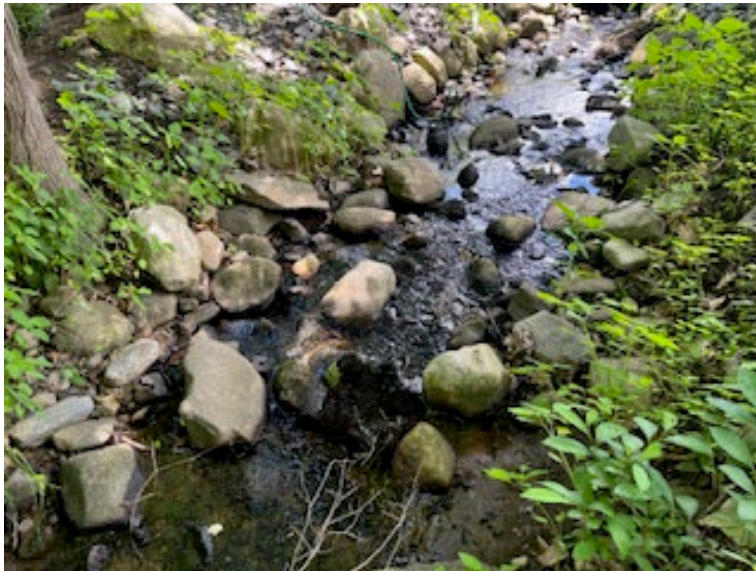
The stream bed (i.e., LUWW) within the proposed temporary impact area consists of stones, cobbles and boulders with a thin layer of medium/coarse sand. The channel bottom is firm and EcoTec was unable to penetrate the stream channel bottom with a hand auger due to the stony substrate. No emergent or submerged vegetation is present within the temporary impact area of the stream bed. On the date of inspection, base flows within the stream channel were approximately 1” to 3” deep. A representative photo of this area is provided below:

View looking southward showing stream bed (LUWW) in the vicinity of the temporary alteration.
